January 24, 2025

Subject: Site Inspection Report for Canyon Elementary School, 421 Entrada Drive, Santa Monica, California

Field Notes and Photographic Log

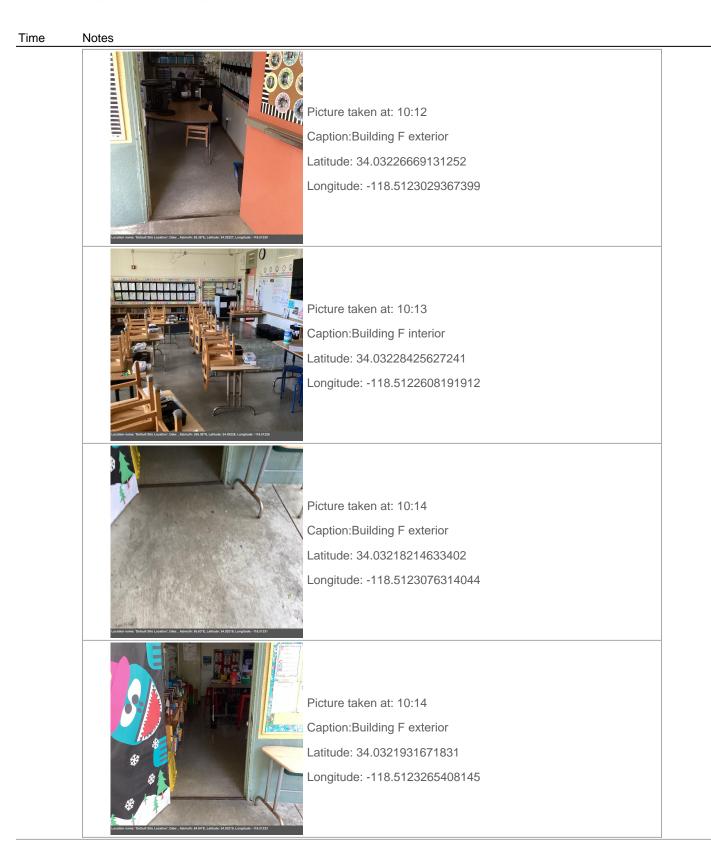
During the inspection on January 18, 2025, minor visible suspect ash was observed in Room 10 of Building F. Terraphase staff notified LAUSD personnel, who took corrective action to remove the visible suspect ash. Smoke odor was noted upon entering all rooms in Buildings A, B, C, D, and Room 21 in Building F.

)	Notes		
	Externant Partel Resource Partel P	Picture taken at: 10:07 Caption:Building F interior Latitude: 34.0325493153434 Longitude: -118.5123018760395	
	Exerciser 2002 Exe	Picture taken at: 10:09 Caption:Ash present in Room 10 building F Latitude: 34.03251774822834 Longitude: -118.5122917913549	
		Picture taken at: 10:11 Caption:Building F interior Latitude: 34.03239749405564 Longitude: -118.5123040858636	
		Picture taken at: 10:11 Caption:Building F interior Latitude: 34.03242135210971 Longitude: -118.5122948595271

- Utilize High-Efficiency Particulate Air (HEPA)-equipped air filtration and deodorizing units in areas where smoke odor was noted including all rooms in Buildings A, B, C, D, and Room 21 of Building F.
- Perform general cleaning of areas where ash was observed.
