January 24, 2025

Subject: Site Inspection Report for Kenter Canyon Elementary School, 645 N Kenter Avenue, Los Angeles, California

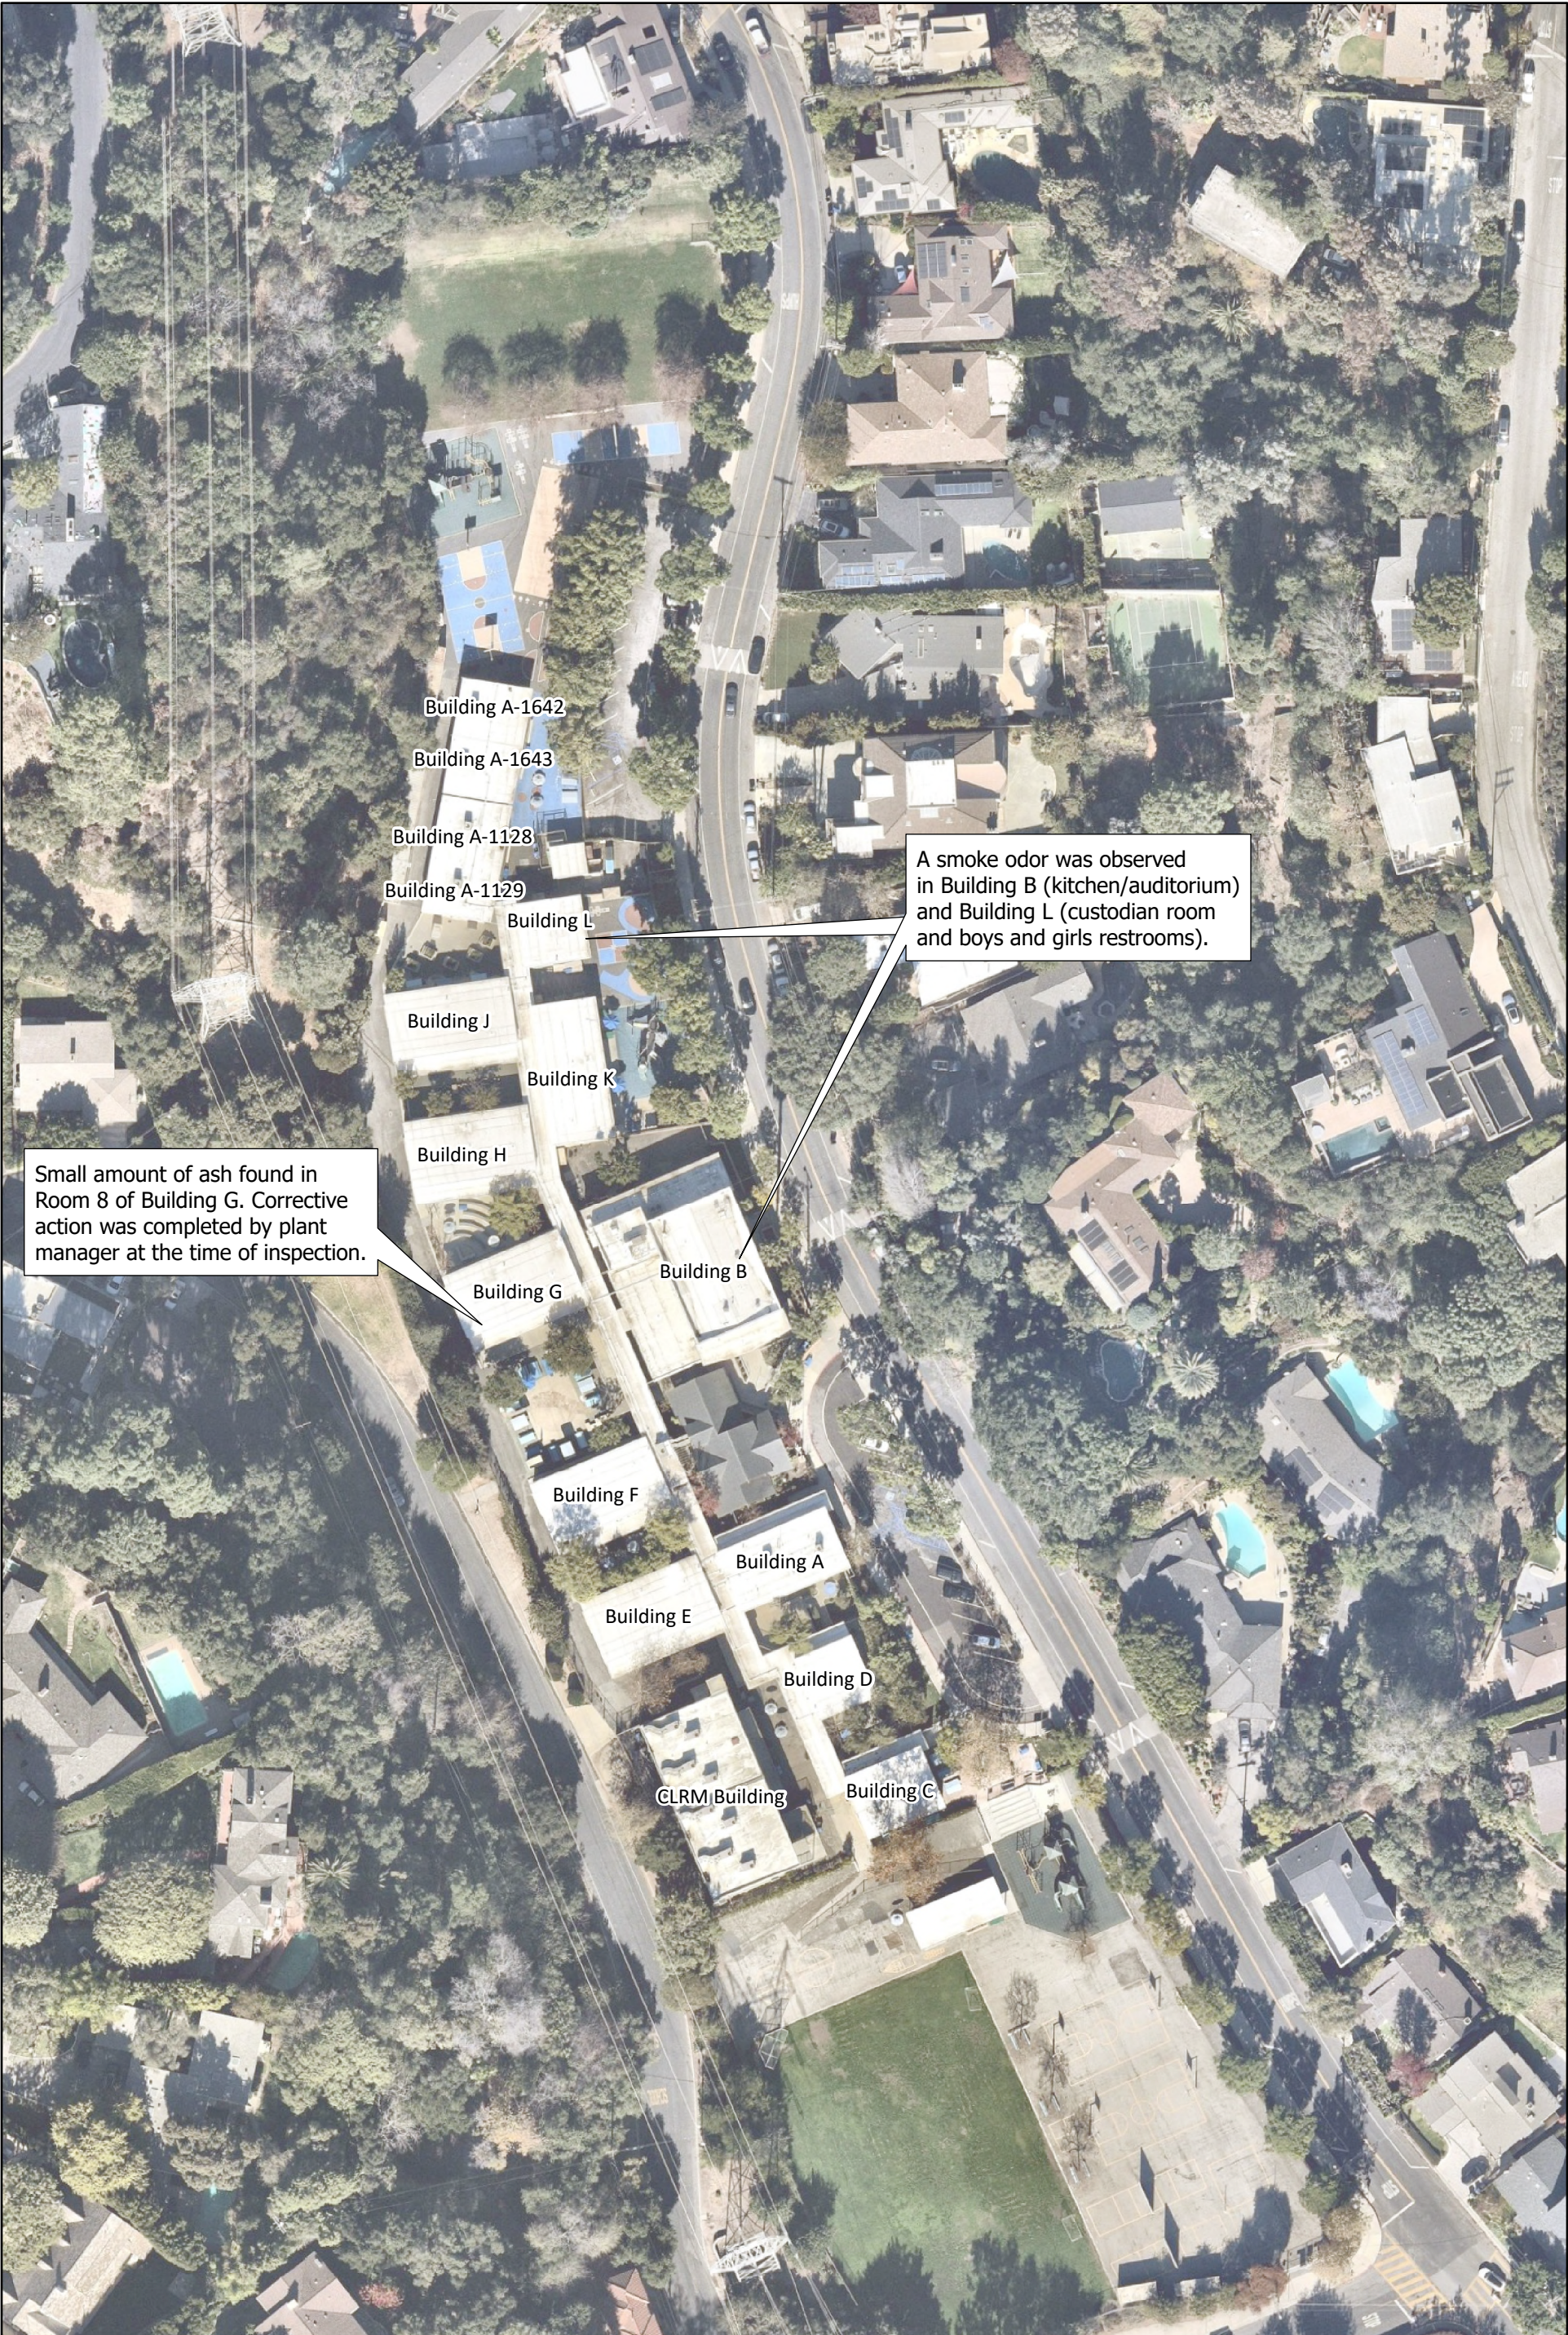
</div></div>	<div>CLIENT: LAUSD</div> <div>PROJECT: Palisades Fire Response 645 N Kenter Ave, Los Angeles, CA</div> <div>PROJECT NUMBER: S030.073.001</div>	<div>Kenter Canyon Elementary School Site Map</div> <div>FIGURE 2</div>

Small amount of ash found in Room 8 of Building G. Corrective action was completed by plant manager at the time of inspection.

A smoke odor was observed in Building B (kitchen/auditorium) and Building L (custodian room and boys and girls restrooms).

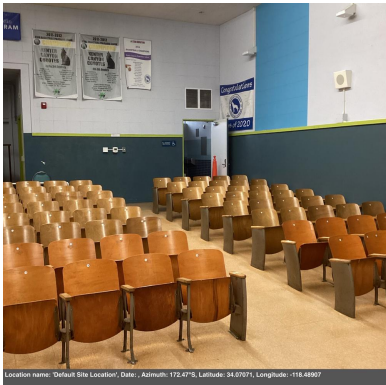
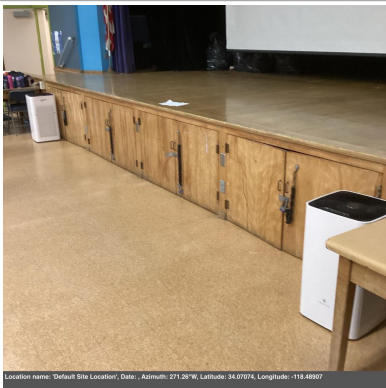
During the inspection, minor visible suspect ash was observed in Room 8 of Building G. Terraphase staff notified LAUSD personnel, who took corrective action to remove the visible suspect ash. Smoke odor was identified by olfaction upon entering the Kitchen and Auditorium in Building B and Custodian's Room, and Boy's and Girl's Restrooms in Building F.

Picture taken at: 07:34
Caption:Auditorium interior.
Latitude: 34.07070820348186
Longitude: -118.4890680634035

Picture taken at: 07:35
Caption:Auditorium interior.
Latitude: 34.07073597958988
Longitude: -118.4890734910593

- Utilize High-Efficiency Particulate Air (HEPA)-equipped air filtration and deodorizing units in areas where smoke odor was noted including the Kitchen and Auditorium in Building B and Custodian's Room, and Boy's and Girl's Restrooms in Building F.
- Perform general cleaning of areas where ash was observed.

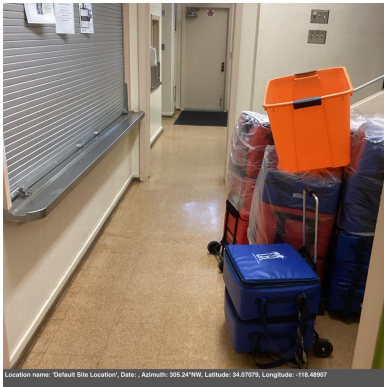
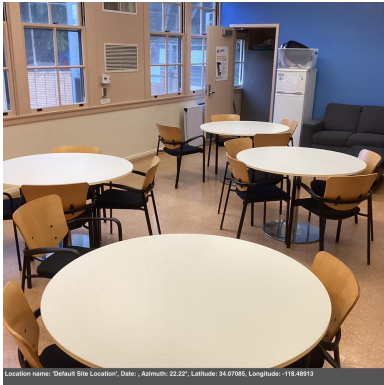
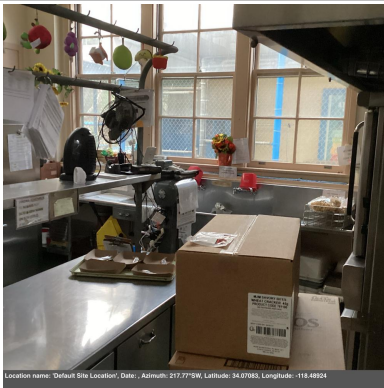
Picture taken at: 07:36
Caption: Kitchen interior.
Latitude: 34.07079186056244
Longitude: -118.4890660182093

Picture taken at: 07:36
Caption: Kitchen interior.
Latitude: 34.07085323200625
Longitude: -118.4891291752299

Picture taken at: 07:37
Caption: Kitchen interior.
Latitude: 34.0708291830644
Longitude: -118.4892423514212

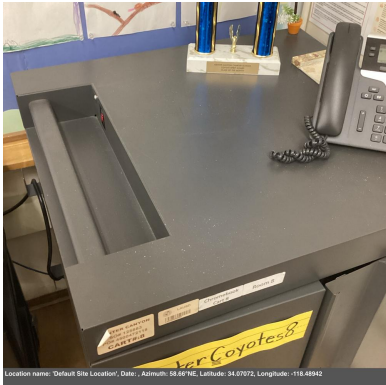
Picture taken at: 07:42
Caption: Room 8 ash present.
Latitude: 34.07071786719325
Longitude: -118.4894229871059

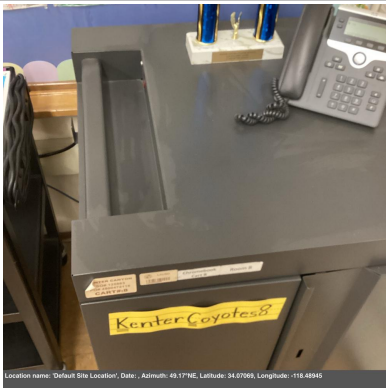
Picture taken at: 07:44
Caption: Room 8 ash removed.
Latitude: 34.07069334513223
Longitude: -118.4894542535565

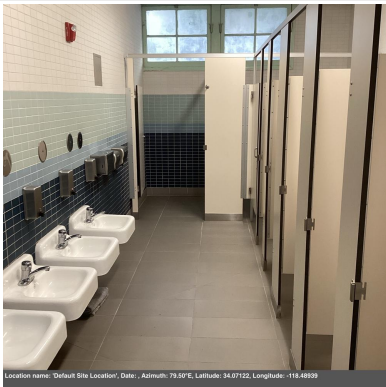
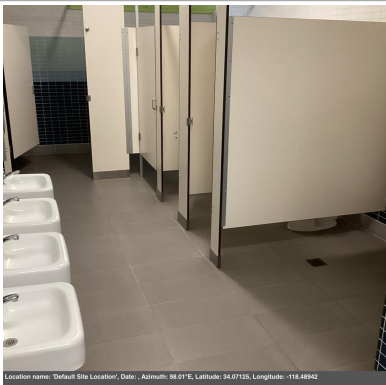
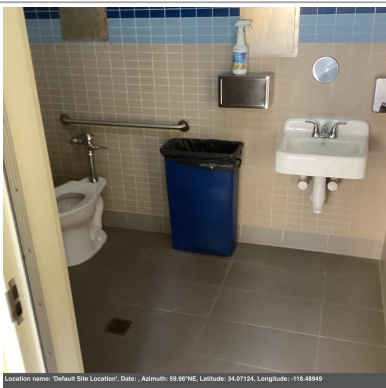
Picture taken at: 07:55
Caption: Building L restrooms.
Latitude: 34.07121611007632
Longitude: -118.4893897683216

Picture taken at: 07:56
Caption: Building L restrooms.
Latitude: 34.07125283398554
Longitude: -118.4894219312079

Picture taken at: 07:57
Caption: Building L restrooms.
Latitude: 34.07124248090737
Longitude: -118.4894942749922
