Limited Wildfire Smoke Impact Assessment
Lanai Road Elementary School
4241 Lanai Road
Encino, California 91436

Los Angeles Unified School District
333 S. Beaudry Avenue, 21st Floor | Los Angeles California 90017

January 23, 2025 | Project No. 211936035

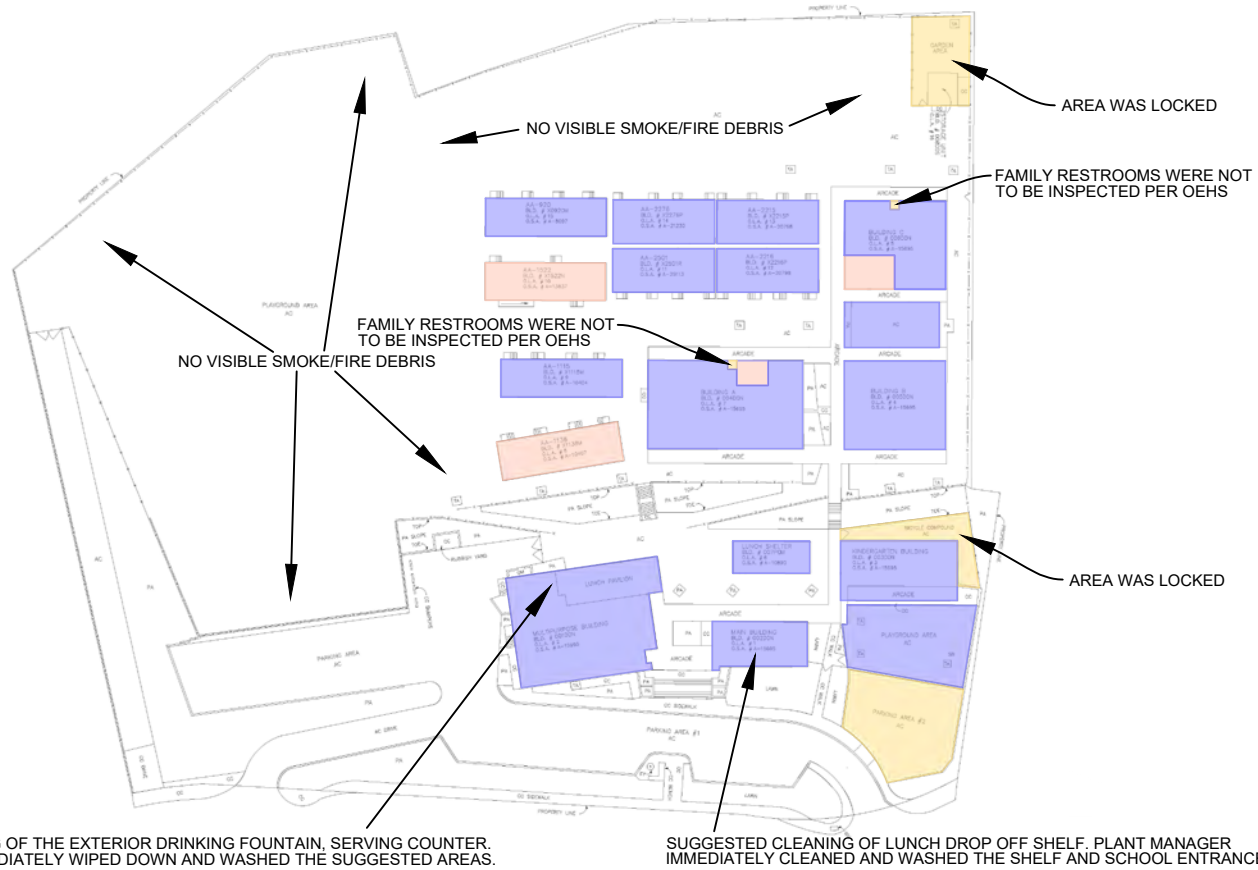
FIGURE 2

LANAI ROAD ELEMENTARY SCHOOL SHOWING THE AREAS INSPECTED

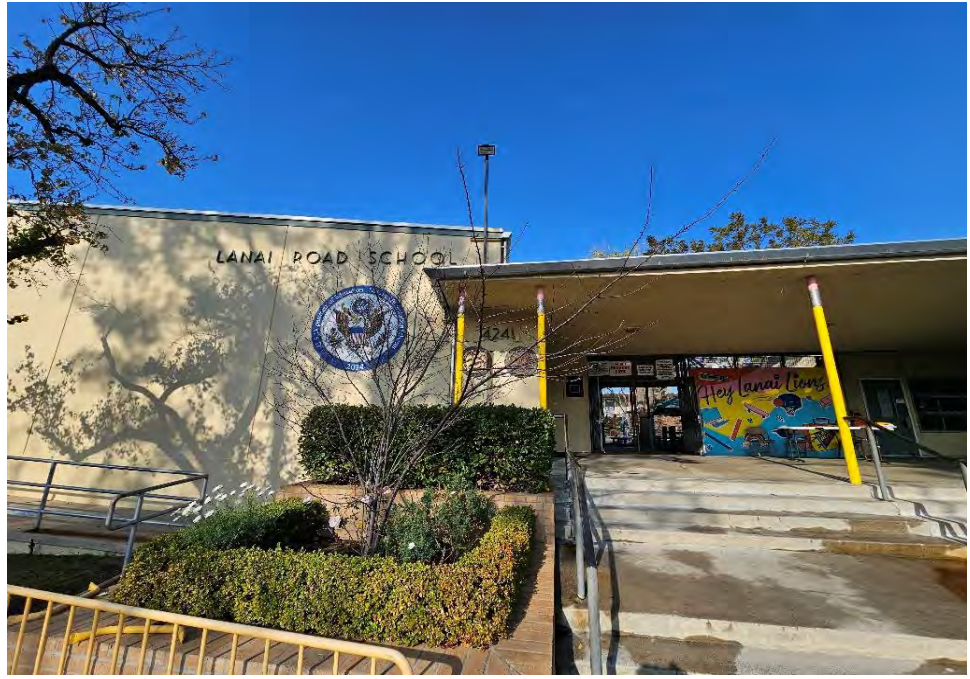
Photograph 1: View of the LAUSD Lanai Elementary School.

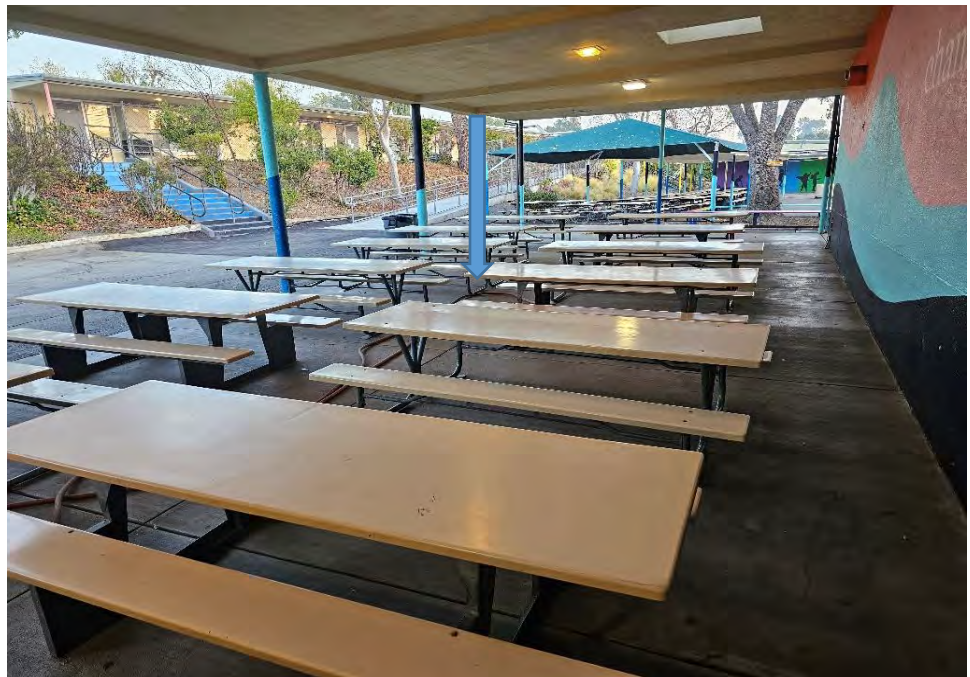
Photograph 2: View of the lunch pavilion. Tables have been cleaned with LAUSD approved cleaning agent. No visible smoke/fire debris.

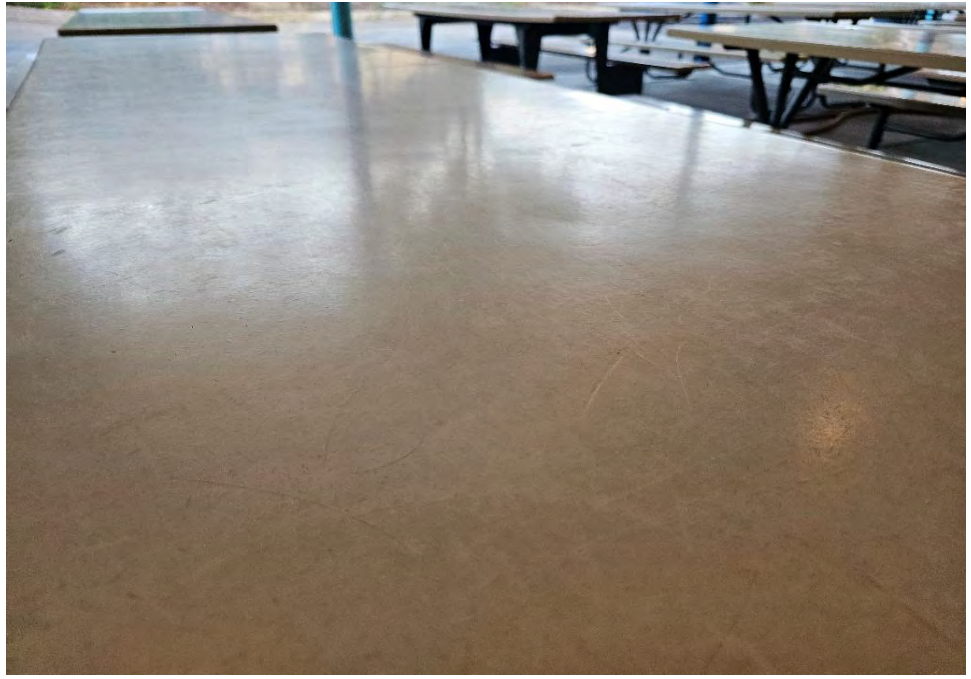
Photograph 3: Close up view of photograph 2.

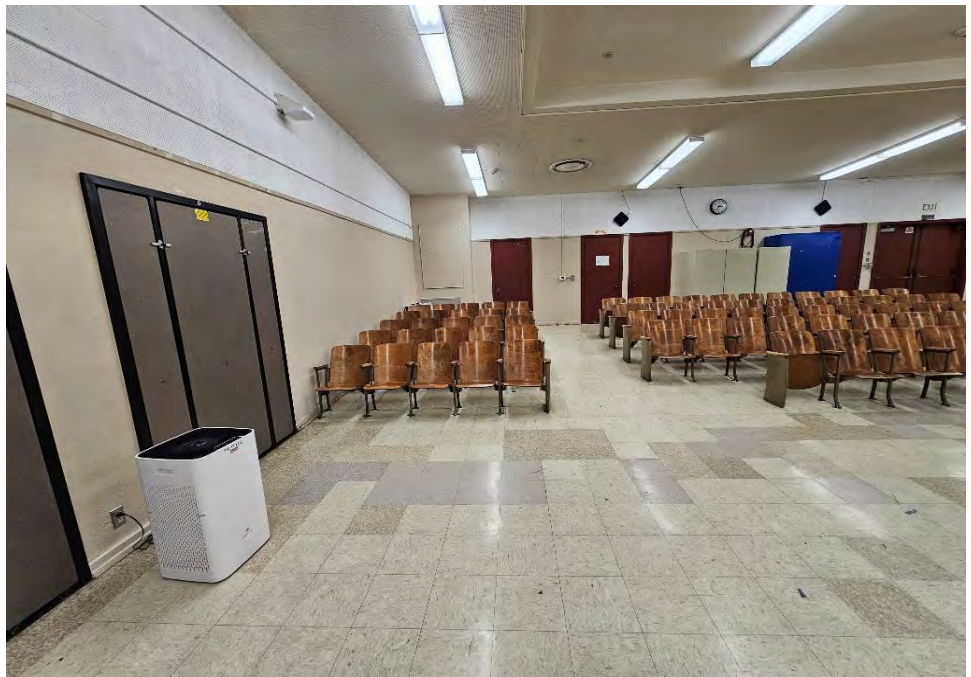
Photograph 4: View of the multipurpose room. No visible smoke/fire debris.

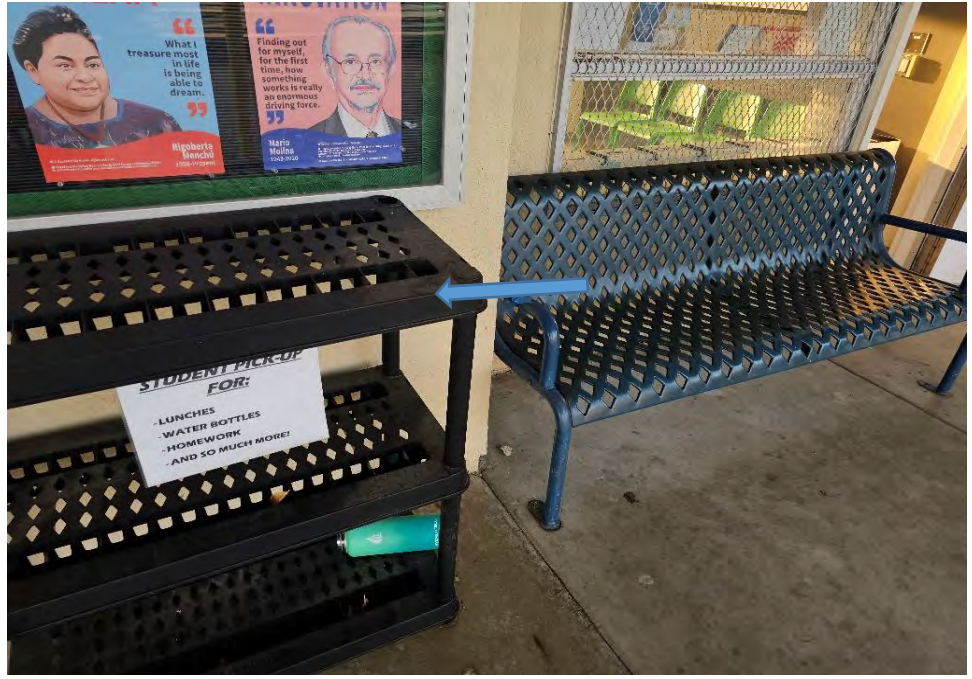
Photograph 5: View of the main office student lunch drop off shelf. Visible smoke/fire debris.

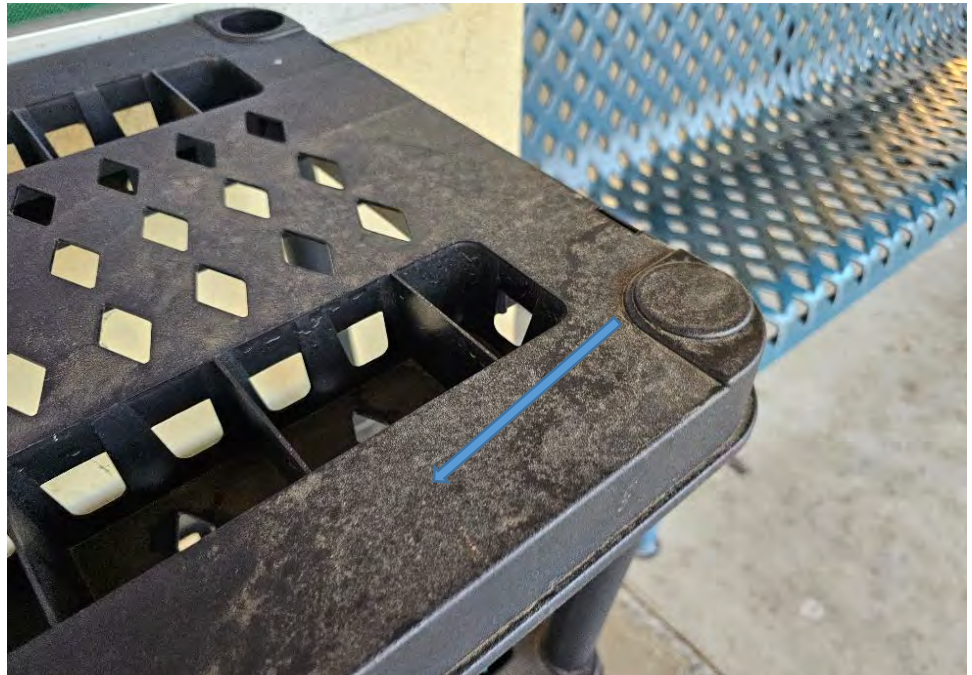
Photograph 6: Close up view of photograph 5.

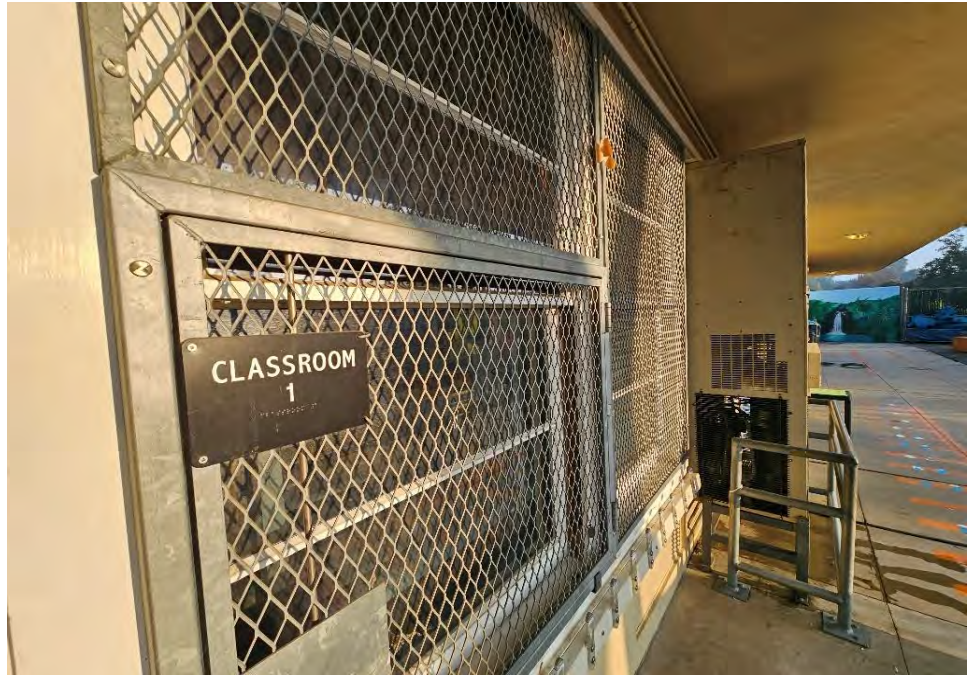
Photograph 7: View of Kindergarten building Classroom 1.

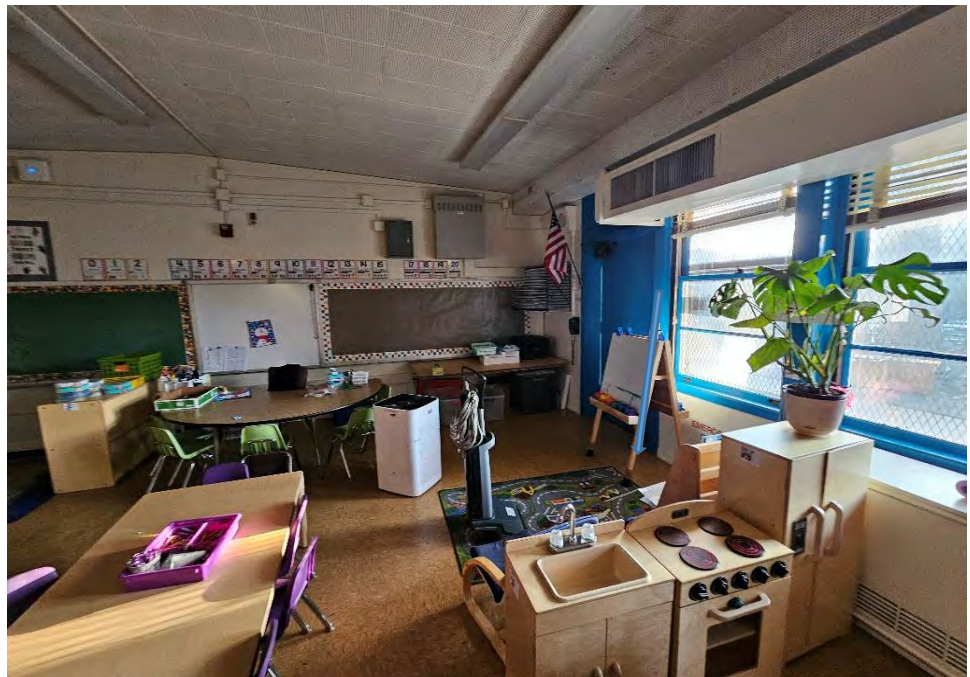
Photograph 8: Interior view of Kindergarten Building classroom 1. No smoke/fire debris observed.

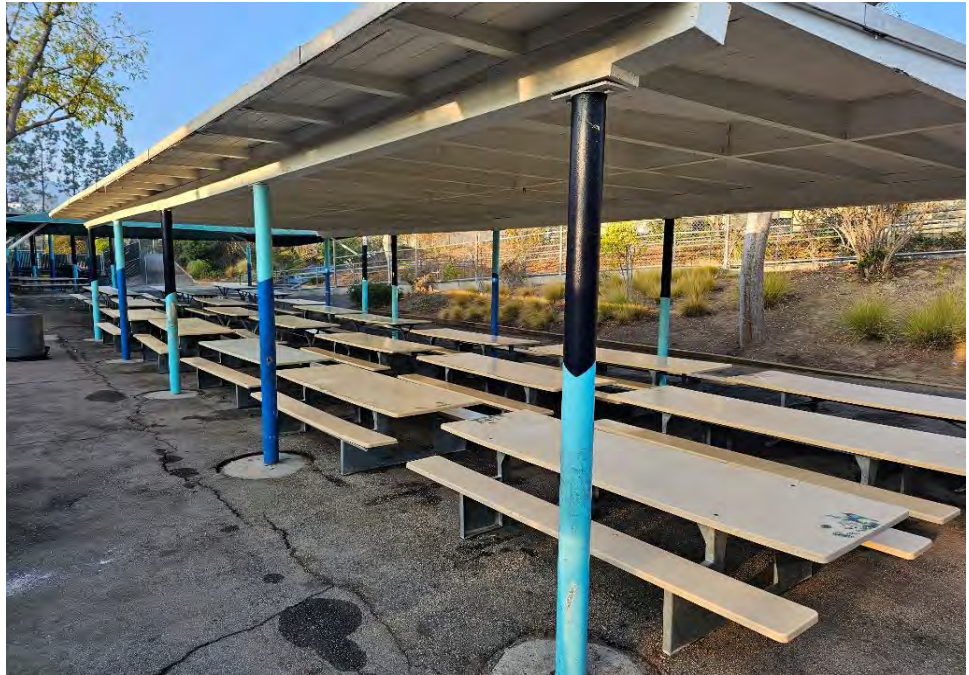
Photograph 9: View of the lunch shelter.

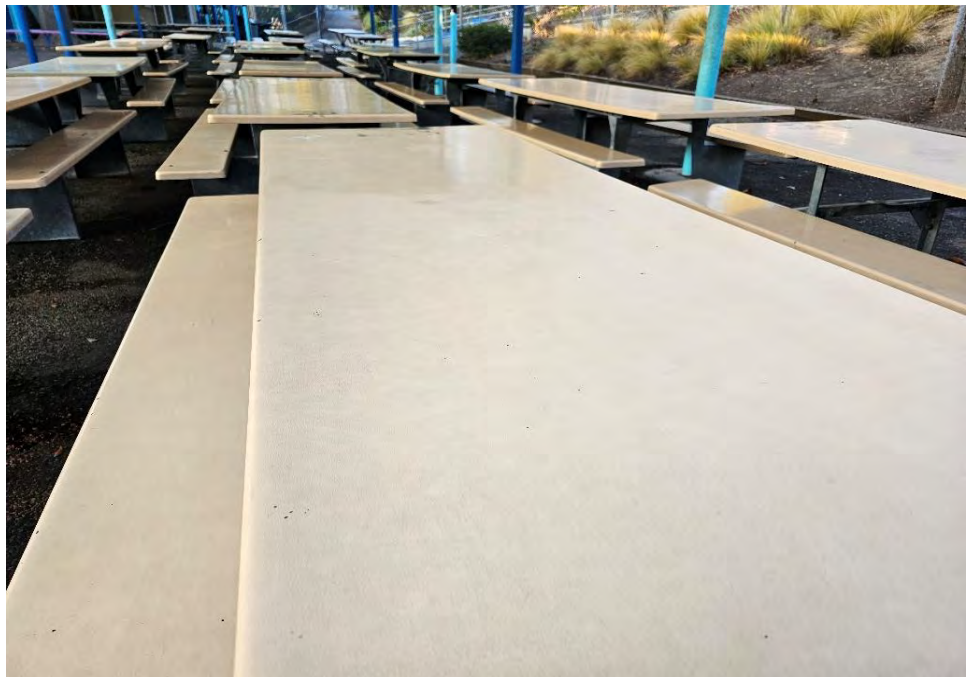
Photograph 10: Close up view of photograph 9. No smoke/fire debris observed.

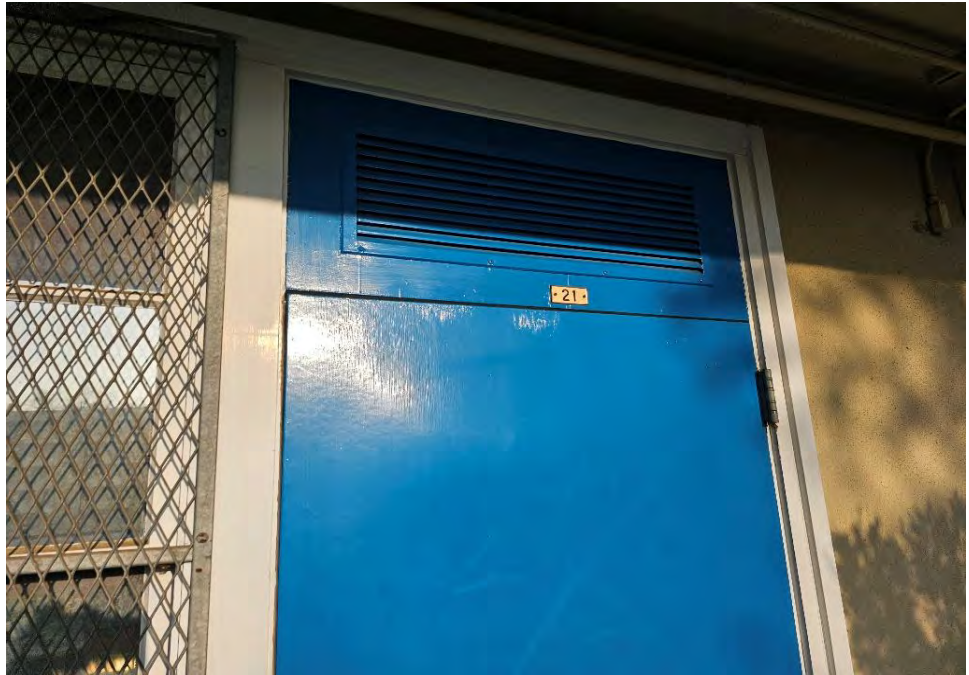
Photograph 11: View of Building C classroom 21.

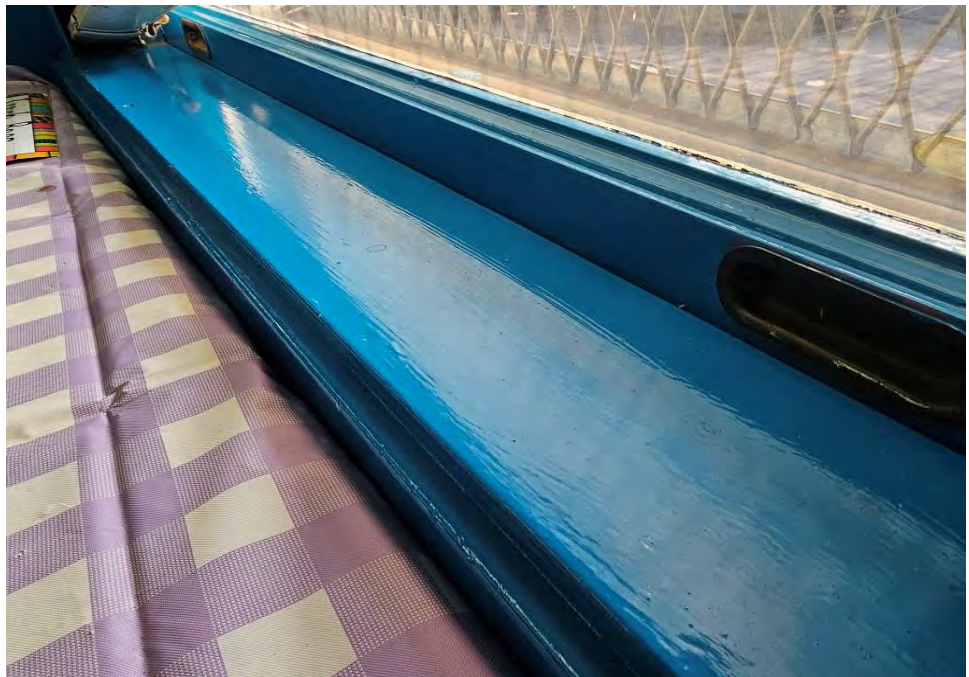
Photograph 12: View of Building C classroom 21 window sill. No smoke/fire debris observed.

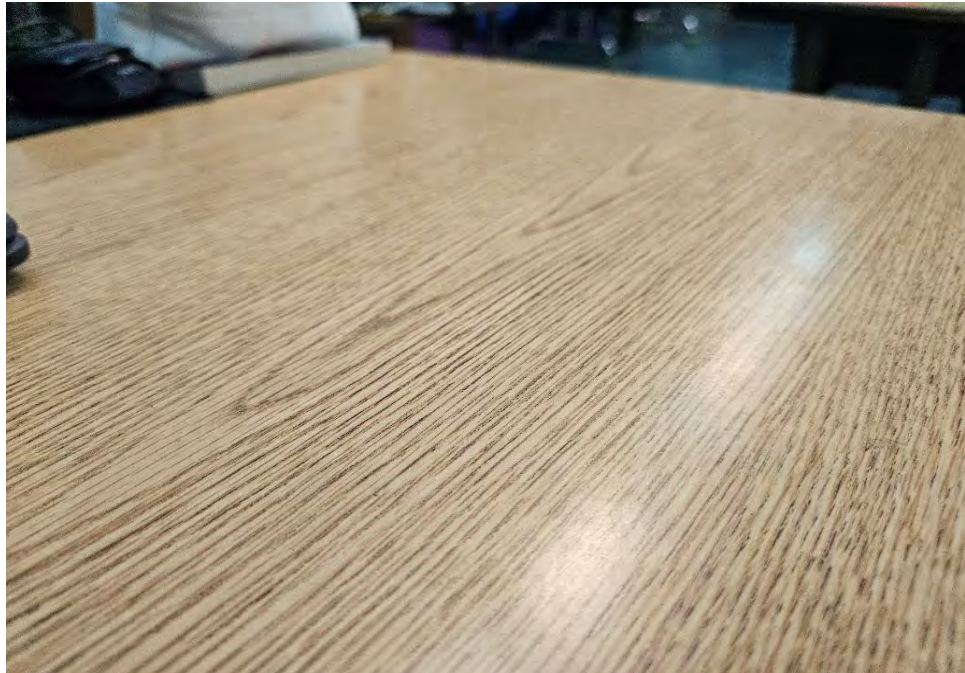
Photograph 13: Close up view of Building C classroom 21 student desk. No smoke/fire debris observed.

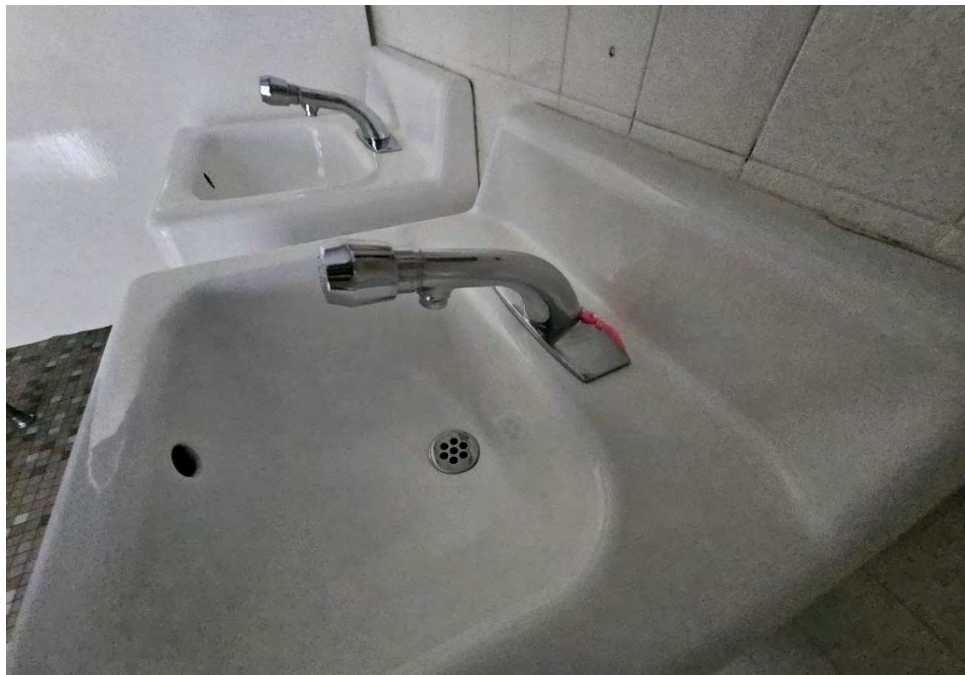
Photograph 14: View of Building C Boy's restroom sinks. No smoke/fire debris observed.

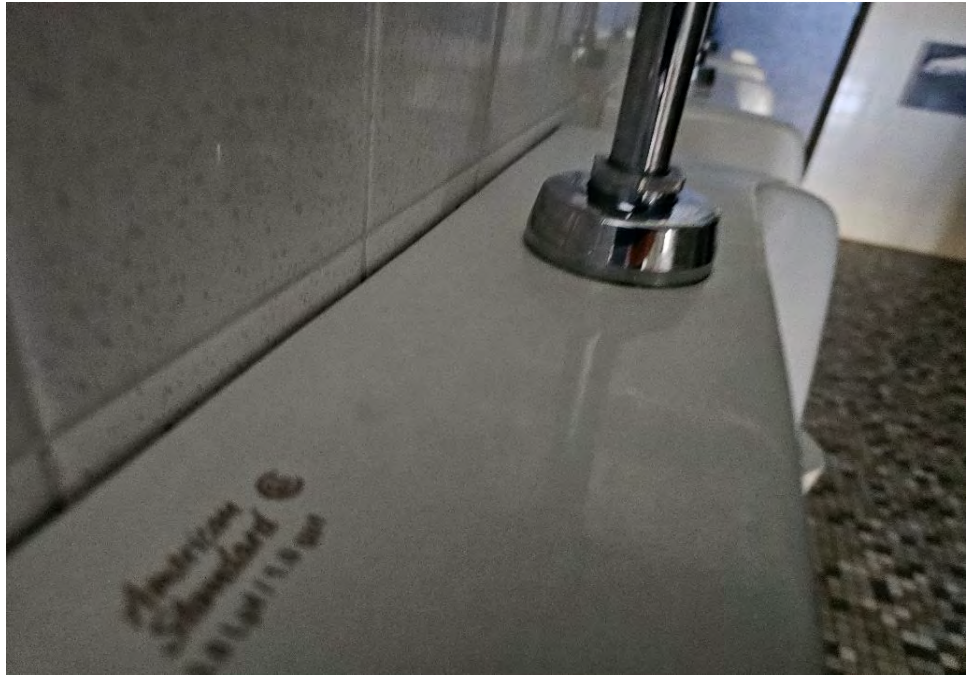
Photograph 15: View of Building C Boy's restroom urinals. No smoke/fire debris observed.

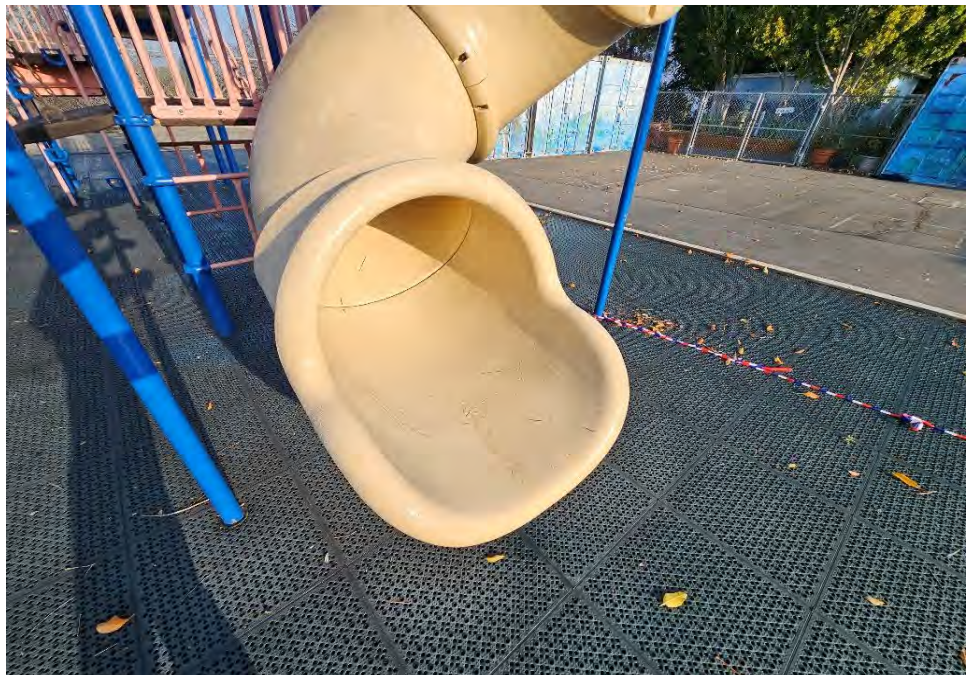
Photograph 16: View school playground. No smoke/fire debris observed.

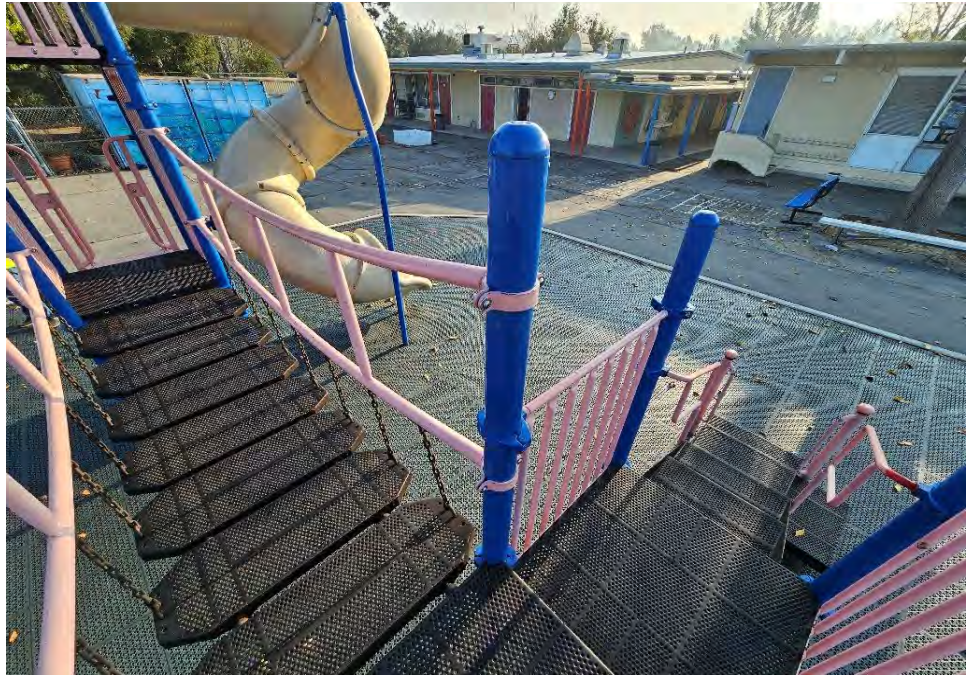
Photograph 17: Continuation of photograph 16.

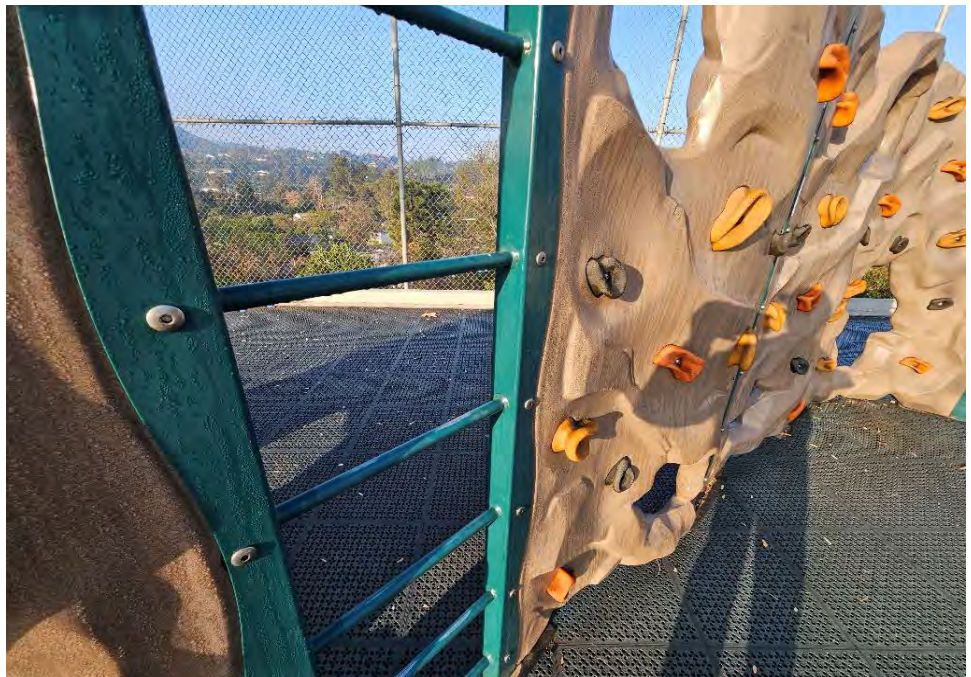
Photograph 18: View children's climbing wall. No smoke/fire debris observed.

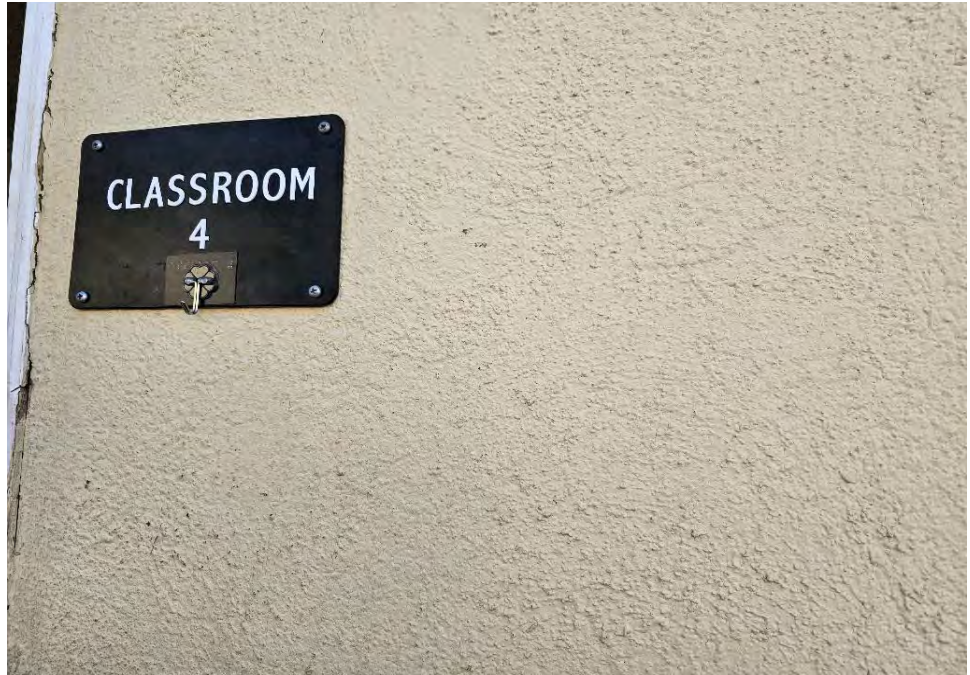
Photograph 19: View of Building AA-1138 Classroom 4.

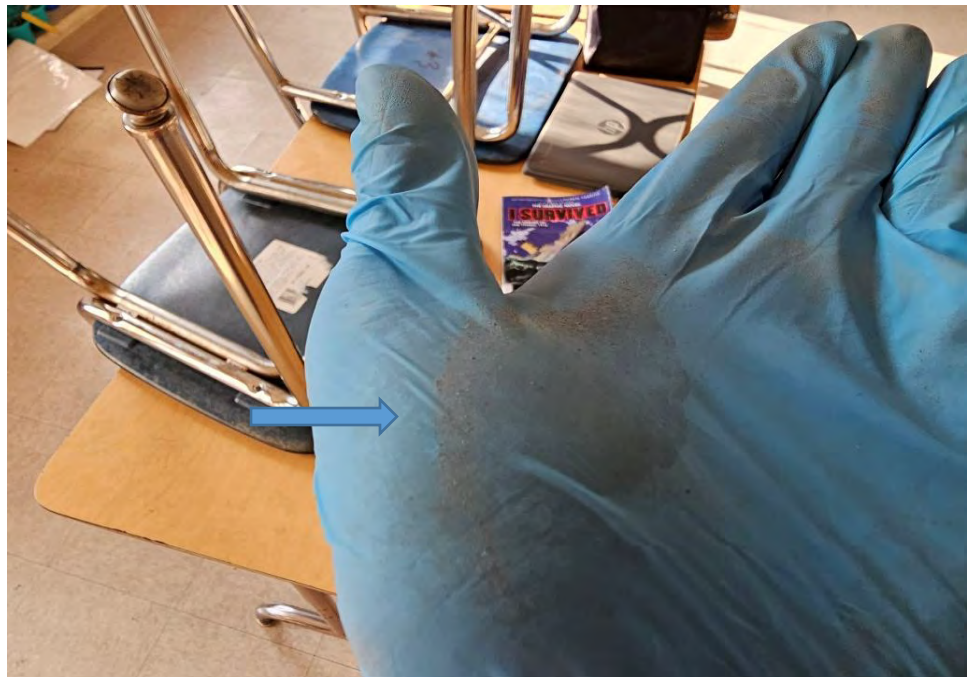
Photograph 20: View of Building AA-1138 Classroom 3 and 4 smoke/fire debris observed on the desks.
