Limited Wildfire Smoke Impact Assessment Topanga Charter Elementary School 2075 Topanga School Road and Topanga, California 90290

Los Angeles Unified School District
333 S. Beaudry Avenue, 21st Floor | Los Angeles California 90017

January 23, 2025 | Project No. 212936035

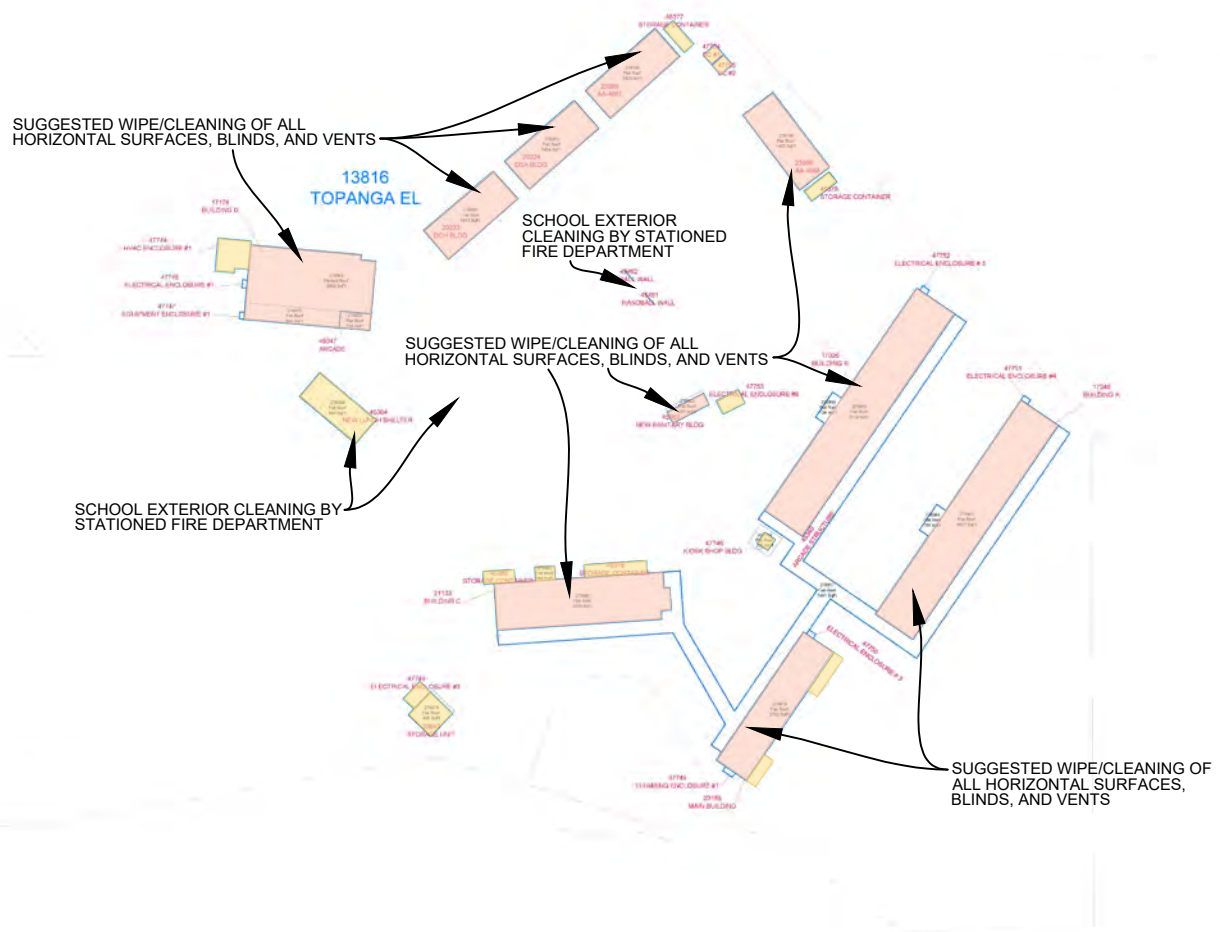
FIGURE 2

TOPANGA CHARTER ELEMENTARY SCHOOL SHOWING THE AREAS INSPECTED WHICH REQUIRE CLEANING

According to our visual observation at this school site, some minor surface cleaning was necessary at the time of our assessment. Areas that needed further immediate cleaning are noted in the attached spreadsheet in Appendix C. The areas noted for further cleaning do not indicate that access to the areas should be strictly controlled, only that our visual inspections identified that additional cleaning would be helpful. We recommend that where notes appear in Appendix C that are associated with indoor areas that the cleaning be completed prior to general use of those indoor areas.

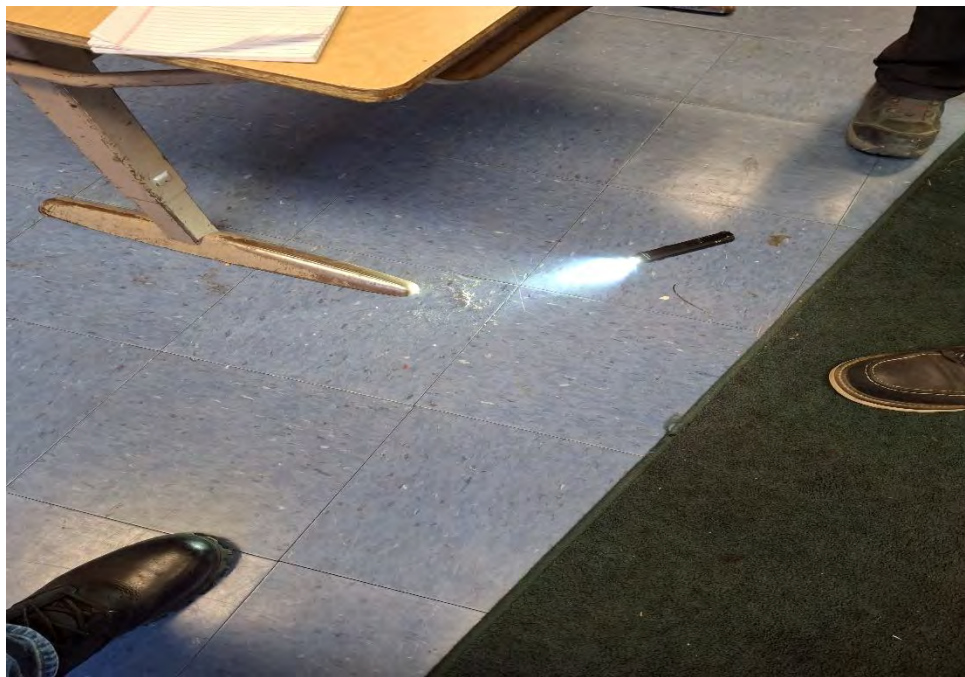
Photograph 2: View of the floor in Building AA-4088. Visible smoke/fire debris.

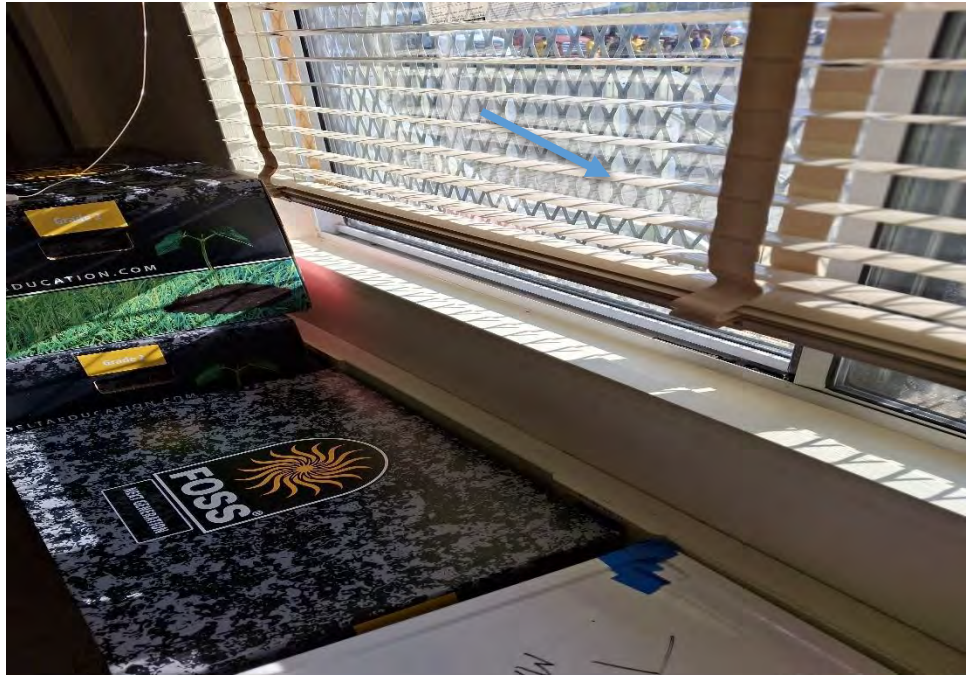
Photograph 3: View of the blinds in building AA-4087. Minor Visible smoke/ fire debris.

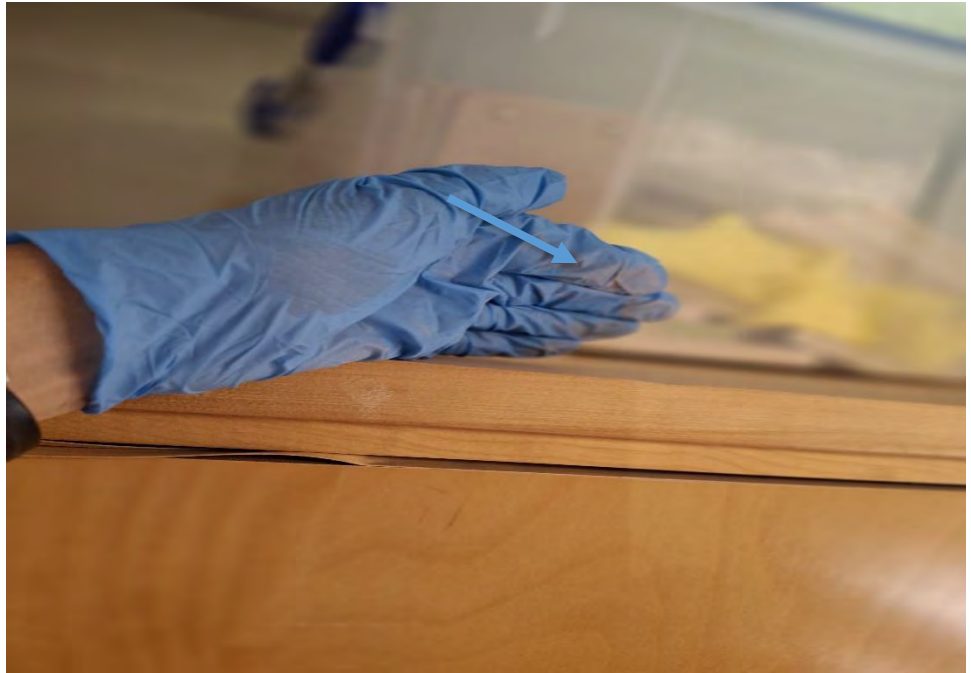
Photograph 4: View of DSA building Shelves. Smoke/ fire debris observed

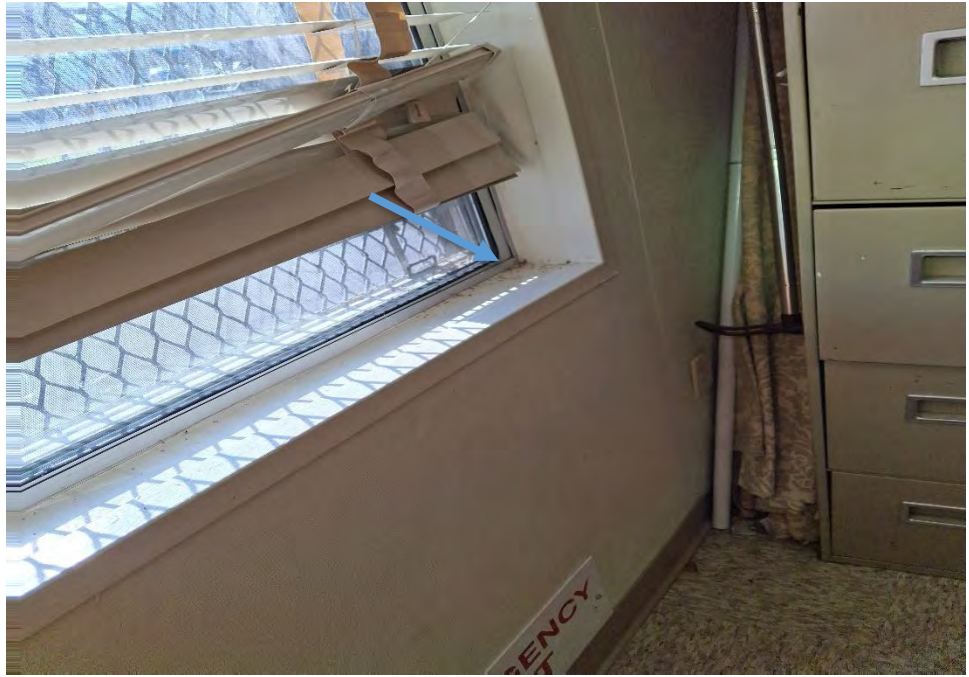
Photograph 5: View of DOH building window sills. Visible smoke/fire debris.

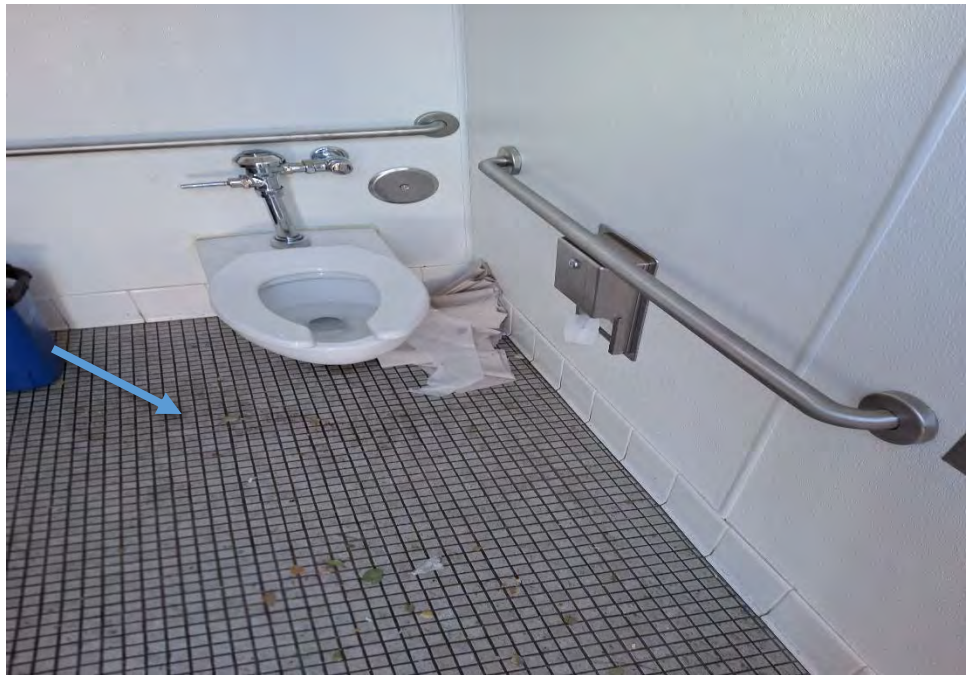
Photograph 6: View of the New Sanitary Building. Visible smoke/fire debris.

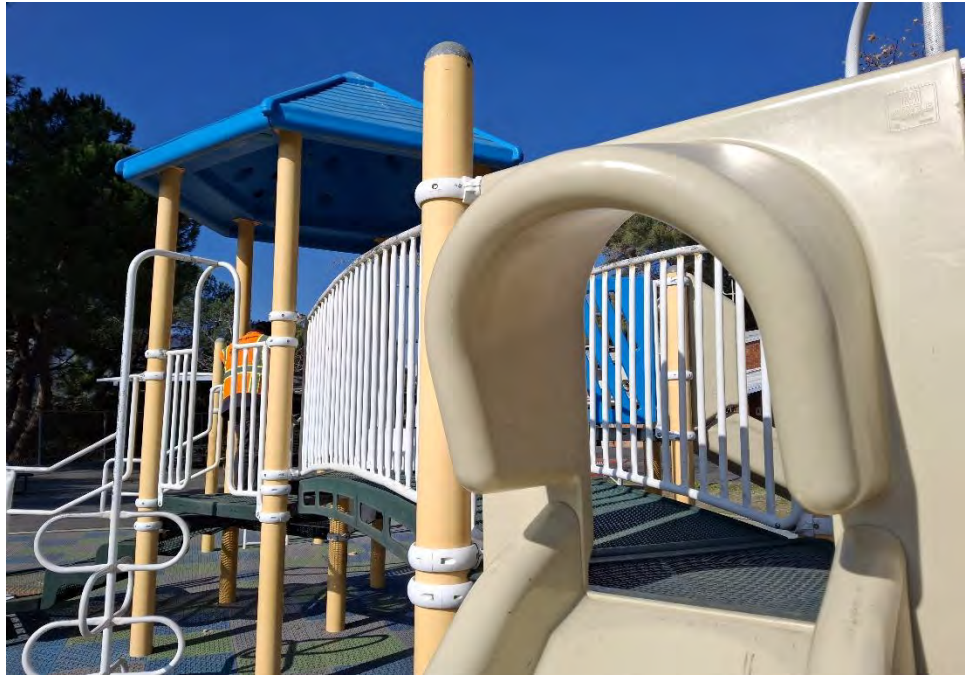
Photograph 7: View of outdoor playground. No smoke/fire debris observed.

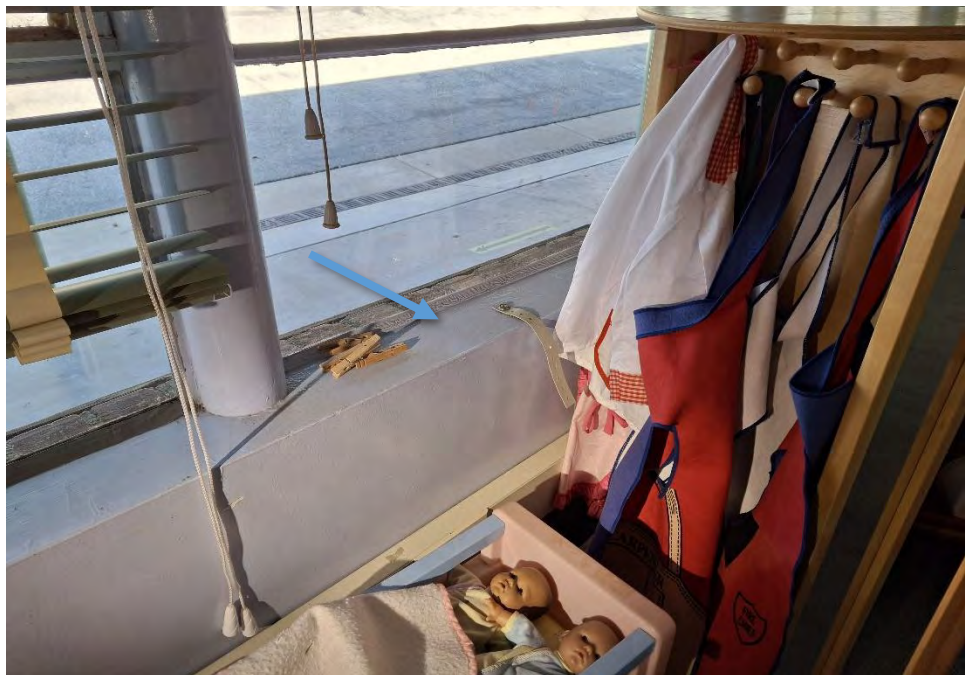
Photograph 8: View of the window sills in the Main Building classroom. Visible smoke/fire debris

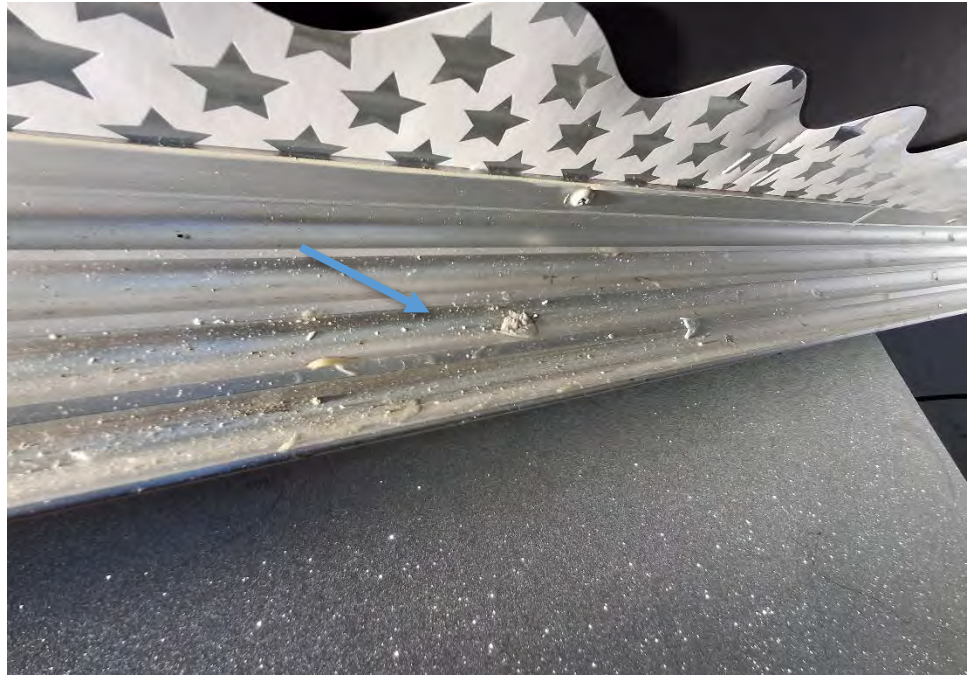
Photograph 9: View of the whiteboard tray sand adjacent desk in Building A. Visible smoke/fire debris

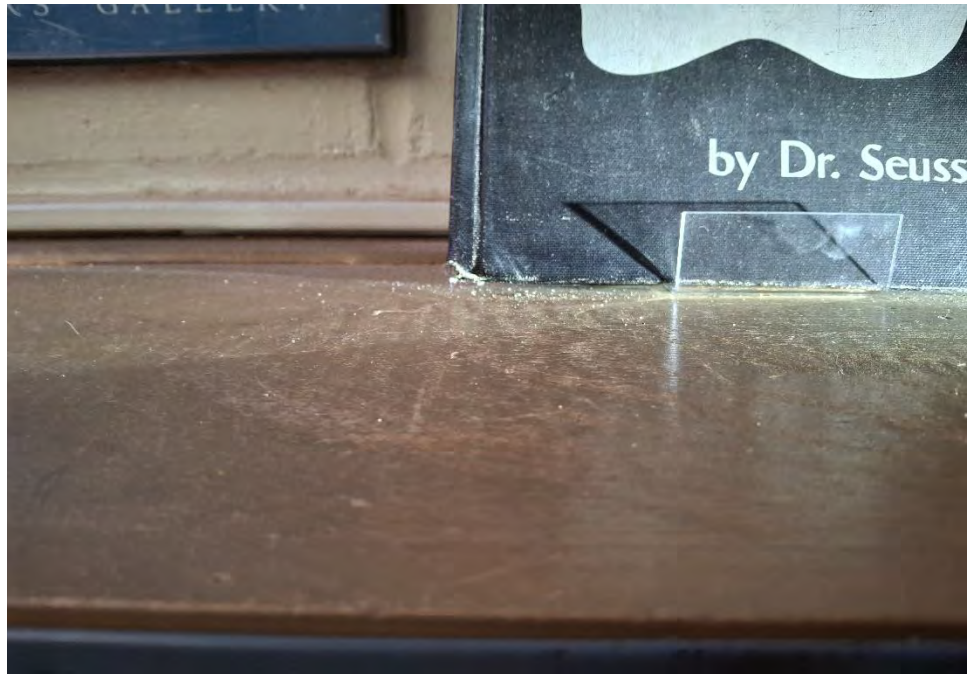
Photograph 10: View of the book shelves in the Library of Building A. Visible smoke/fire debris.

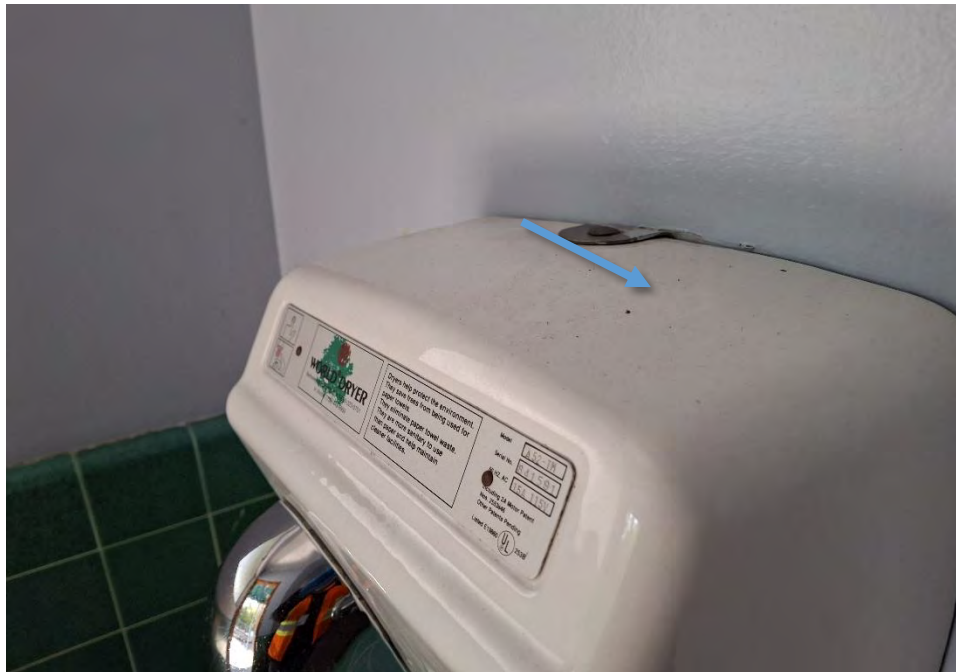
Photograph 11: View of the hand dryer in Building B. Visible smoke/fire debris.

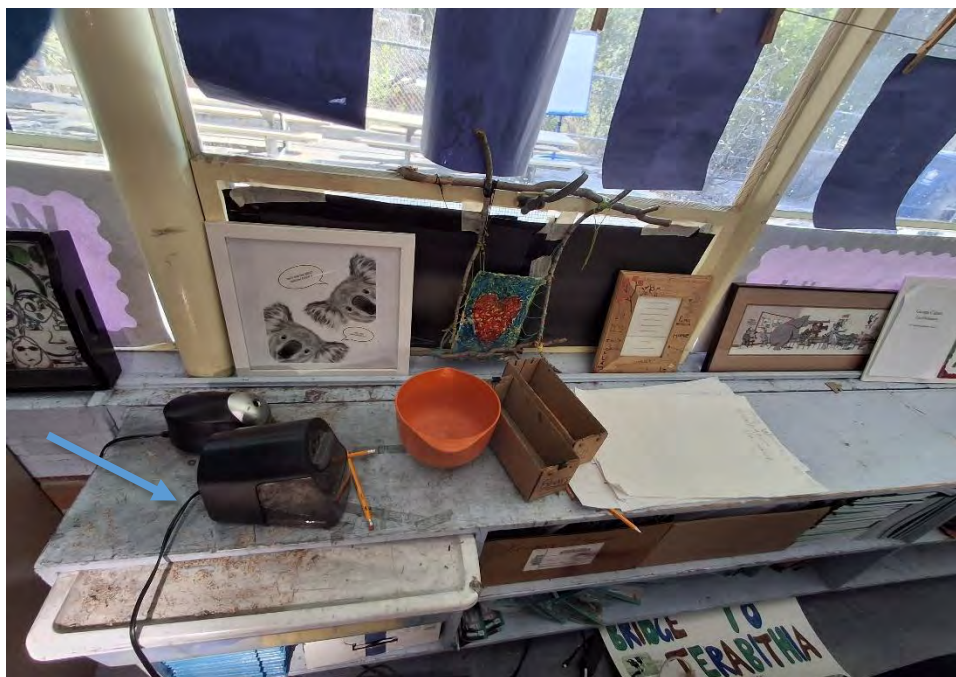
Photograph 12: View of low shelves in Building B. Visible smoke/fire debris.

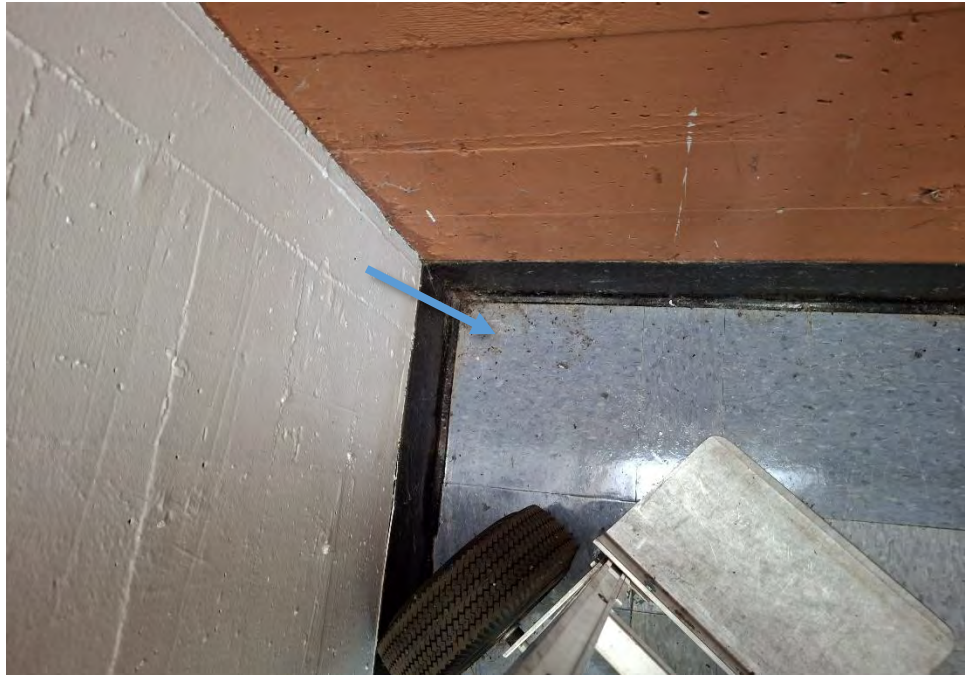
Photograph 13: View of the floors in Building C. Visible smoke/fire debris.

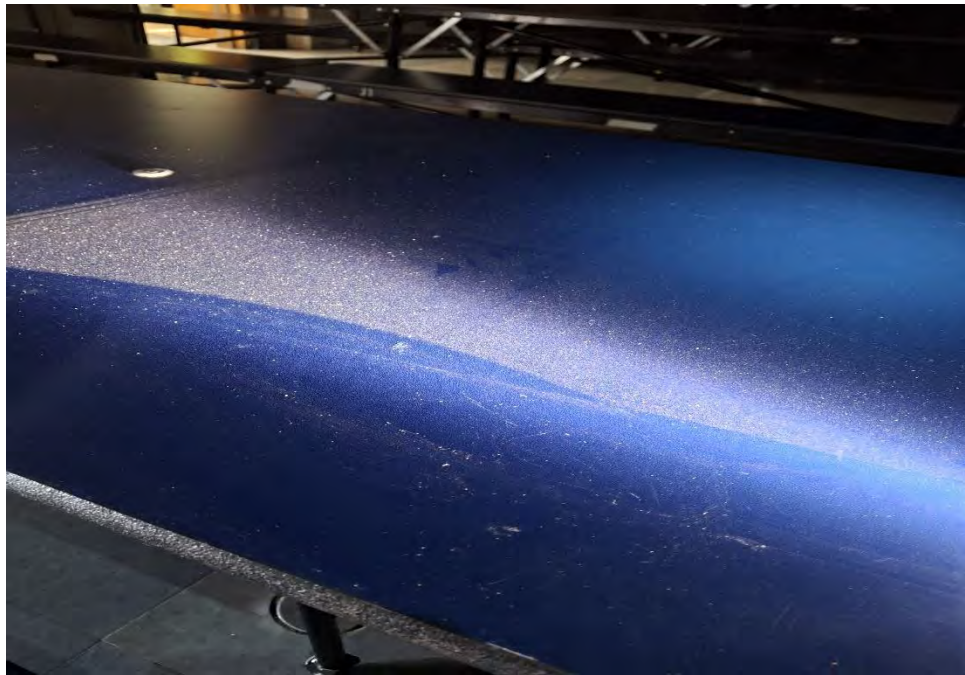
Photograph 14: View of Building D tables. Visible smoke/fire debris.

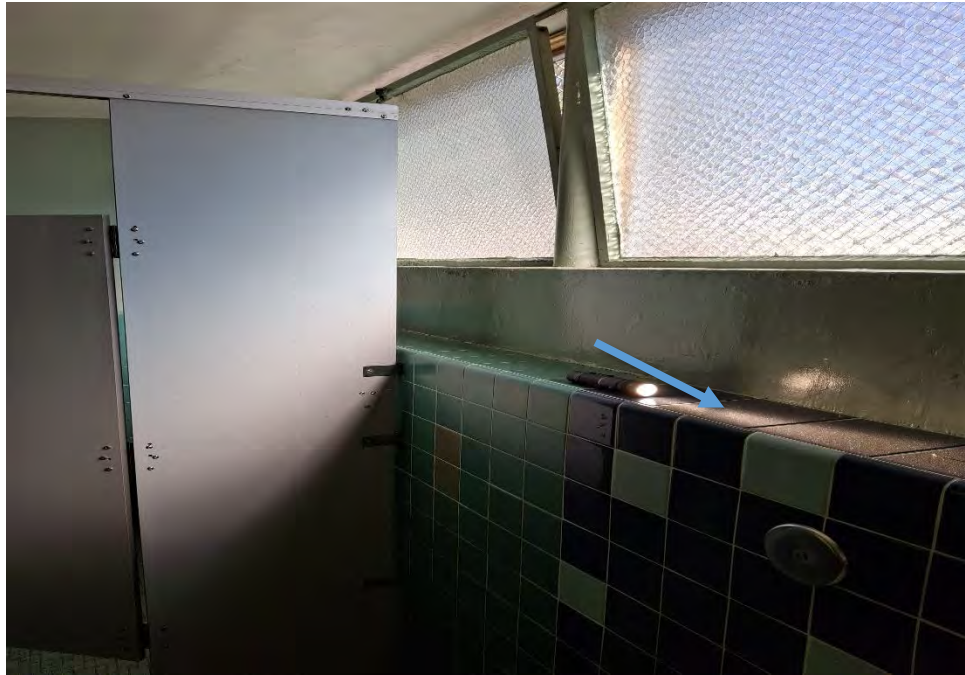
Photograph 15: View of Building D out of order restrooms. Visible open window, and smoke/fire debris
