**Los Angeles Unified School District
Office of the Inspector General**

Technical Evaluation

**Pars Arvin Construction, Inc.
and the ADA Improvement
Project at Westchester Enriched
Sciences Magnets High School
Contract No. 4400009903**

**25-0204-TE
July 28, 2025**

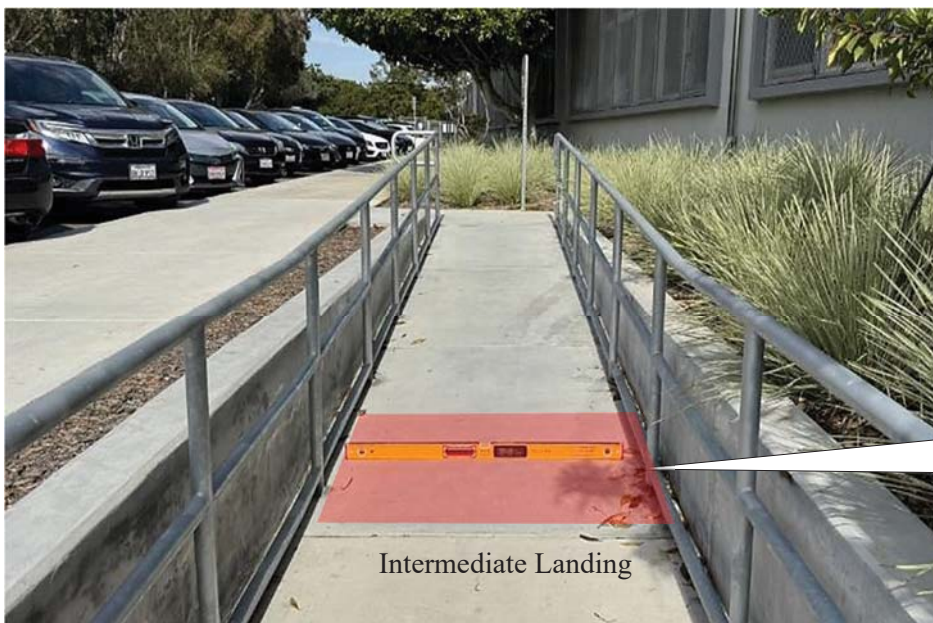
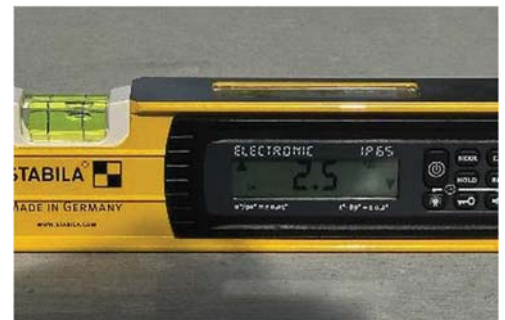
Figure 4. OIG Measurement – Concrete Ramp #2 on February 19, 2025

We found that the cross-slope of Concrete Ramp #2 exceeded the allowable limit in certain areas, measuring between 2.4% and 2.5%. According to ADA Standards, the maximum allowable cross slope is 2.08%, while the DSA-approved plan—part of the contract documents—specifies a stricter limit of 1.8%.

According to ADA Standards Section 405.3, ramp cross slopes should not exceed 2.08% (1:48) to ensure safe movement for wheelchair users and pedestrians.⁶ However, measurements taken during our site visits showed that the cross slope of the ramp just above the intermediate landing ranged from 2.4% to 2.5% (Figure 4). Fehoko Concrete Inc., the concrete subcontractor for PACI, was responsible for constructing this ramp. During our site measurement, the owner of PACI, who was present with us, stated that they will have their concrete subcontractor correct the non-conforming cross slope by grinding the concrete surface at no additional cost.

Area of Non-Compliance:
Cross Slope Ranged from
2.4% to 2.5%

Even when considering the recommended 0.5% tolerance, the existing cross slope exceeds the allowable limit. Therefore, we determined that the slope does not align with the ADA Standards nor the contract documents, which were designed with tolerances in mind.

A ramp cross slope exceeding 2.08% can create safety concerns, hinder navigation, and potentially violate ADA standards, leading to legal implications and liability. If concrete grinding may result in a slippery surface or cause other issues, applying a slip-resistant coating after grinding could be a viable remedy. However, if this is not considered a sufficient long-term solution, the non-compliant section should be removed and replaced to ensure full compliance.

1. PACI should correct the non-compliant cross slope of Ramp #2 to comply with the ADA Standards. Please see OIG's Response below for additional information regarding this recommendation.
2. FSD should inspect and ensure the ramp's cross slope complies with the ADA Standards if/when PACI rectifies the issue. Furthermore, future design plans from FSD for ramp

construction should specify a maximum cross slope of 1.5%. This will ensure that, even with the recommended +0.5% tolerance, the ramp's cross slope will not exceed the 2.08% maximum allowed by ADA Standards.

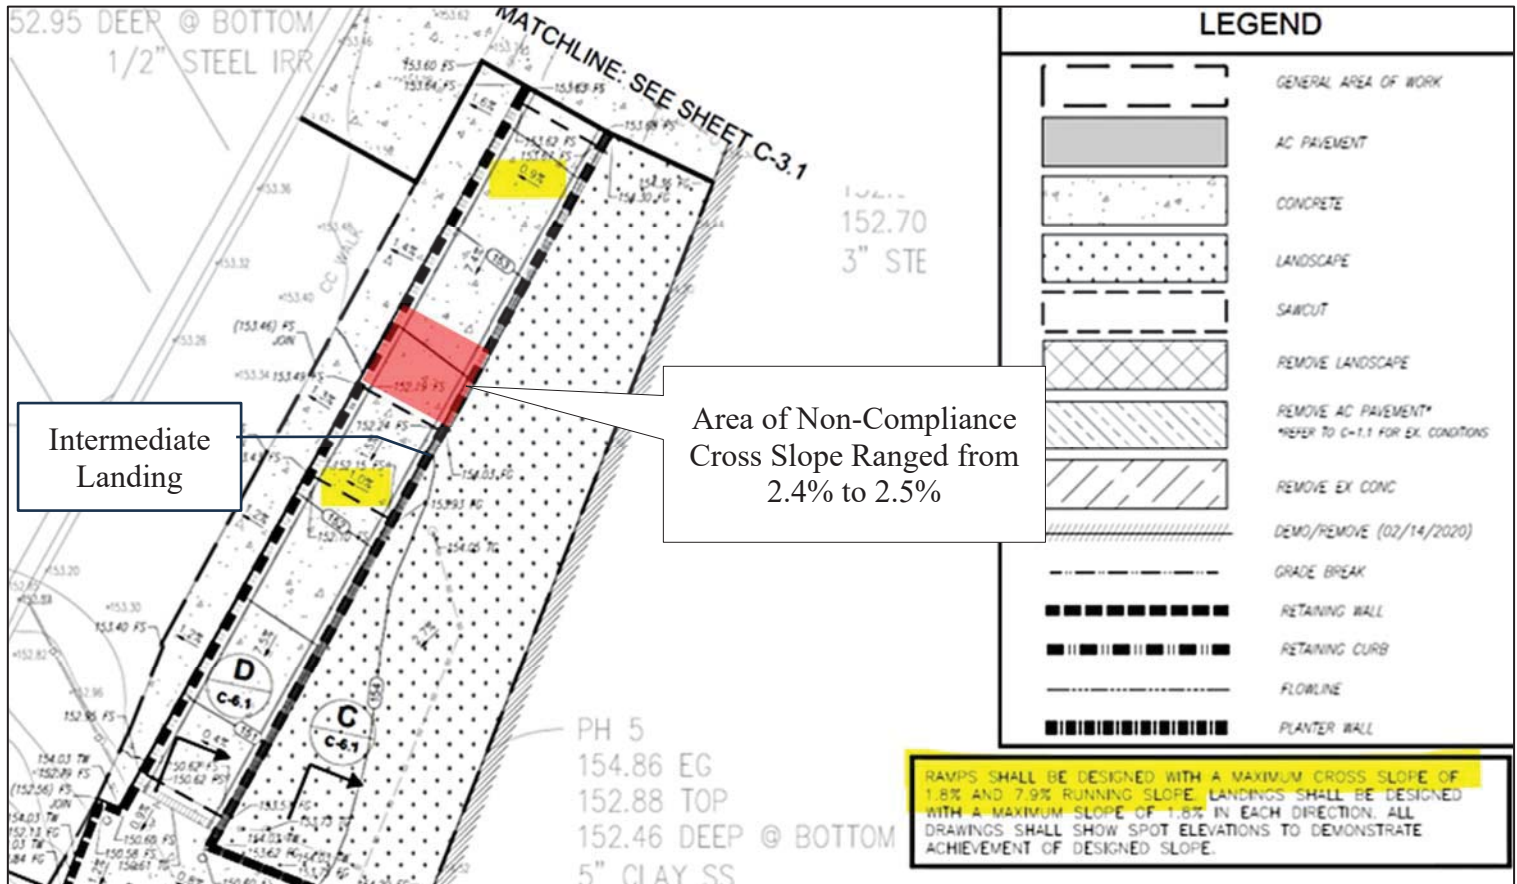
Figure 5. DSA Approved Plan C-3.0 Partial Plan for Concrete Ramp #2

To accommodate field variations, the ADA Standards recommend designing slopes below the maximum limits.¹⁰ Our review of DSA-approved plan C-3.0 confirms that the ADA ramp was designed in accordance with this guidance, with cross slopes less than 2.0%. Specifically, the cross slope at the upper portion of the ramp is 0.9%, and the landing near the non-compliant area is 1.0%. The plan also notes: "*Ramp shall be designed with a maximum cross slope of 1.8% and 7.9% running slope.*" (Figure 5)

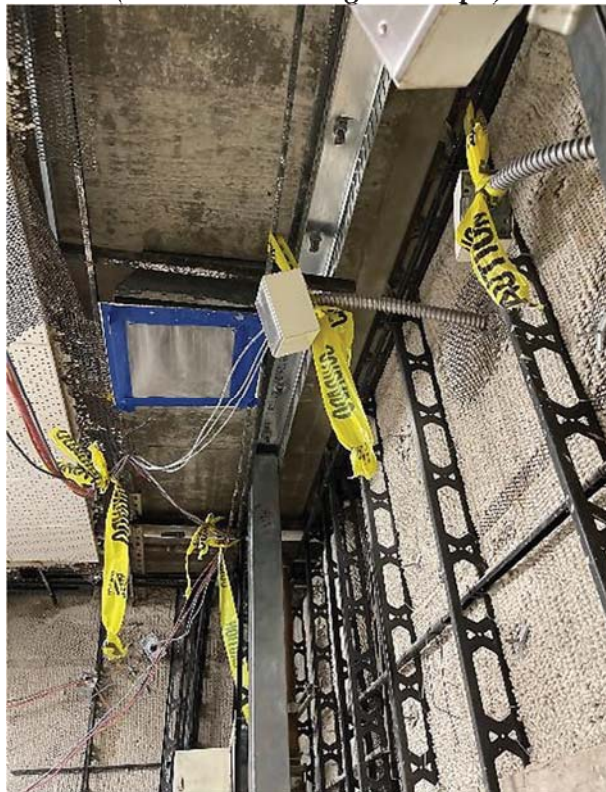
***Figure 6. Black Iron Walls at the South Wall of the Girl’s Gym Women’s Restroom
(CO T-523 Package Excerpt)***

We found that the contract amount increased by 9.14%, amounting to \$533,971, due to eight COs resulting from unforeseen black iron wall issues. FSD and its design team could have mitigated these issues through more thorough initial field assessments and selective pre-construction demolition.

Project records indicated that PACI encountered a black iron wall while opening the walls for restroom upgrades in the Boy’s Gym, Girl’s Gym, and Assembly Building (Figure 6).

We discussed this matter with the Project Architect from Bureau Veritas (Formerly Owen Group). During the meeting, they explained that difficulties accessing the ceiling and wall panels to inspect the internal structures during the initial field assessment hindered their ability to fully understand the existing system. Additionally, they noted that another challenge was the inaccuracy of the as-built drawings—some dating back to the 1960s or 1970s—which often did not accurately reflect current conditions.

1. To mitigate "black iron wall" issues and improve project efficiency, FSD should enhance initial field assessments, conduct selective pre-construction demolition, and ensure accurate as-built drawing updates.
2. We recommend that FSD ensure the Project Architect updates the project's as-built drawings to incorporate all CCDs, including those related to the black iron issues, to ensure accurate documentation.

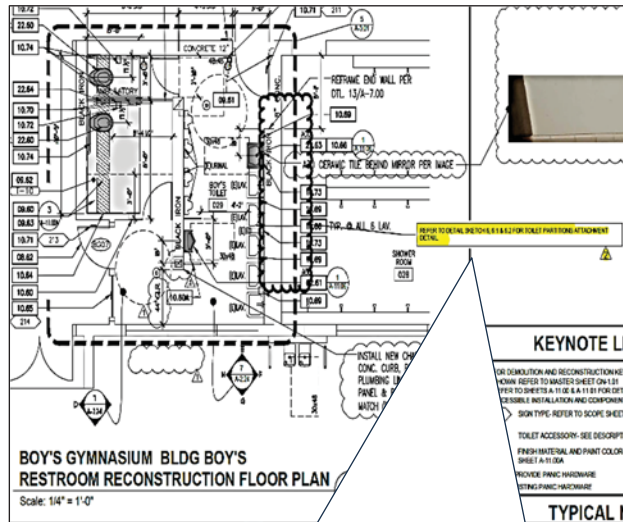
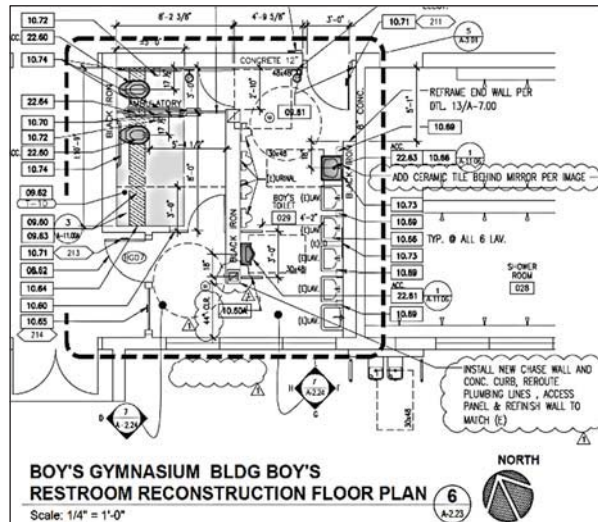
We also found that this project's final record drawings (as-built drawings) did not include the revisions associated with the redesign to address the black iron issues. We reviewed the as-built drawings for the project, retrieved from the LAUSD Drawing Archives (Vault). During our review, we found that four Construction Change Document Category A¹² - CCD-As #007, 008, 010, and 012 – which revised the wall layout to address the black iron issue, were not reflected in the as-built drawings (Figures 8a and 8b). Of the 20 CCD-As issued for this project, only one—CCD-A #017—was incorporated into the as-built set. The as-built drawings should have included all CCDs

**Figure 8a. Boy's Gym Boy's Restroom Plan
In CCD-A #007**

**Figure 8b. Boy's Gym Boy's Restroom Plan
in As-built Drawings**

These changes to the black iron wall were not reflected in the as-built drawings.
