Appendices

Belvedere Middle School Modernization - Construction - South Coast Air Basin, Annual

ARBORIST TREE SURVEY & RECOMMENDATIONS | 5.3.3

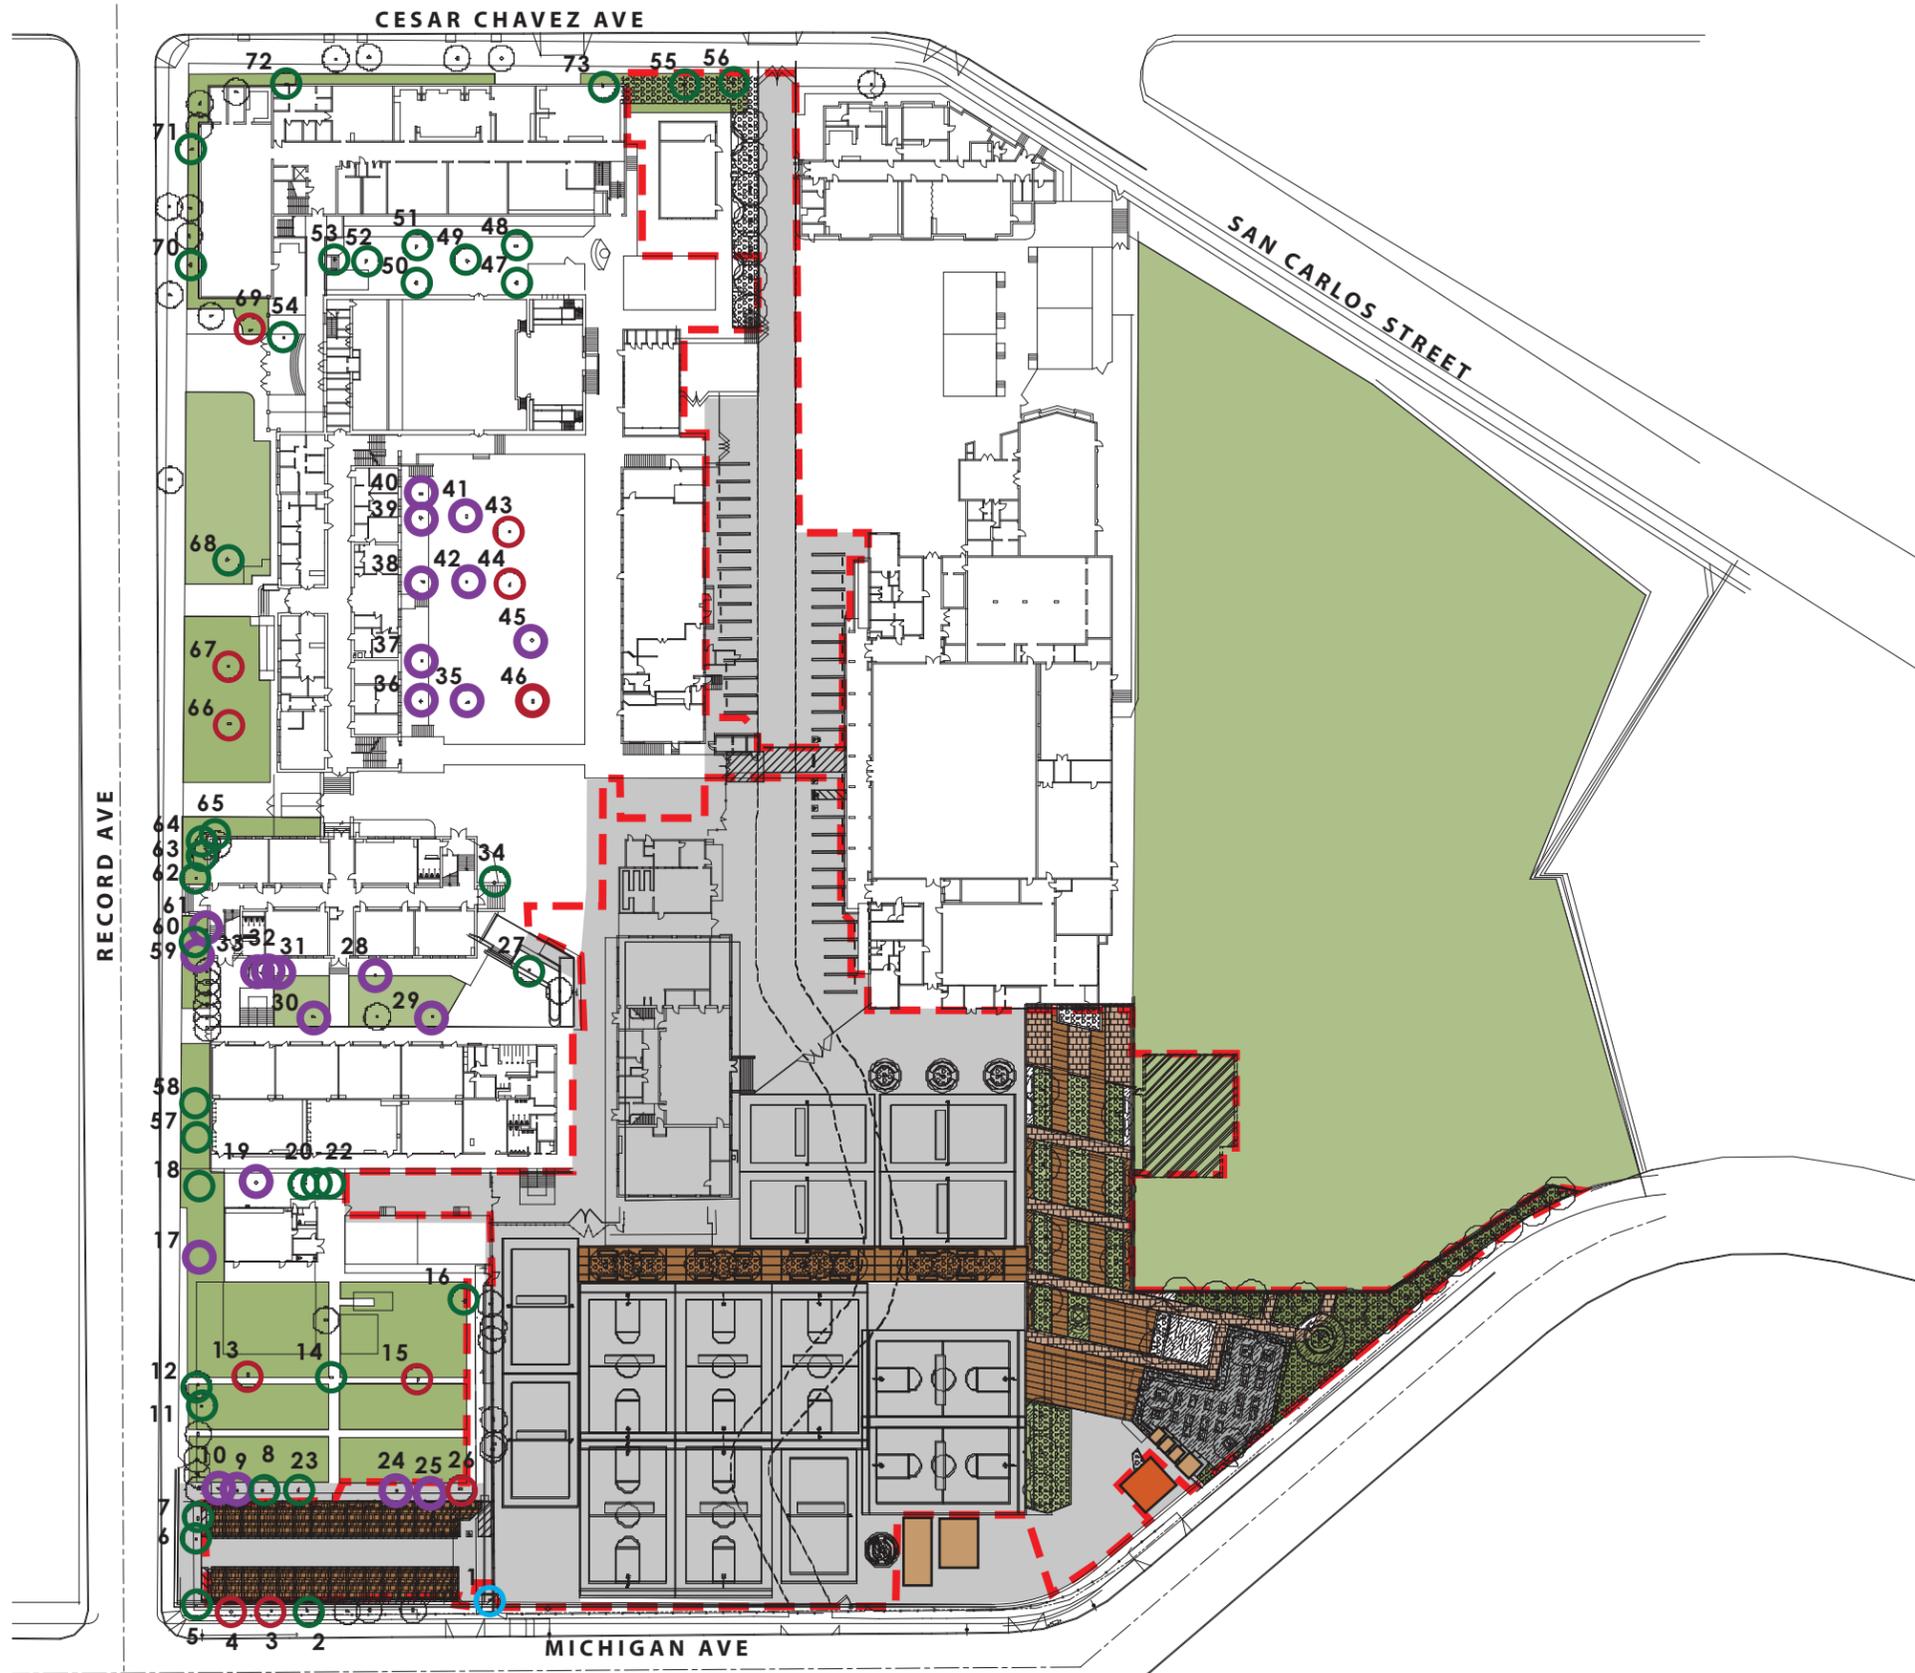
TREE EVALUATION

- Protected Tree
- Preserve Tree
- Remove Tree
- Neutral

Please Refer to Tree Survey Matrix for Tree Diameter, Height, Canopy and Evaluation Condition and Rating.

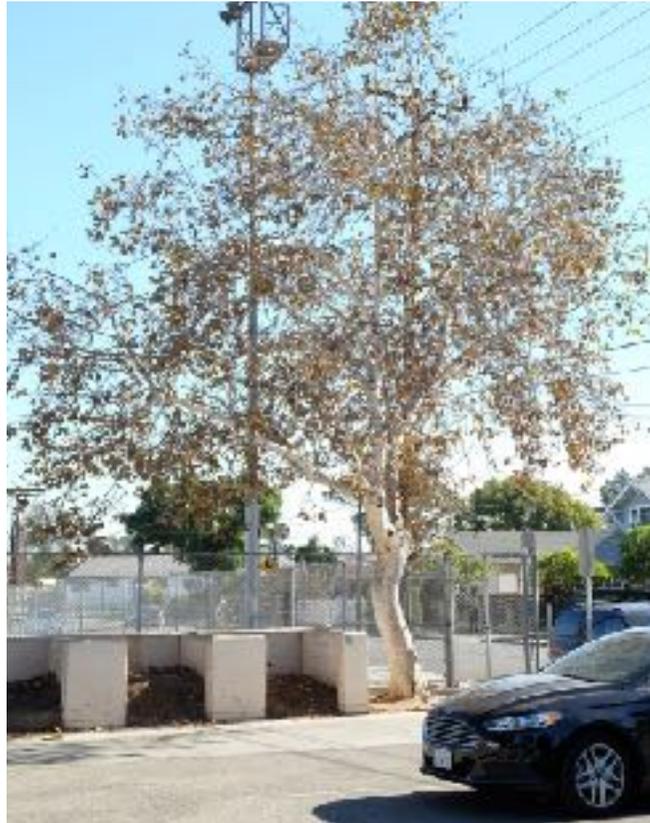
CA Sycamore #1

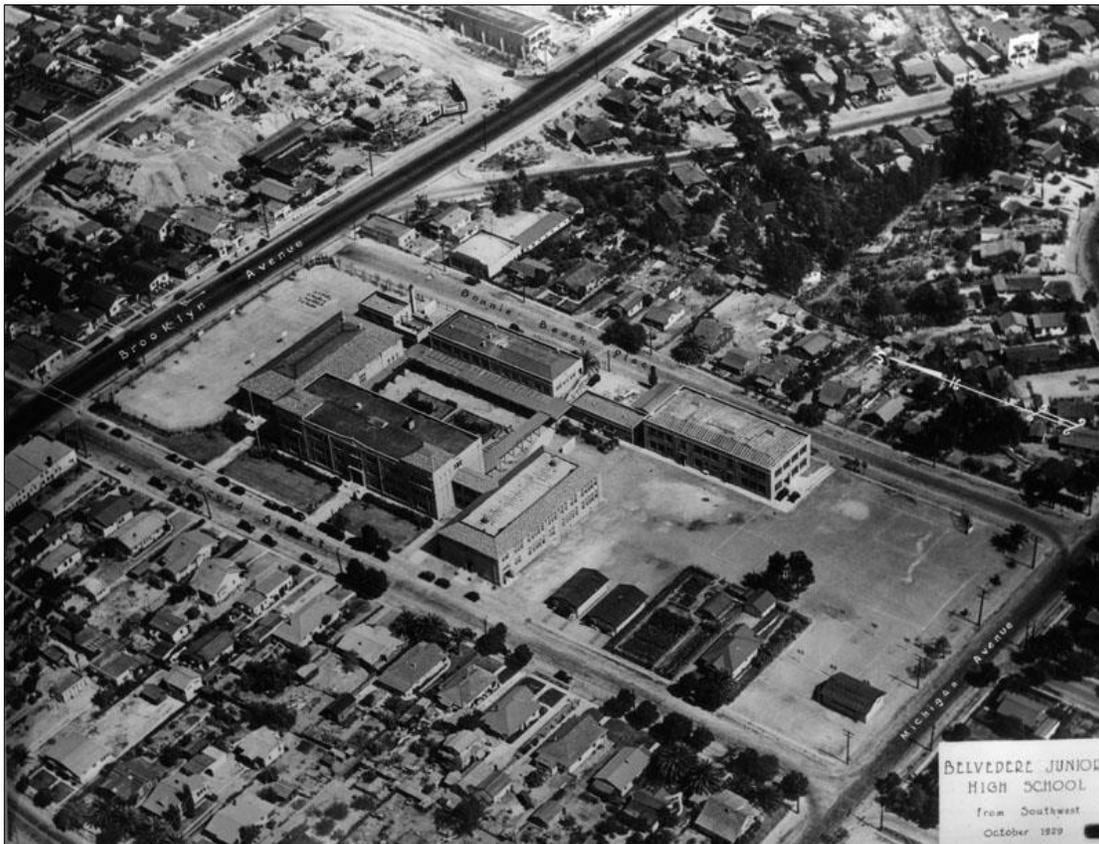
Figure 12 Historic Aerial Photograph of the Belvedere Junior High School Campus, October 1929

By 1930, six substantial, functionally distinct buildings and a system of covered corridors, all organized around a central, interior courtyard, had been constructed on the campus. Four of these remain (the Home Economics, Main, Academic, and Shop buildings). Also present on the campus as of 1930 were a number of other small buildings categorized as bungalows, a cottage on the south end of the campus, and three small ancillary structures (Figure 12).²³

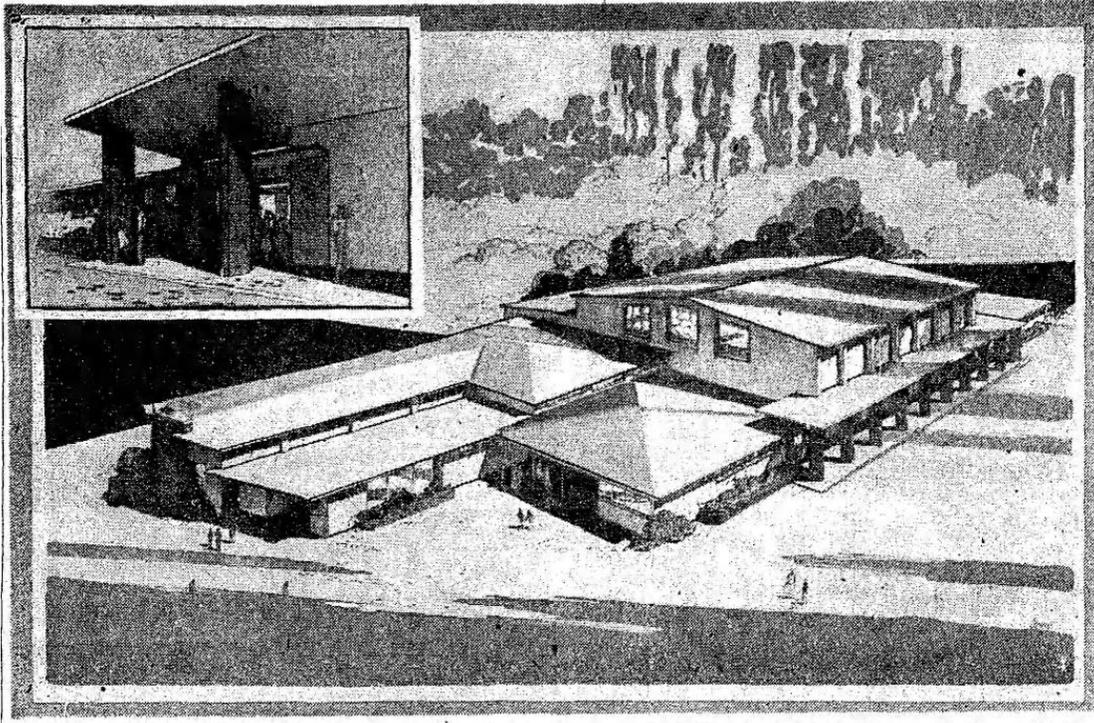
Figure 14 Barker & Ott's 1949 Rendering of the New Physical Education Building, Belvedere Junior High School ³⁷

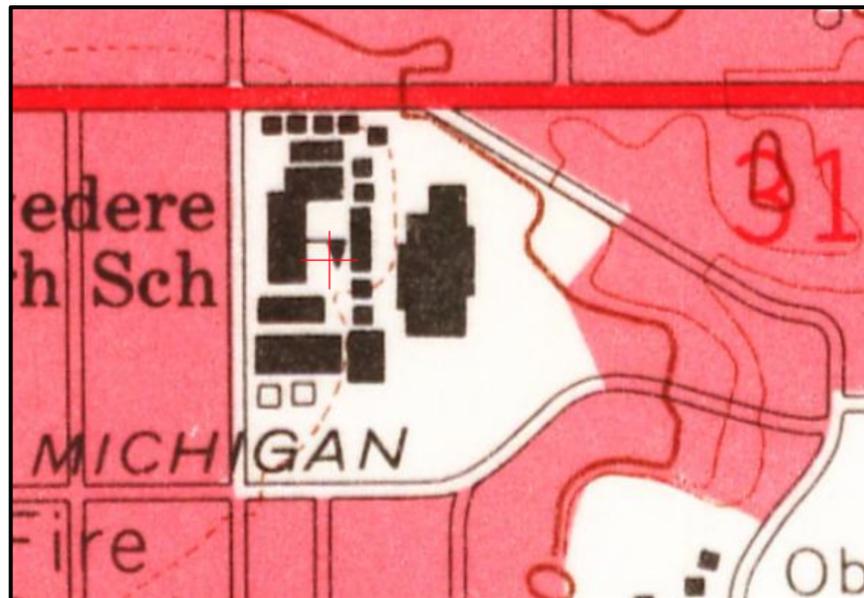
Figure 15: The 1966 Los Angeles USGS Map.

The 1966 Los Angeles USGS Map shows the Belvedere High School complex being expanded, with multiple additional large and small buildings being added (**Figure 15**). The buildings are also connected for the first time, and it appears that some of the original structures were removed, with replacement buildings of different sizes being added. The 1972 and 1981 Los Angeles USGS Maps show even more in-filling of buildings until the current pattern of structures is shown.

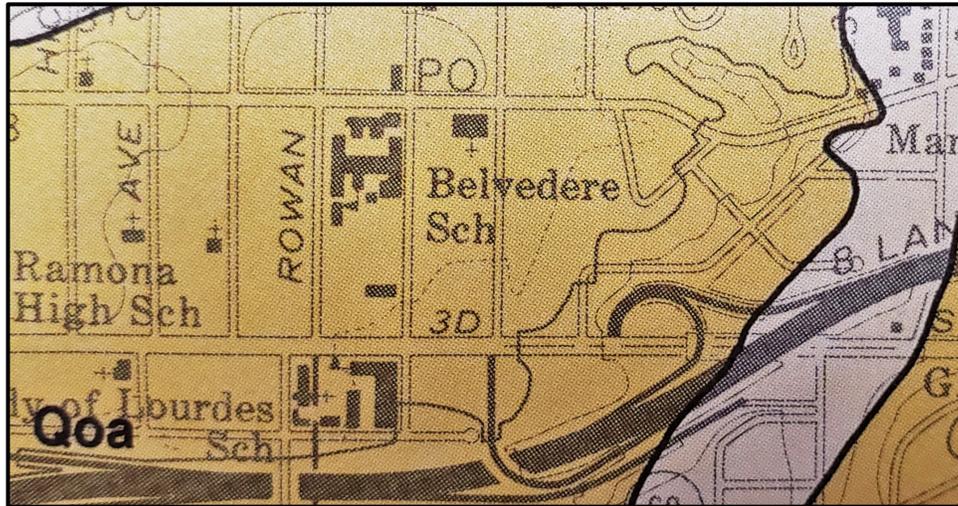
Figure 19: The entire project lies over older alluvial material (Qoa).

Examination of the 1989 Thomas Dibblee Jr. geological map for the project area, which is based on the 1980 Los Angeles USGS Quadrangle Map, indicated that the project property is completely contained within older alluvial material (Qoa) (**Figure 19**). Since older alluvial sediments can contain significant fossil resources, spot check monitoring by a qualified paleontologist when grading is within such material is recommended.

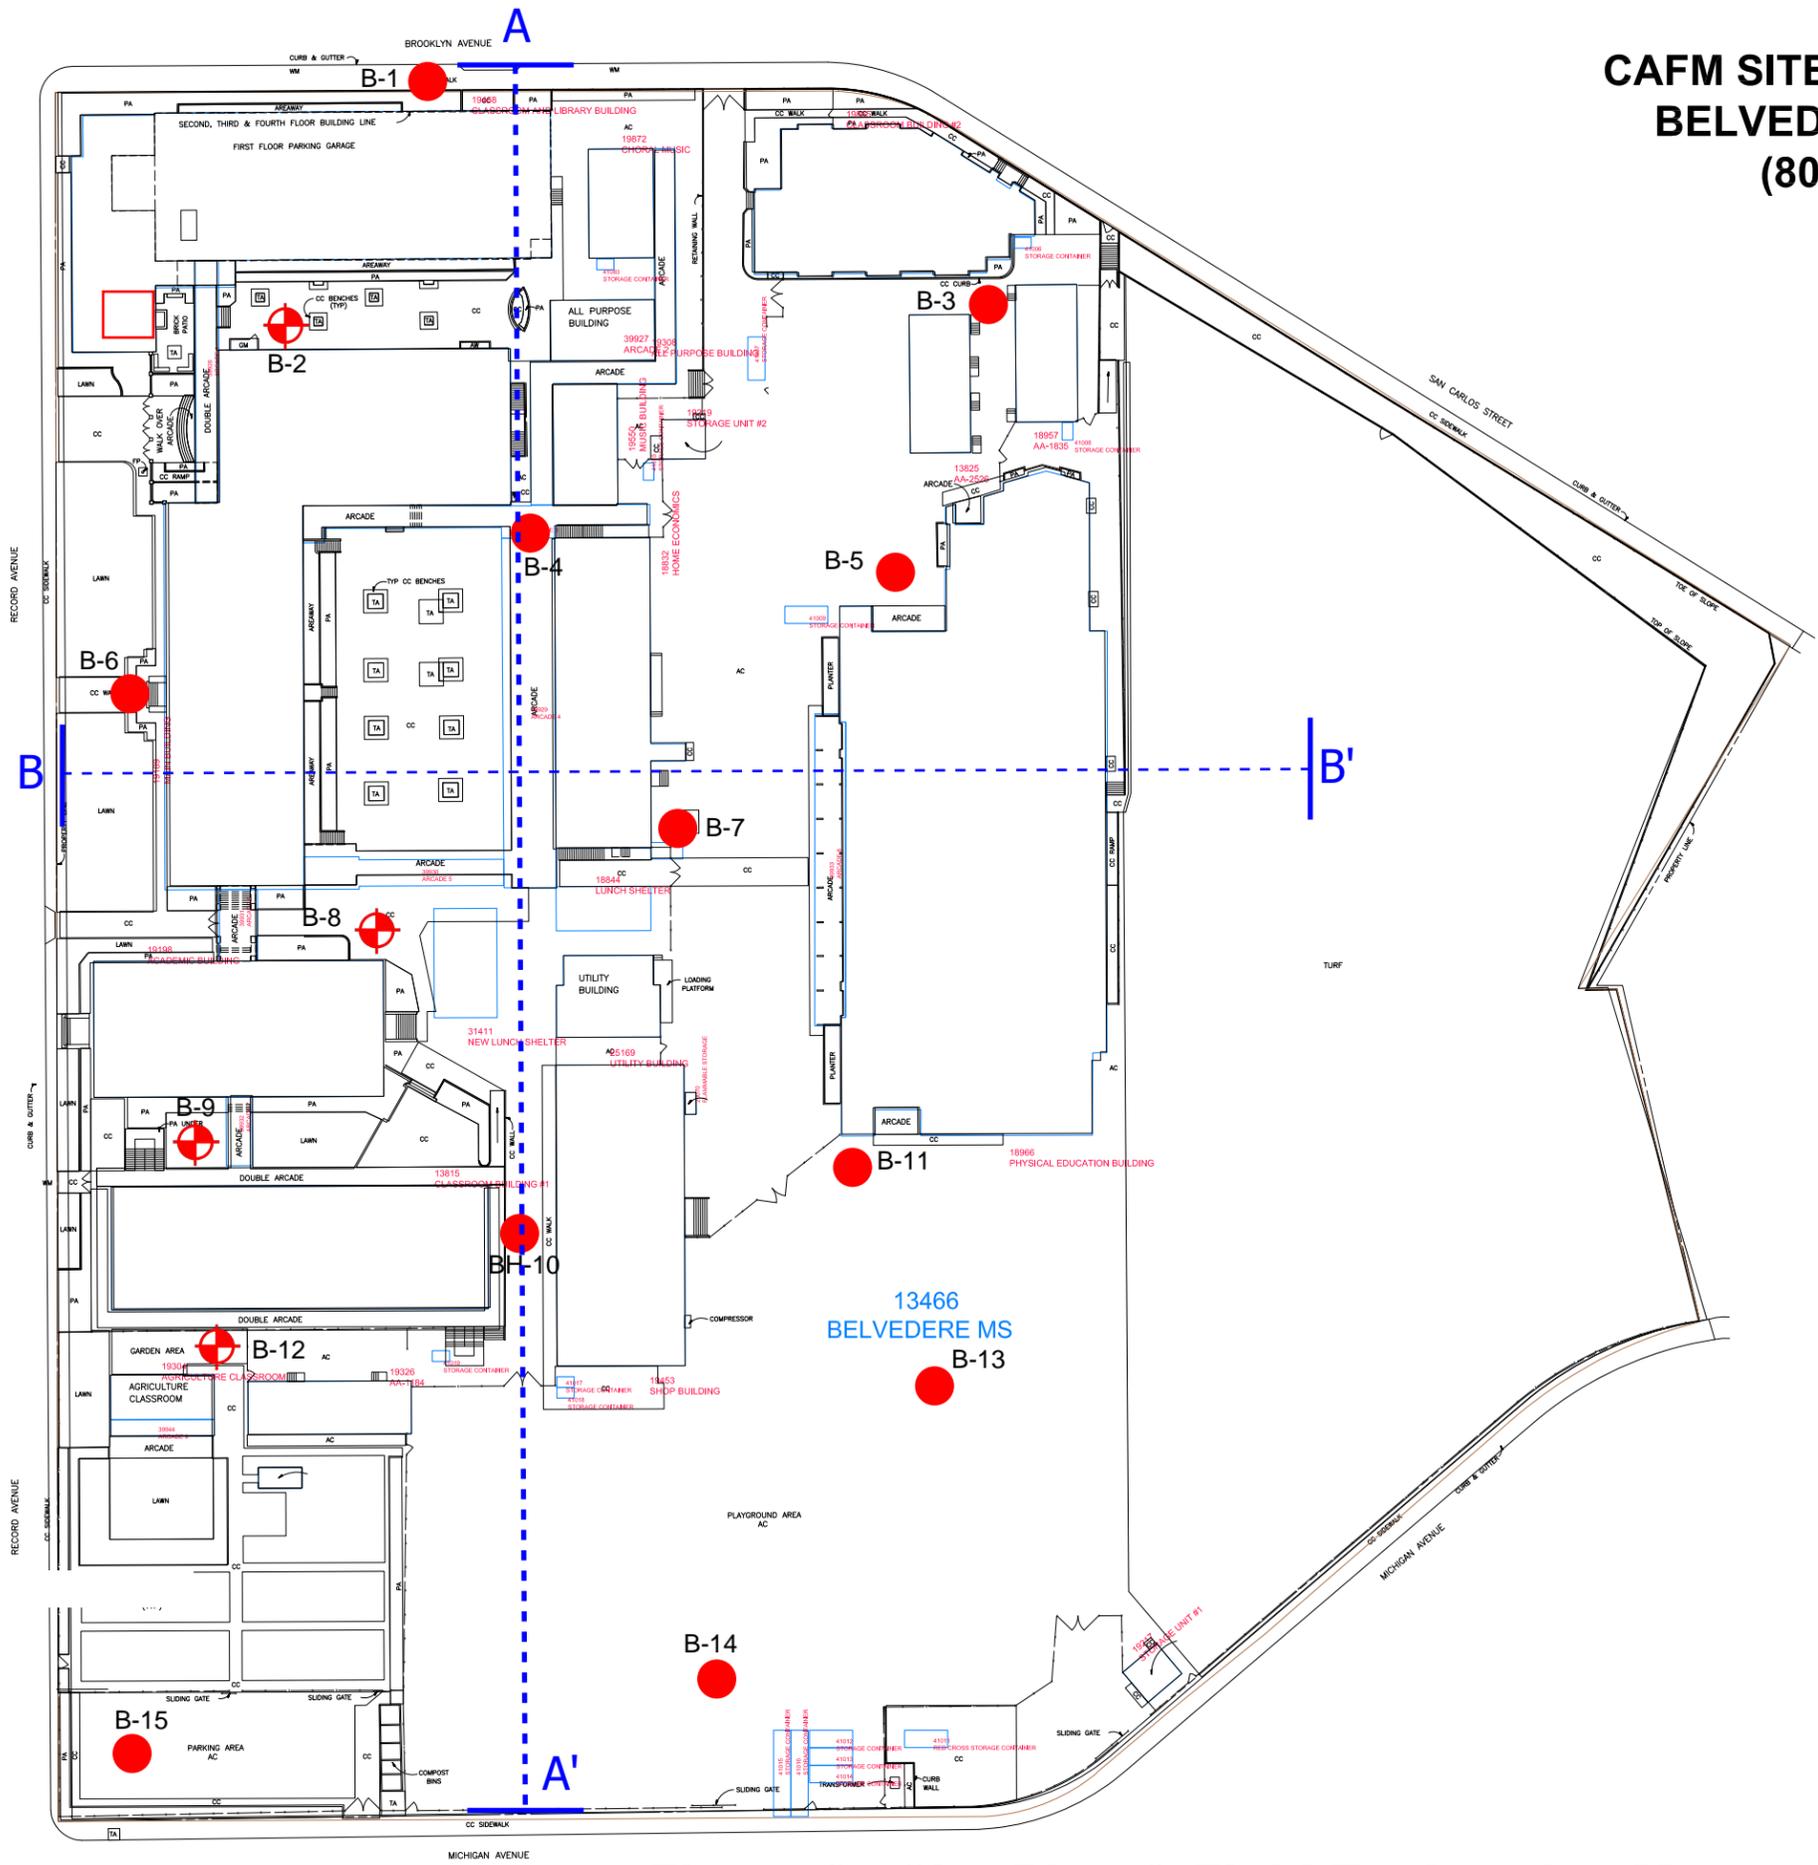
LEGENDS :

- B-12 Hand Auger Bore Holes
- B-15 Hollow Stem Auger Bore Holes

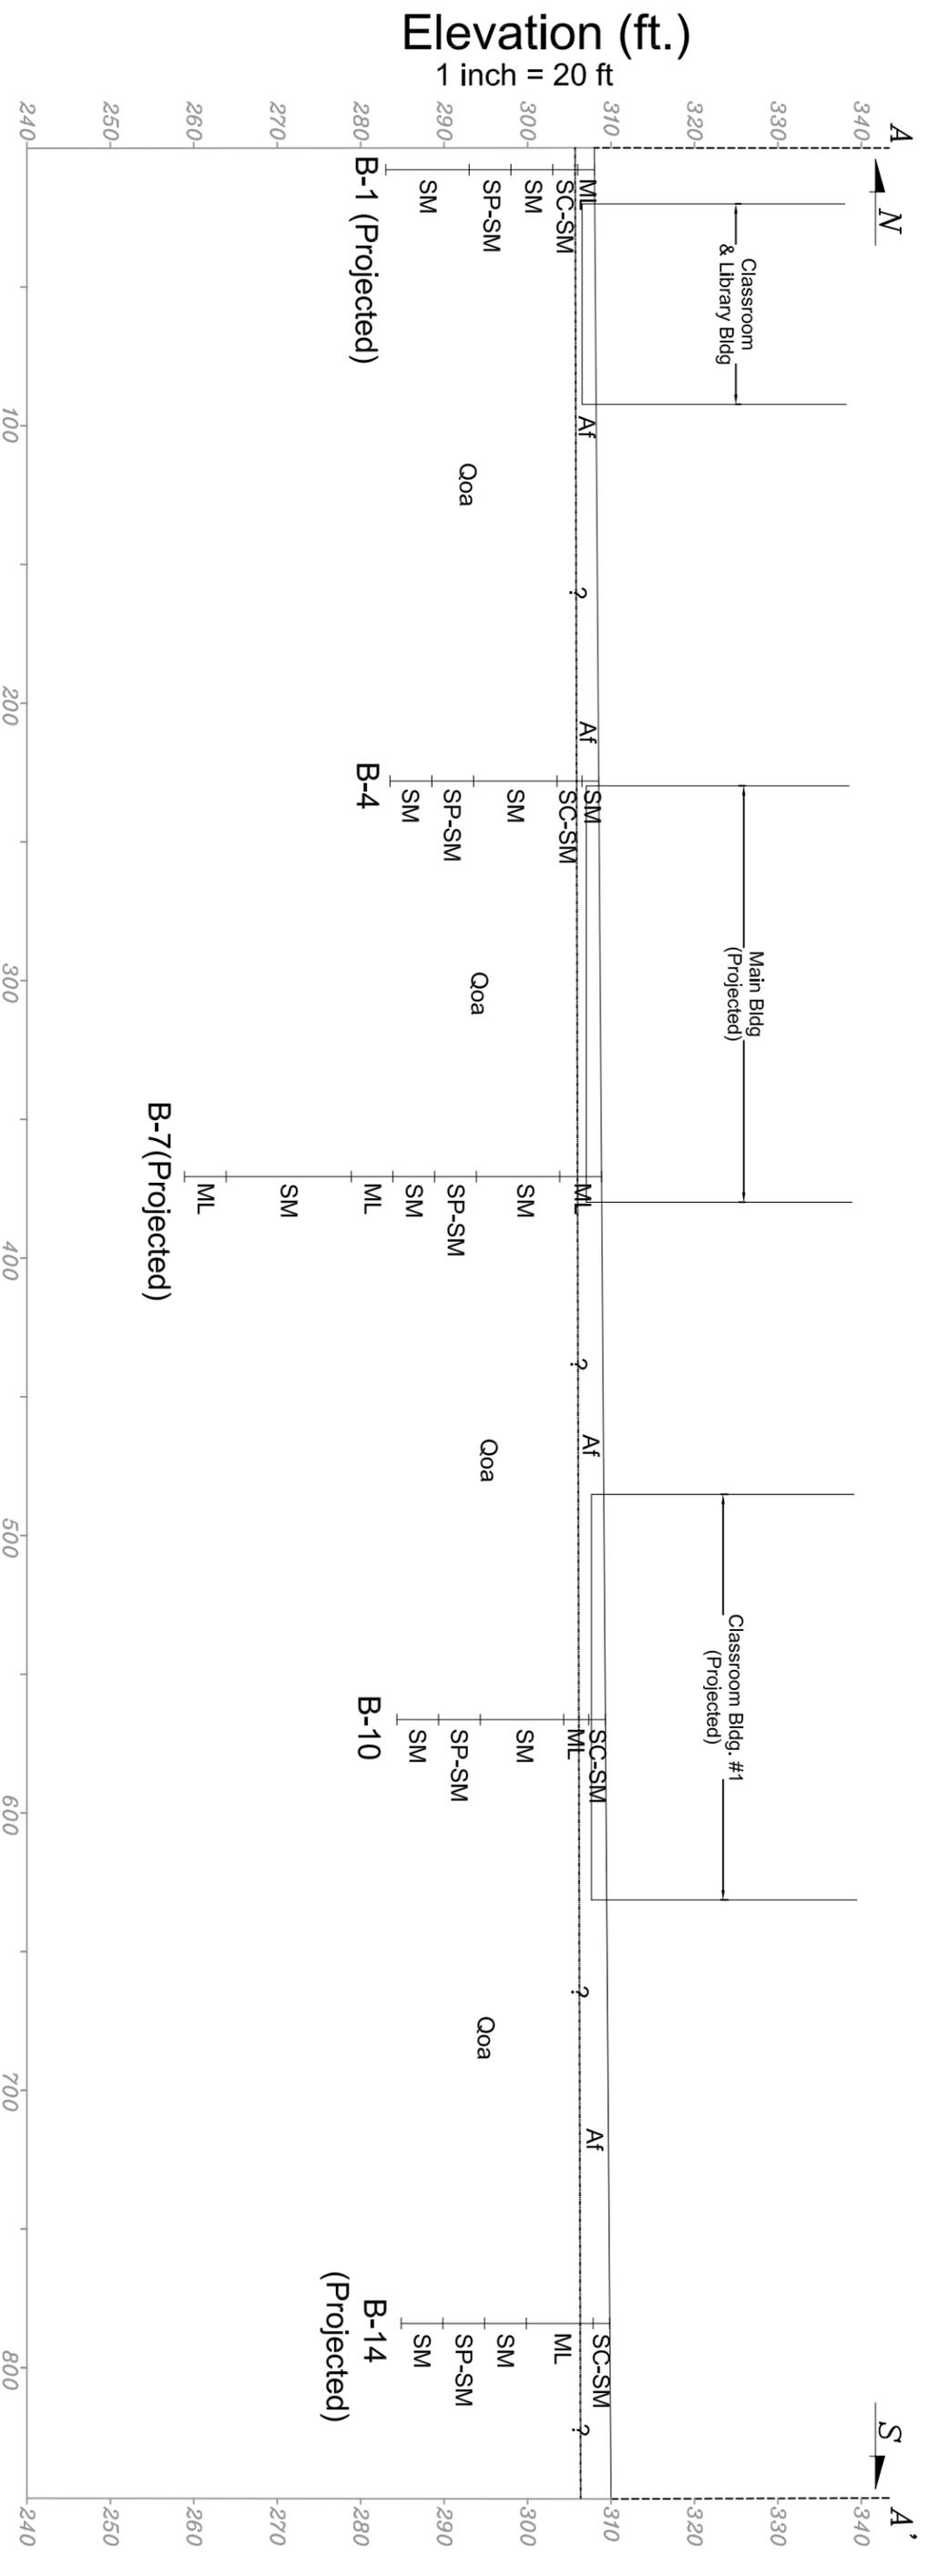
Distance along Section A - A' (ft.)

1 inch = 60 ft

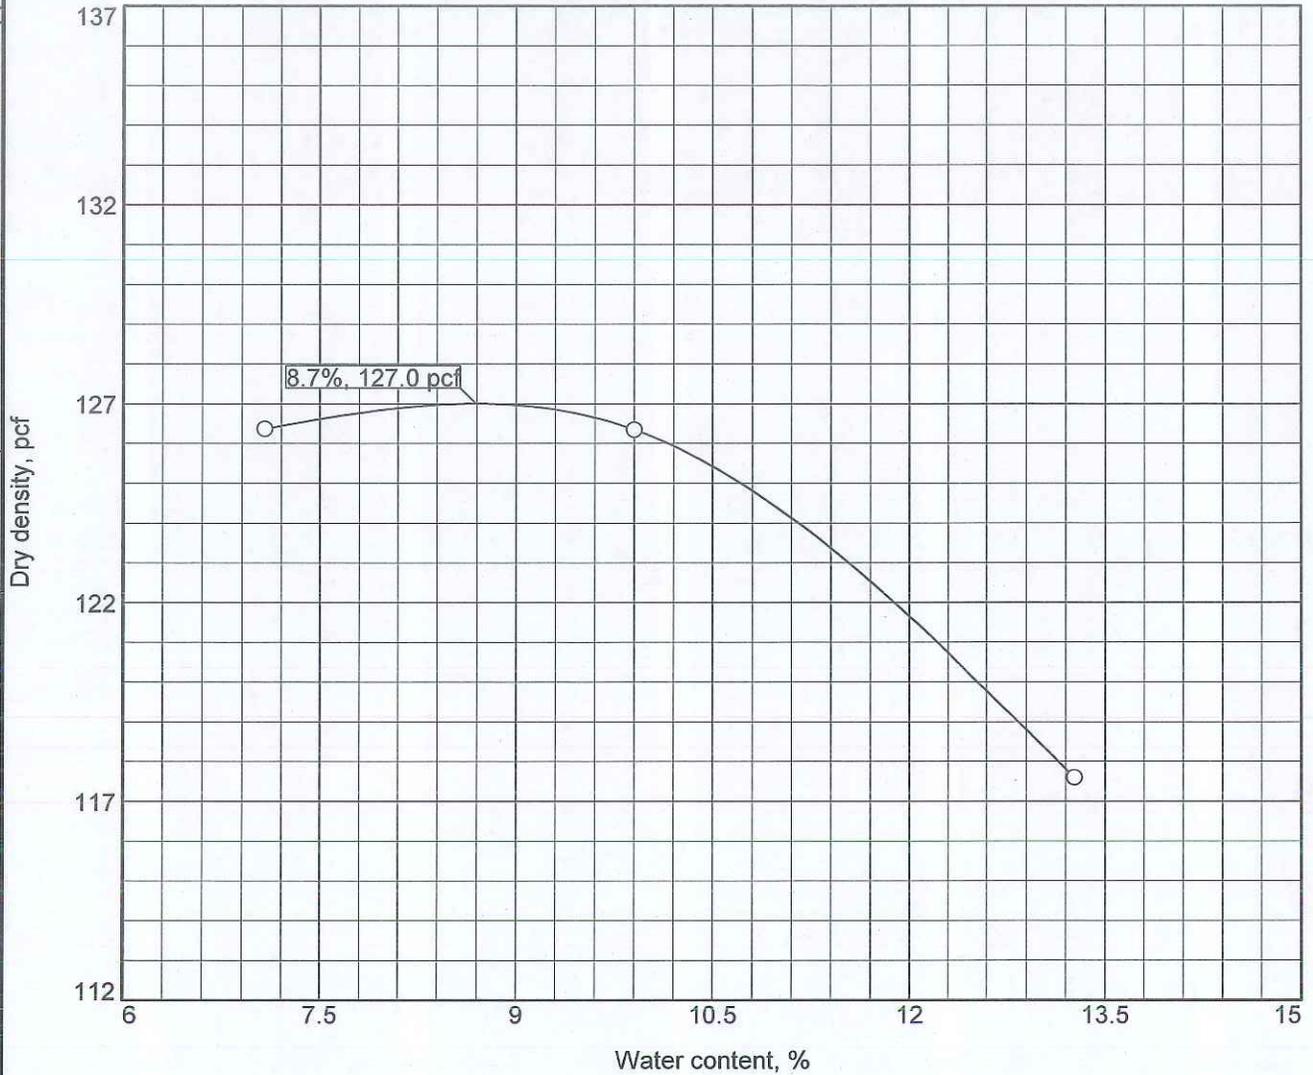
COMPACTION TEST REPORT

Test specification: ASTM D 1557-00 Method A Modified

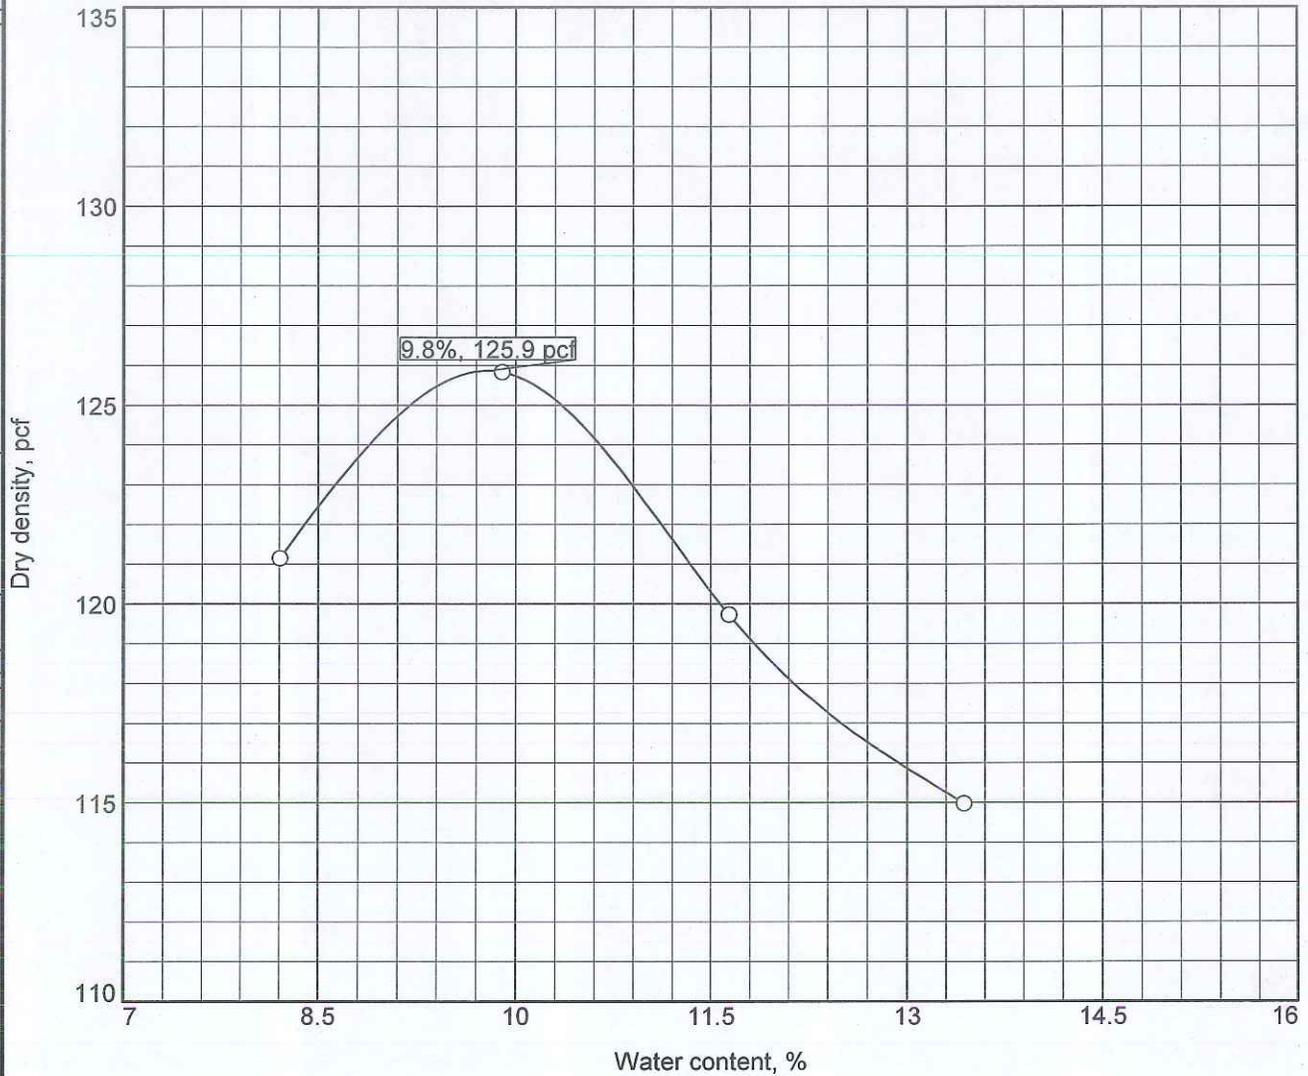
COMPACTION TEST REPORT

Test specification: ASTM D 1557-00 Method A Modified

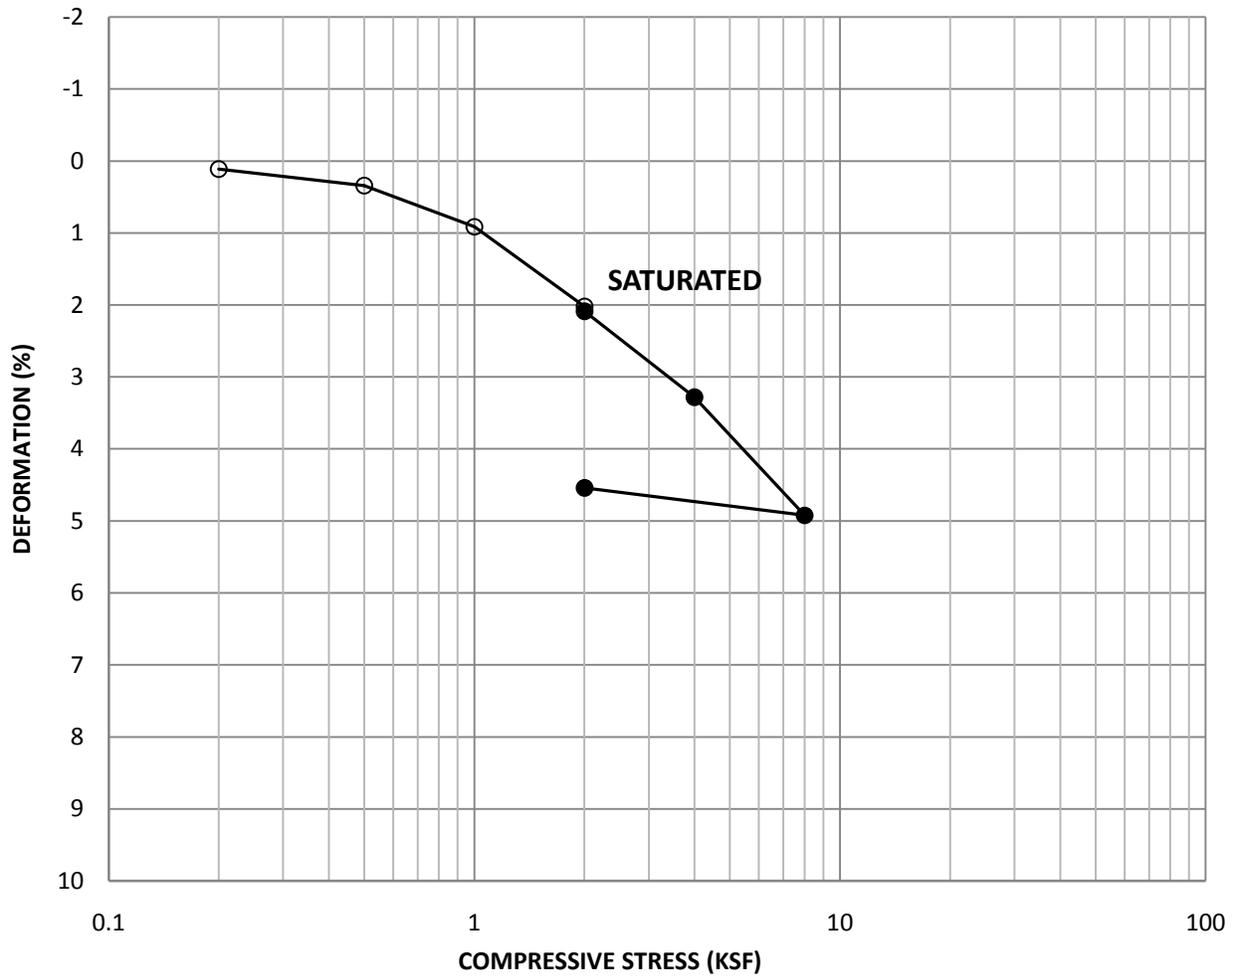
SYMBOL	BORING NO.	SAMPLE NO.	DEPTH (FT)	SOIL TYPE	INIT. MOISTURE CONTENT (%)	INIT. DRY DENSITY (PCF)	INIT. VOID RATIO
	B-7	N/A	10	SM	13.9	107.4	0.569

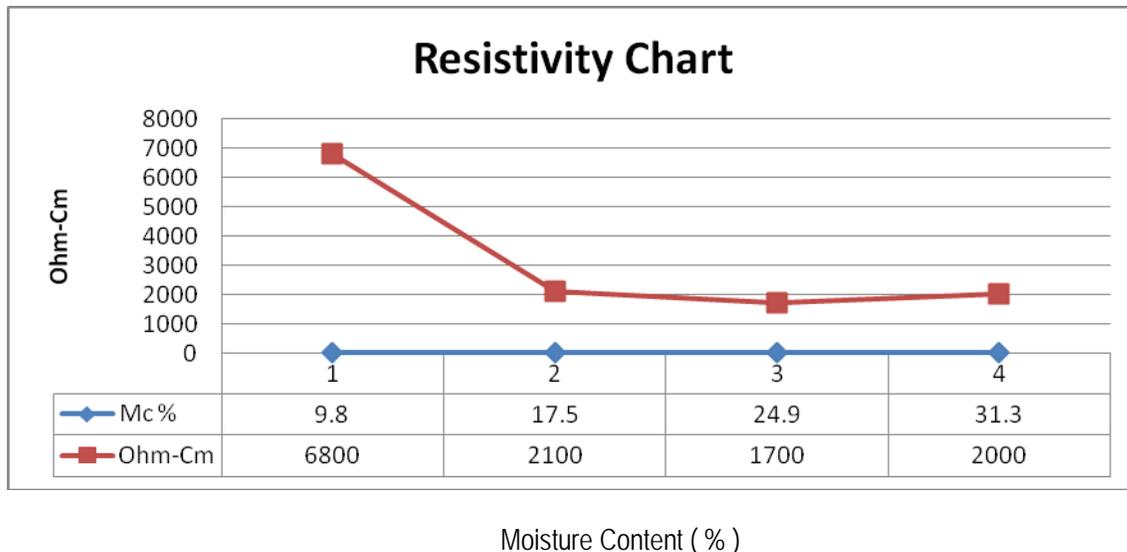
II. Soil Resistivity Chart- AASHTO T-288 / CTM 532 (Ohm-Cm)

Resistivity= 1700 Ohm-Cm @ 24.9 % Moisture Content

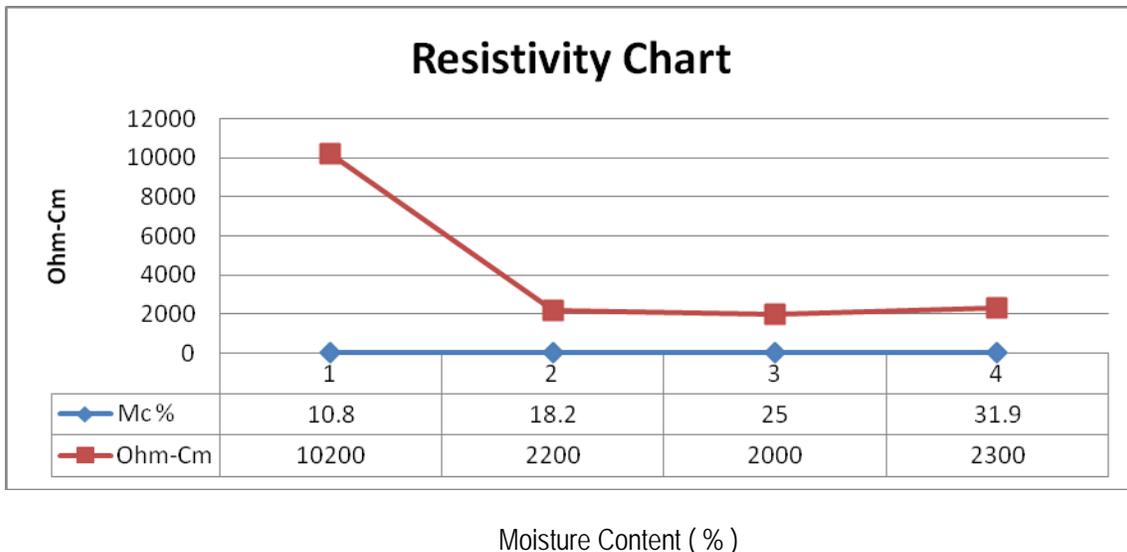
II. Soil Resistivity Chart- AASHTO T-288 / CTM 532 (Ohm-Cm)

Resistivity= 2000 Ohm-Cm @ 25.0 % Moisture Content

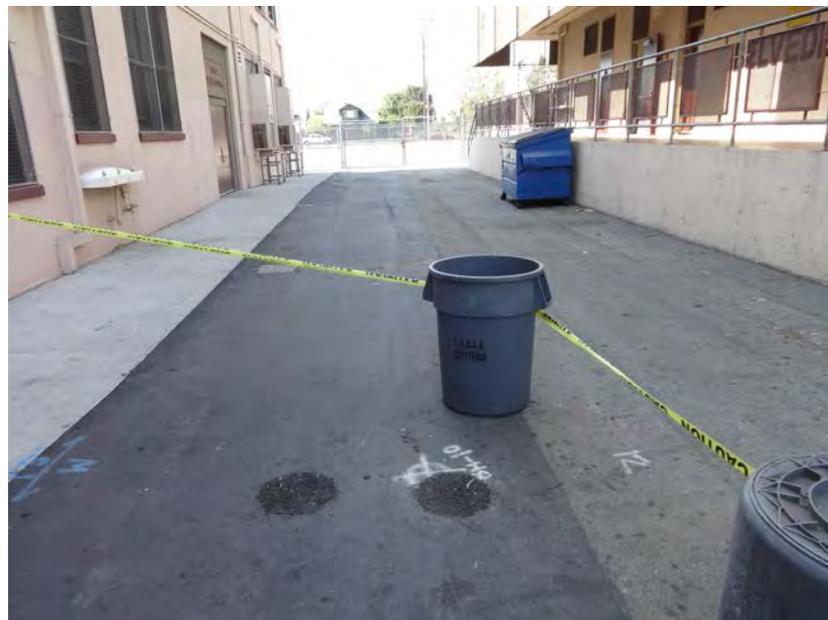
Photo: 4

Description: View of apparent geotechnical boring location; one of several noted in the area of the Shop building and Physical Education building

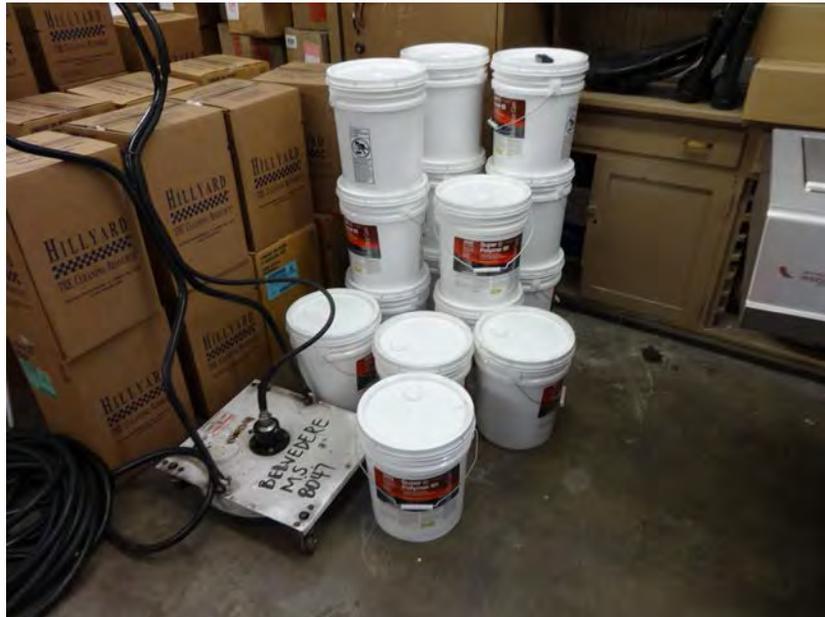
Photo: 8

Description: View of 5-gallon buckets of floor cleaner observed in the Plant Manager's office (i.e. Utility building)

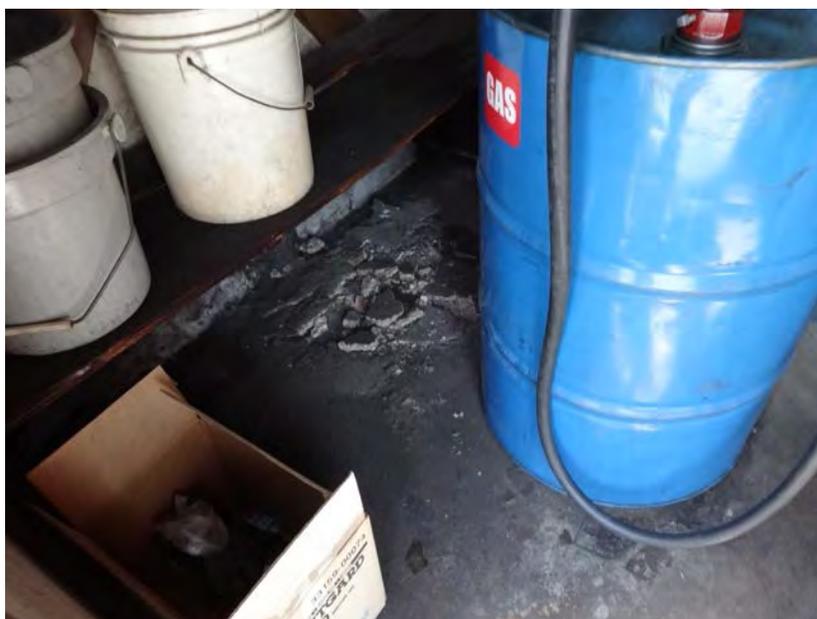
Photo: 12

Description: View of the deteriorated floor inside the fuel bunker

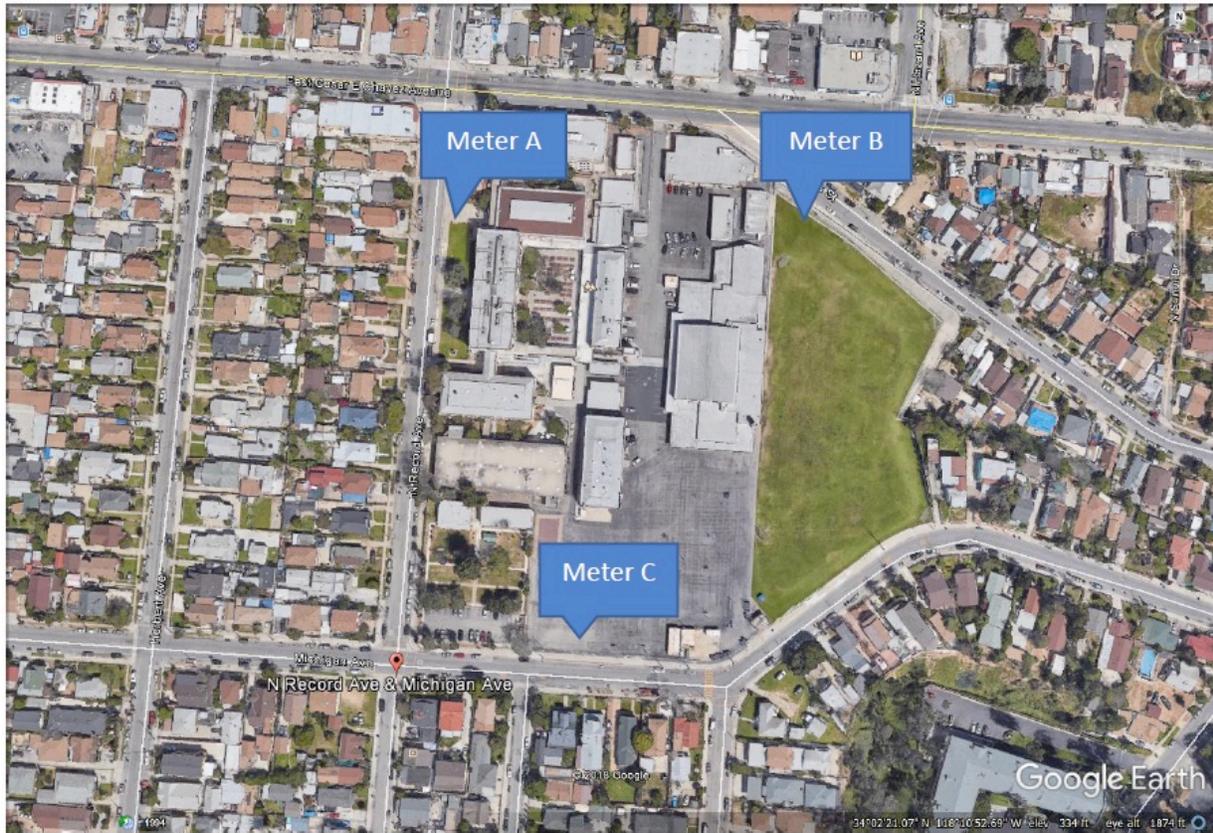
Figure 1
Noise Meter Locations

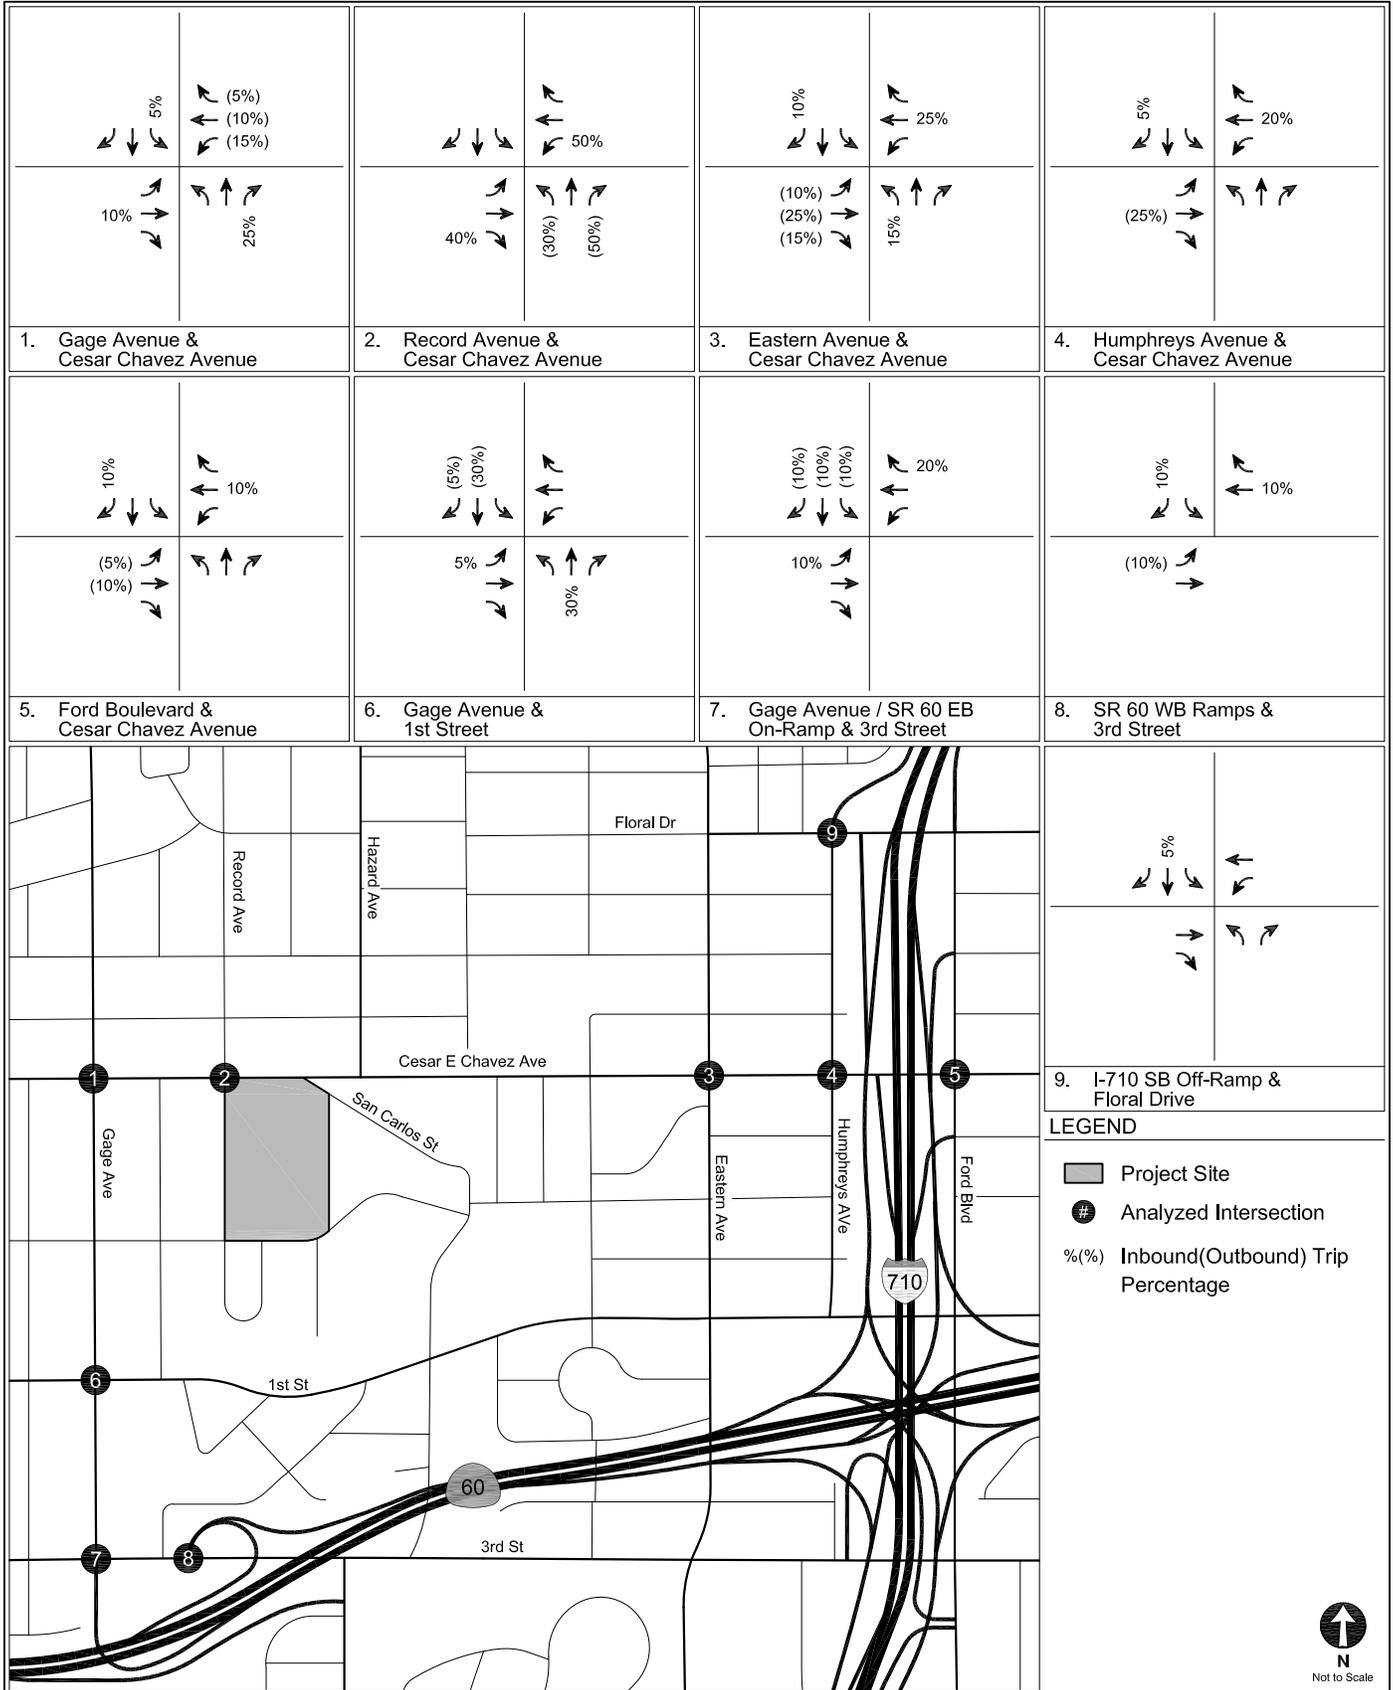
FIGURE
4

TRIP DISTRIBUTION
CONSTRUCTION WORKER TRIPS
