Appendices

Belvedere Middle School Modernization - Construction - South Coast Air Basin, Annual

ARBORIST TREE SURVEY & RECOMMENDATIONS | 5.3.3

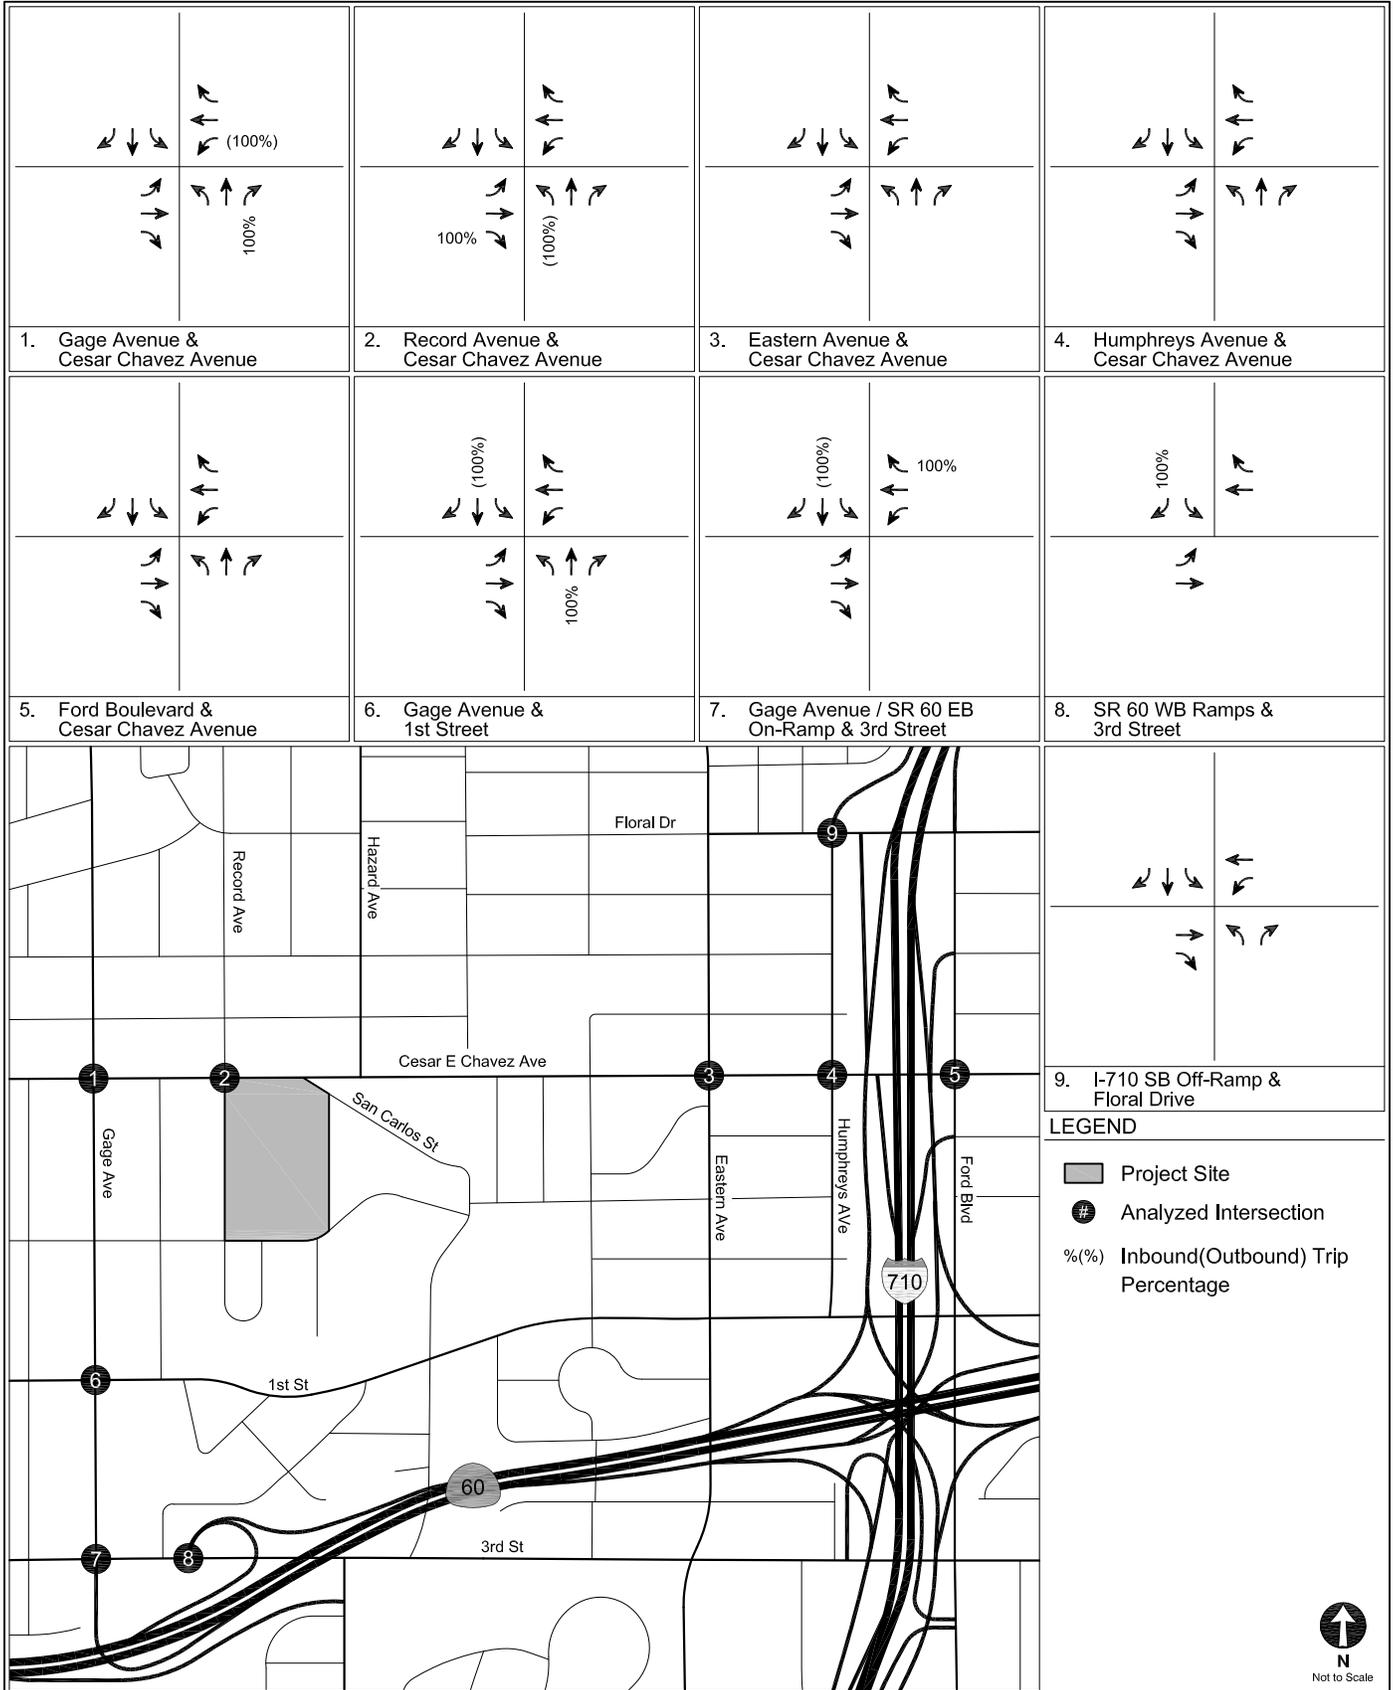
FIGURE
5A

TRIP DISTRIBUTION
CONSTRUCTION TRUCK TRIPS (SR 60 HAUL ROUTE)
