Standard Conditions of Approval

Burroughs Middle School Comprehensive Modernization Project

August 2017

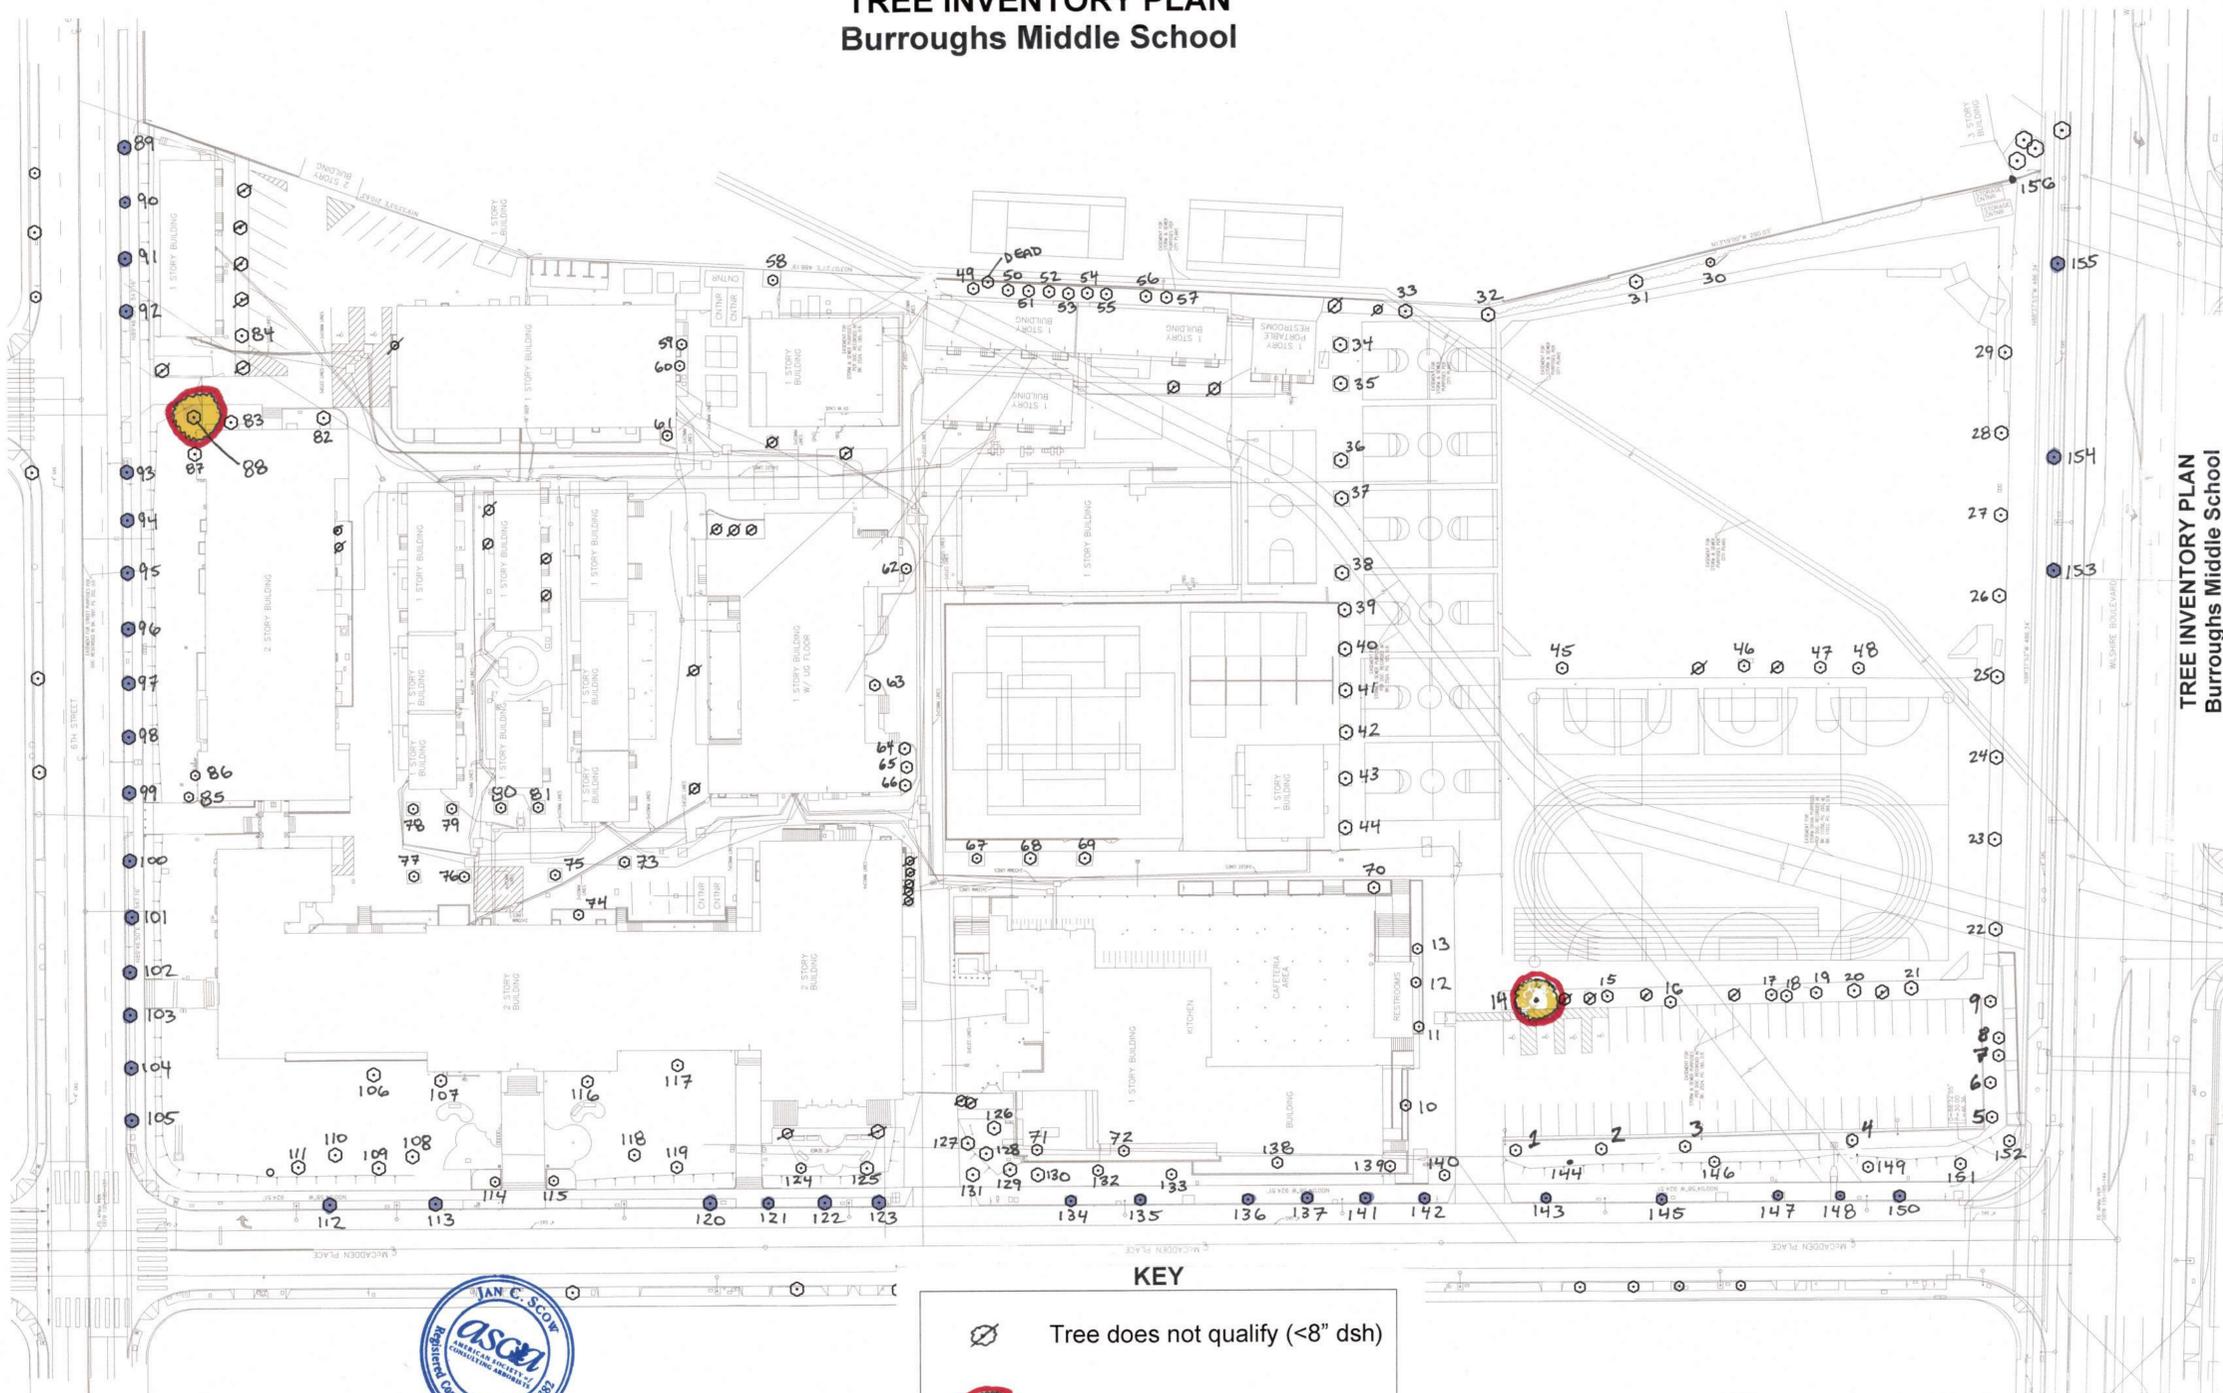
TREE INVENTORY PLAN Burroughs Middle School

- Tree does not qualify (<8" dsh)
- Protected oak tree
- Street tree (protected)

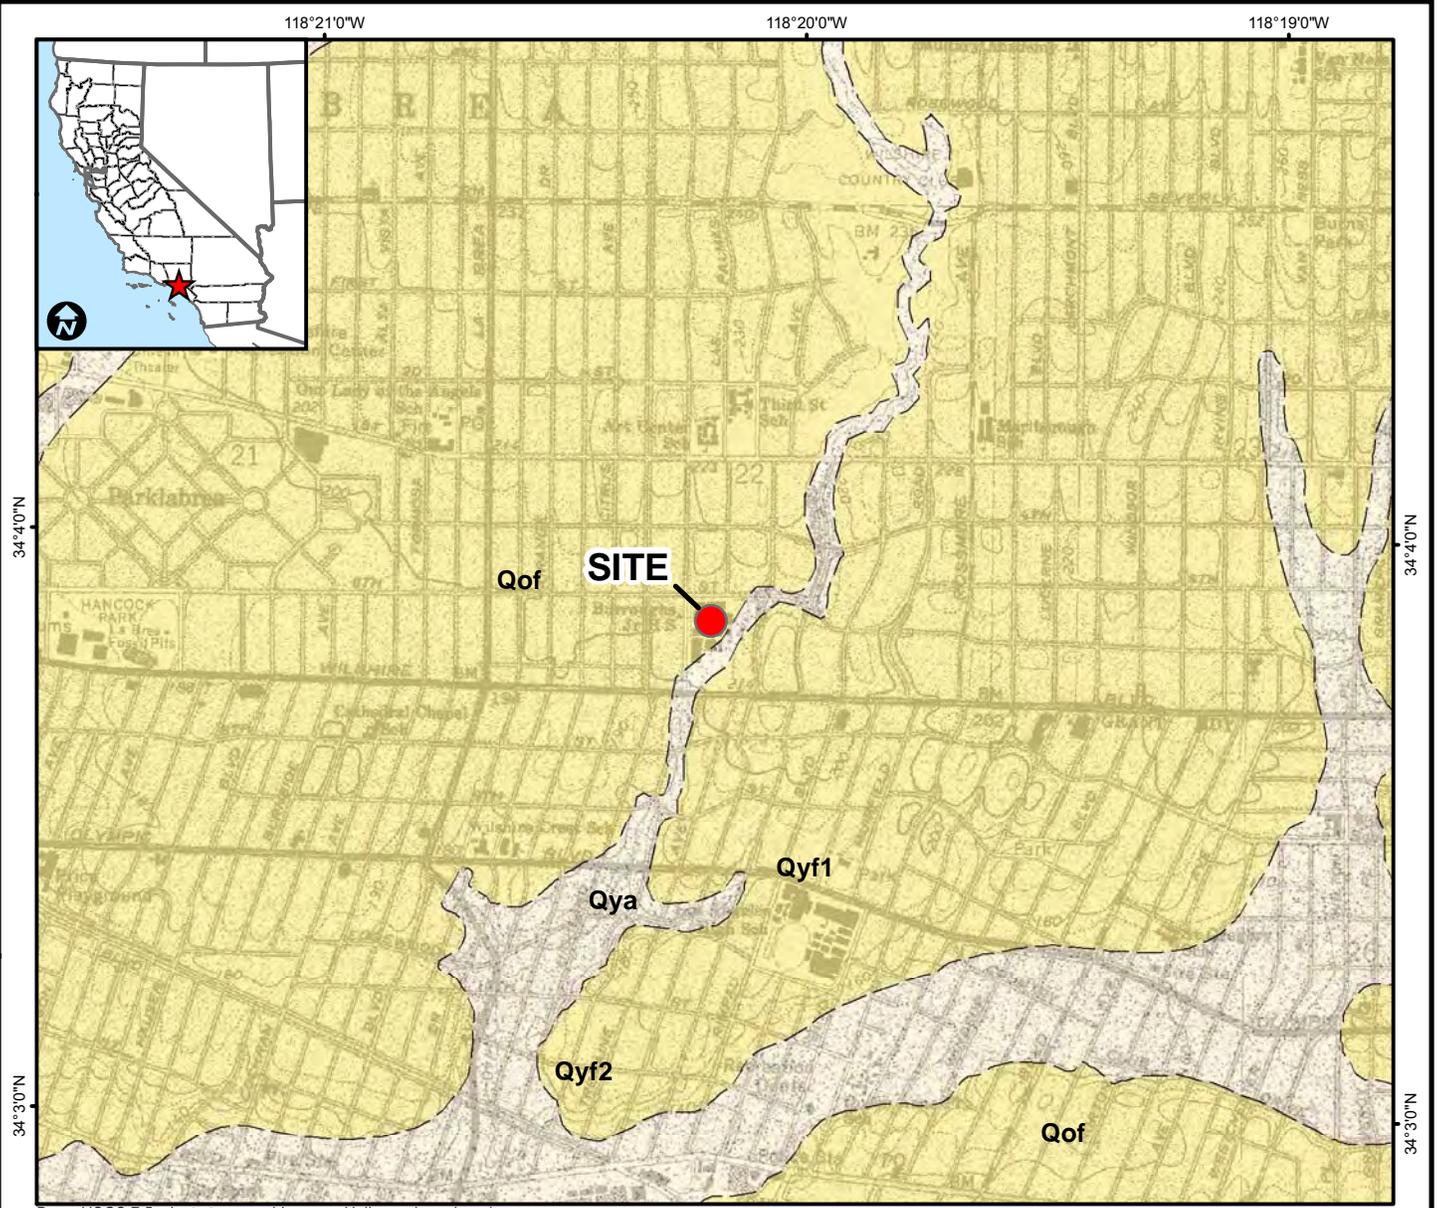
Geologic Units

Note: Only core geologic units shown for some units

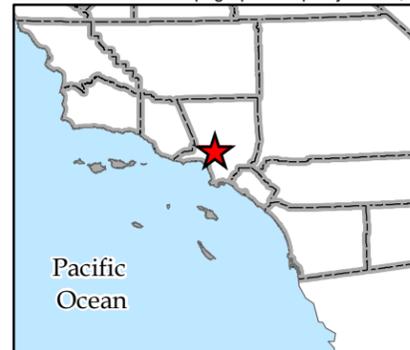
The relationship of the site to local topographic features is shown in Figure 1, Vicinity Map. Local geologic conditions are depicted in Figure 3, Local Geologic Map. Regional geologic conditions are shown in Figure 4, Regional Geologic Map. The location of major faults and earthquake epicenters in Southern California are shown on the Regional Faults and Seismicity Map, Figure 5.

The numerous faults in Southern California include active, potentially active, and inactive faults. The criteria for these major groups are based on criteria developed by the California Geological Survey, CGS (previously the California Division of Mines and Geology), for the Alquist-Priolo Earthquake Fault Zoning Program (Bryant and Hart, 2007). By definition, an active fault is one that has had surface displacement within Holocene time (about the last 11,700 years). A potentially active fault is a fault that has demonstrated surface displacement of Quaternary age deposits (last 1.6 million years). Inactive faults have not moved in the last 1.6 million years. A list of nearby active faults (those faults included in Field et al., 2013) and the distance in miles between the site and the nearest point on the fault, the maximum magnitude, and the slip rate for the fault is given in Table 1. A similar list for potentially active faults is presented in Table 2. The faults in the vicinity of the site are shown in Figure 5, Regional Faults and Seismicity Map.

The seismicity of the region surrounding the site was determined from research of an electronic database of seismic data (Southern California Seismographic Network, 2014). This database includes earthquake data compiled by the California Institute of Technology for 1932 through 2014 and data for 1812 to 1931 compiled by Richter and the U.S. National Oceanic Atmospheric Administration (NOAA). The search for earthquakes that occurred within 100 kilometers of the site indicates that 435 earthquakes of Richter magnitude 4.0 and greater occurred from 1932 through 2014; one earthquake of magnitude 6.0 or greater occurred between 1906 and 1931; and one earthquake of magnitude 7.0 or greater occurred between 1812 and 1905. Epicenters of some of the moderate and major earthquakes (magnitude 5.0 and greater) are shown in Figure 5.

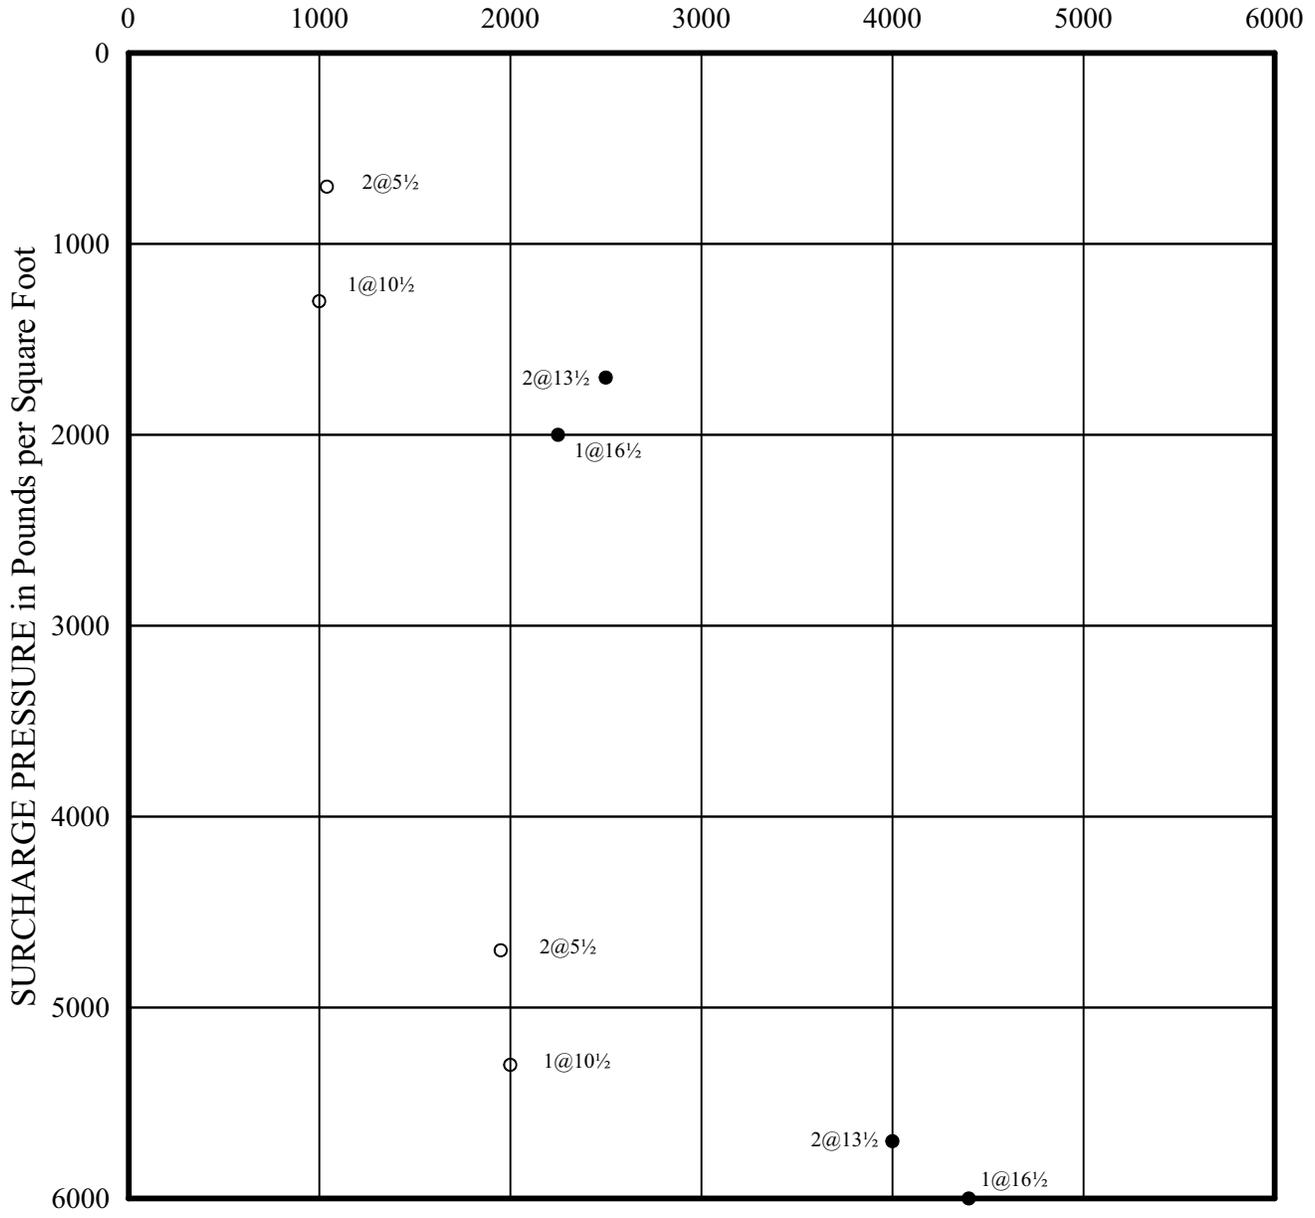
Figure A-2

SHEAR STRENGTH in Pounds per Square Foot

- Samples tested after soaking to a moisture content near saturation
- Samples tested at field moisture content

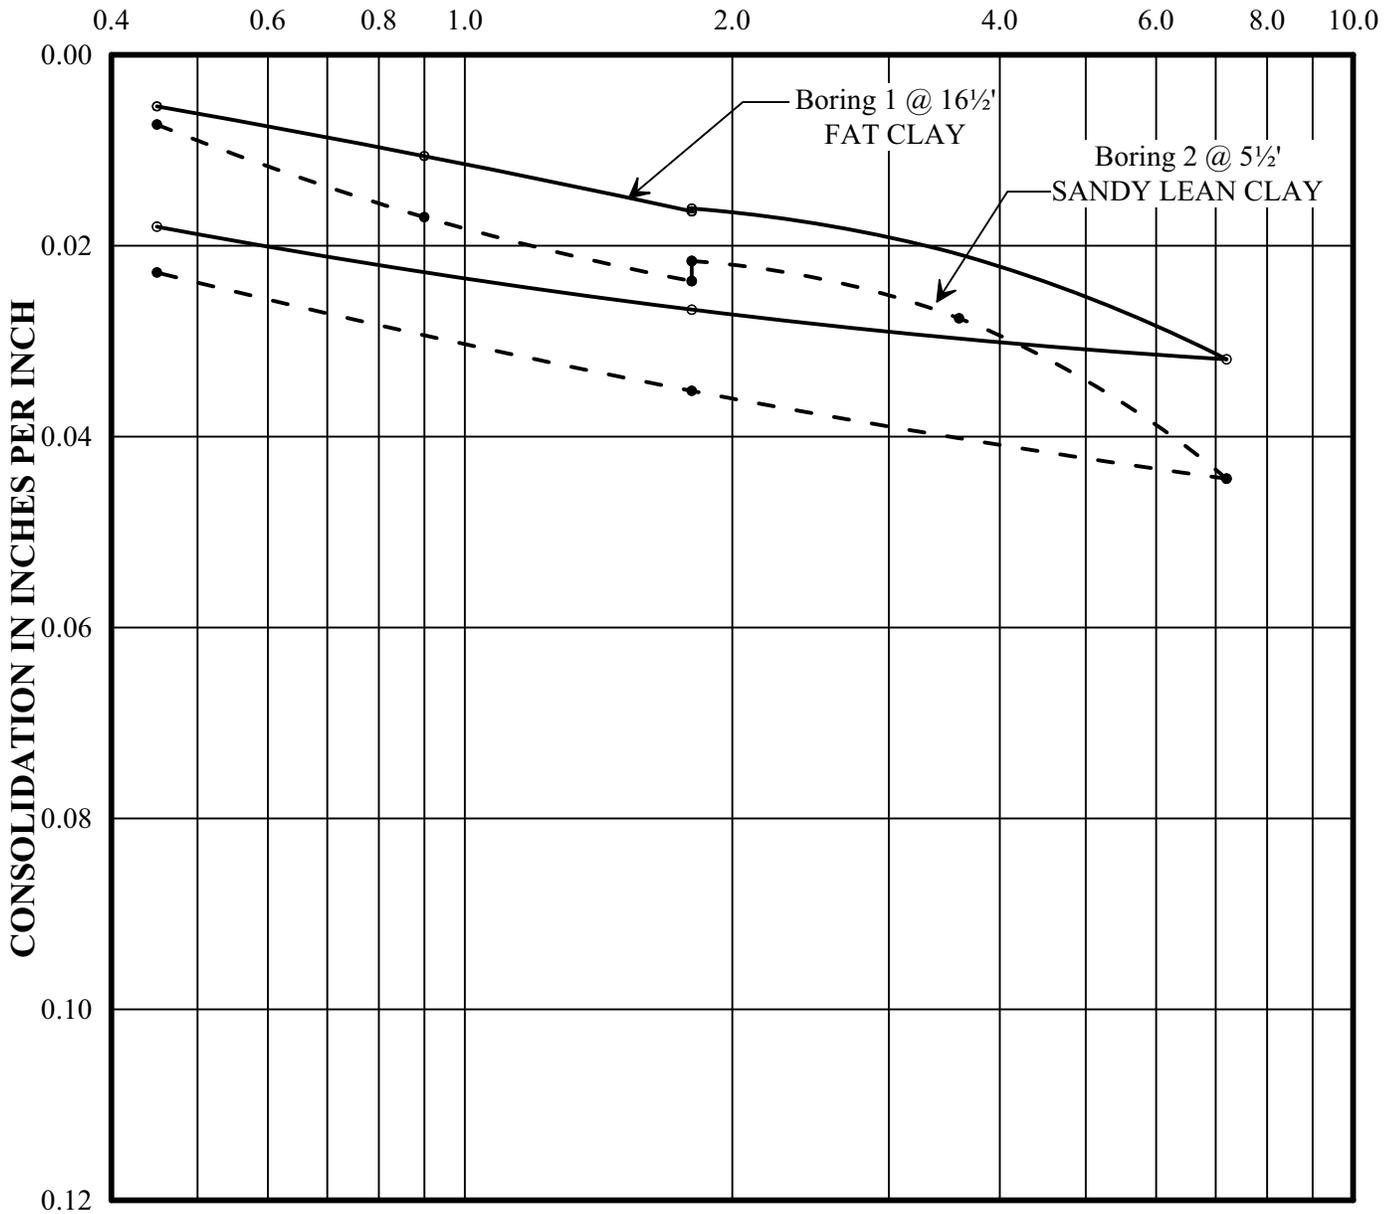
LOAD IN KIPS PER SQUARE FOOT

Note: Water added to samples after consolidation under a load of 1.8 kips per square foot.

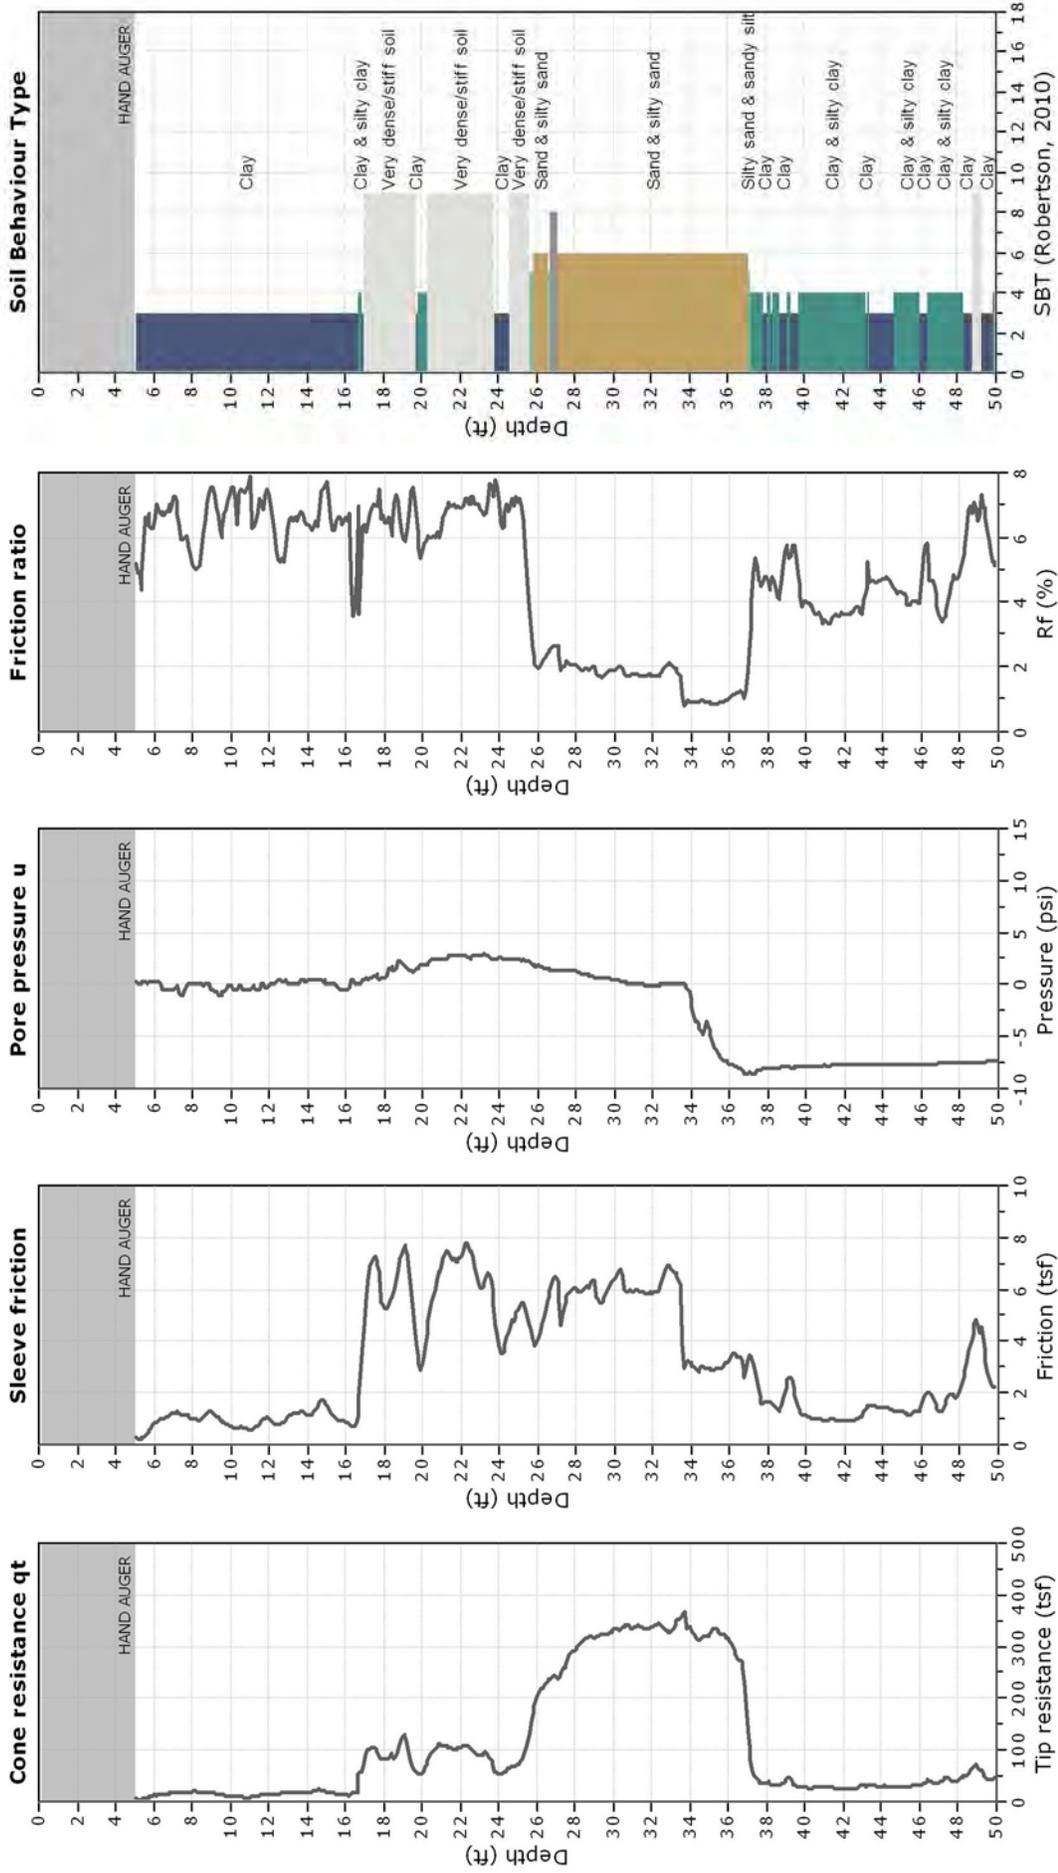
CPT: CPT-1
 Total depth: 50.24 ft, Date: 7/13/2015
 Cone Type: Vertek

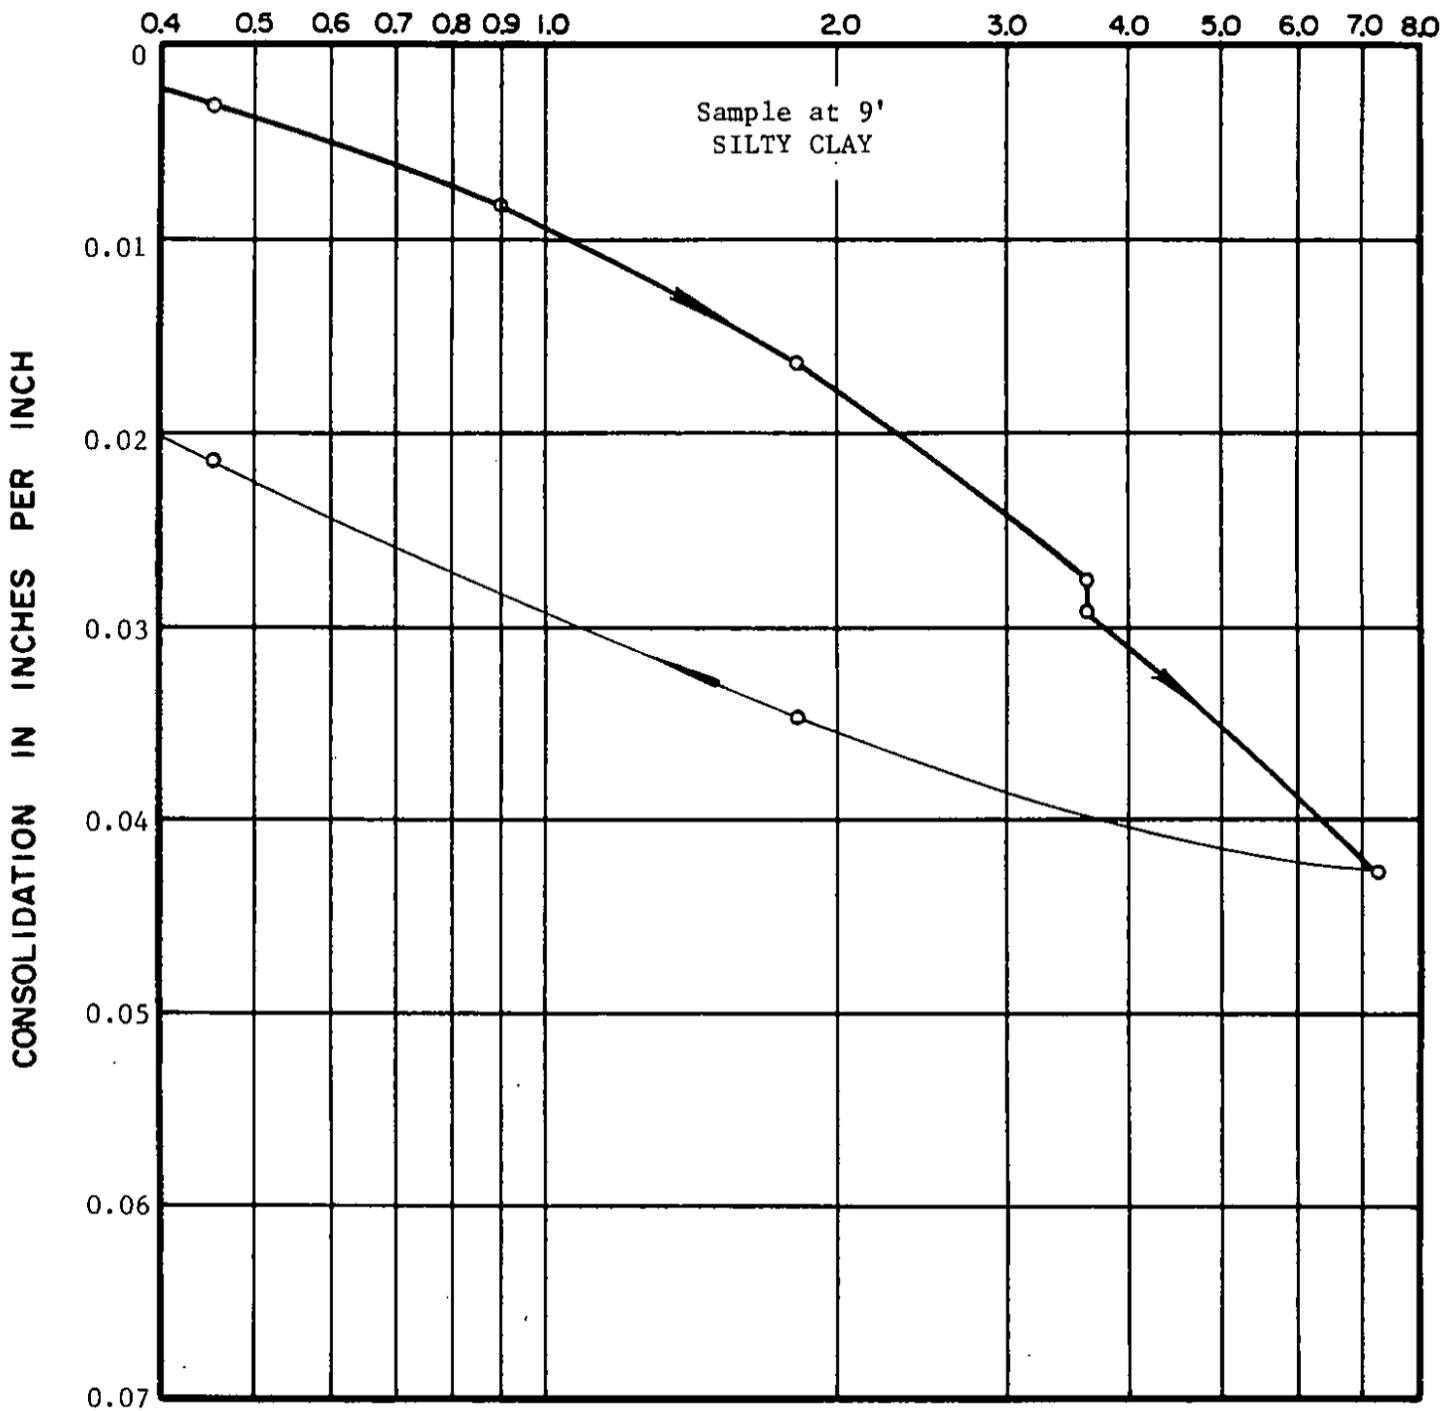
CONSOLIDATION TEST DATA

LOAD IN KIPS PER SQUARE FOOT

NOTE: Water added to sample after consolidation under a load of 3.6 kips per square foot.

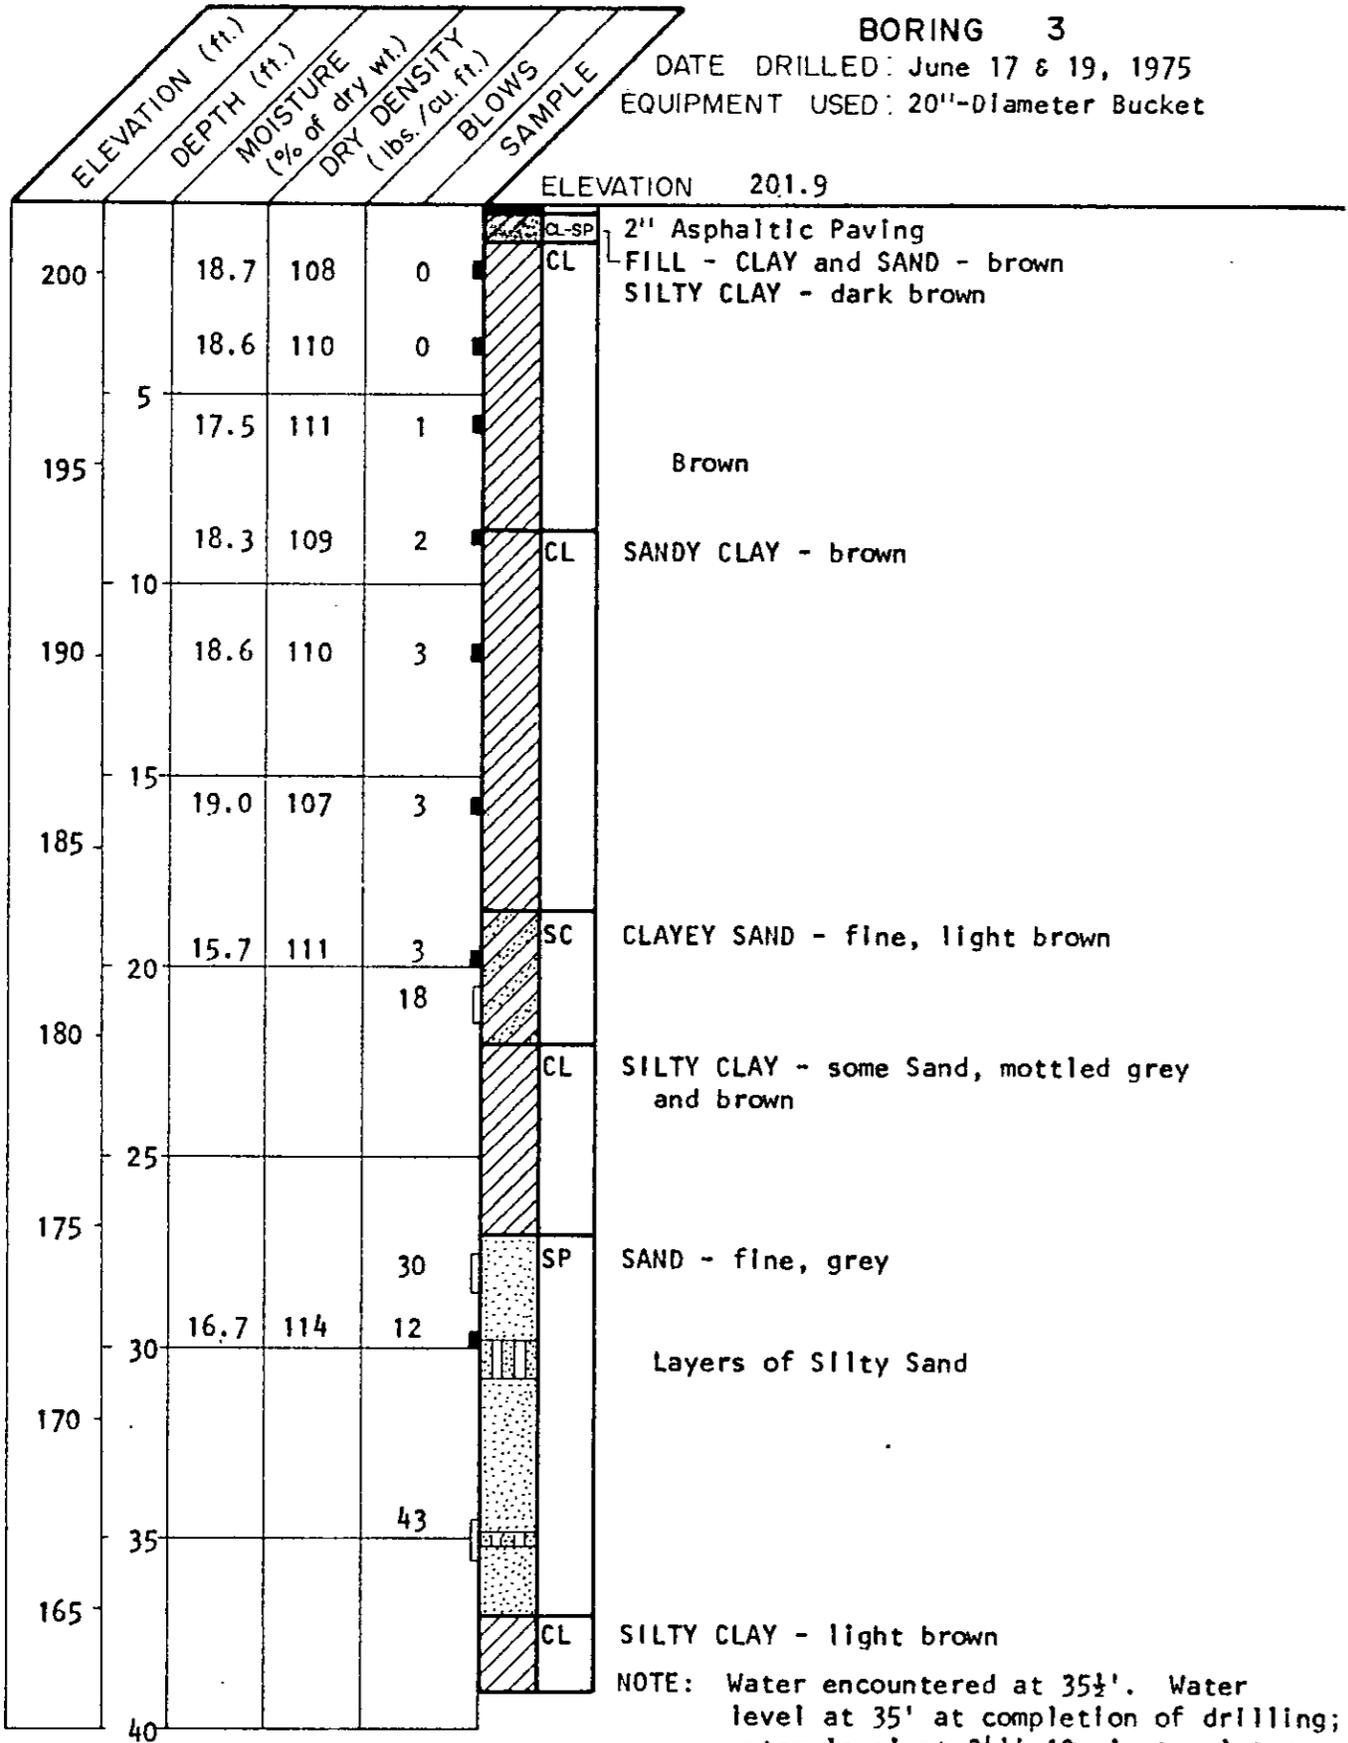
LOG OF BORING

NOTE: Water encountered at 35½'. Water level at 35' at completion of drilling; water level at 34½' 10 minutes later. Caving below 35'.

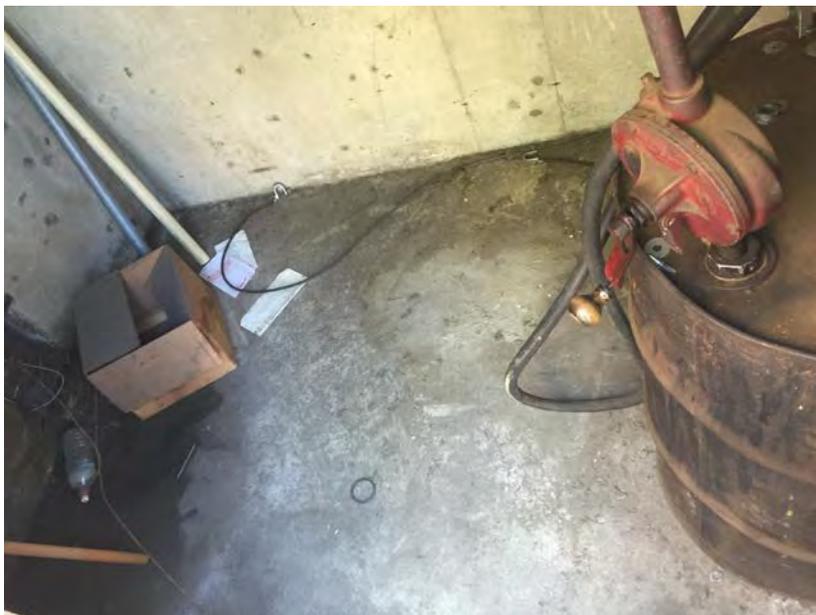
Photo 14: 55-gallon drum storing gasoline and hydrocarbon staining/spill, in the flammable materials storage building, located southeast of Building No. 9 (Shop Building).

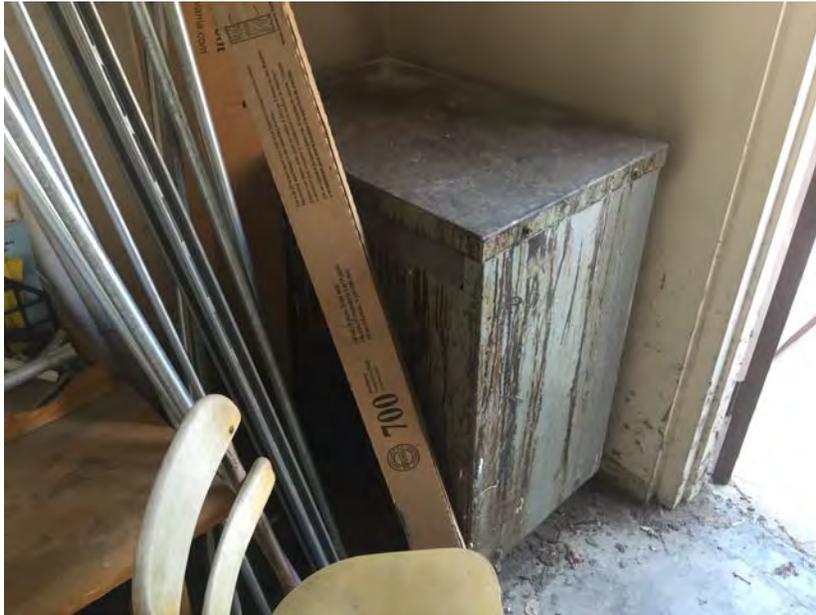
Photo 19: Transformer stored in the sprinkler room located in the northern portion of Building No. 20 (Cafeteria Building).

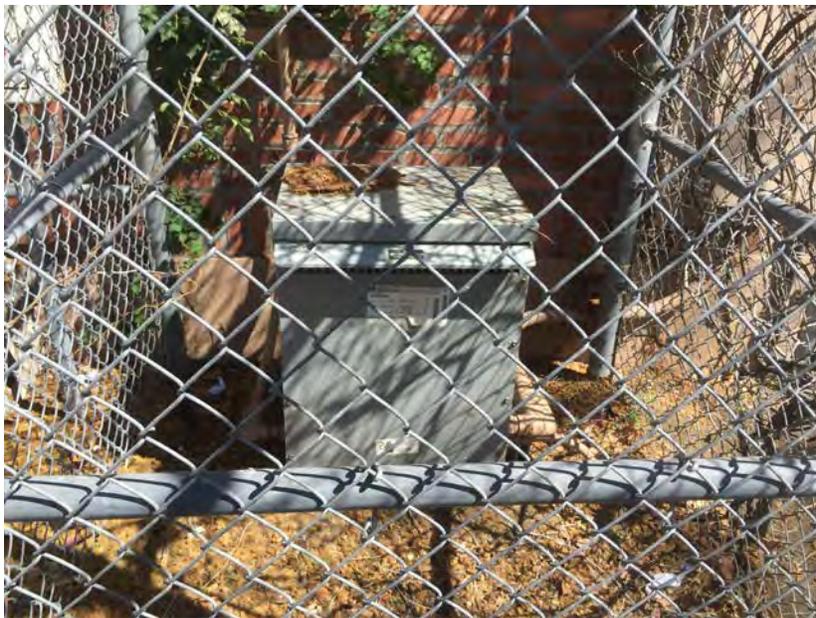
Photo 20: Transformer located south of Building No. 9 (Shop Building).

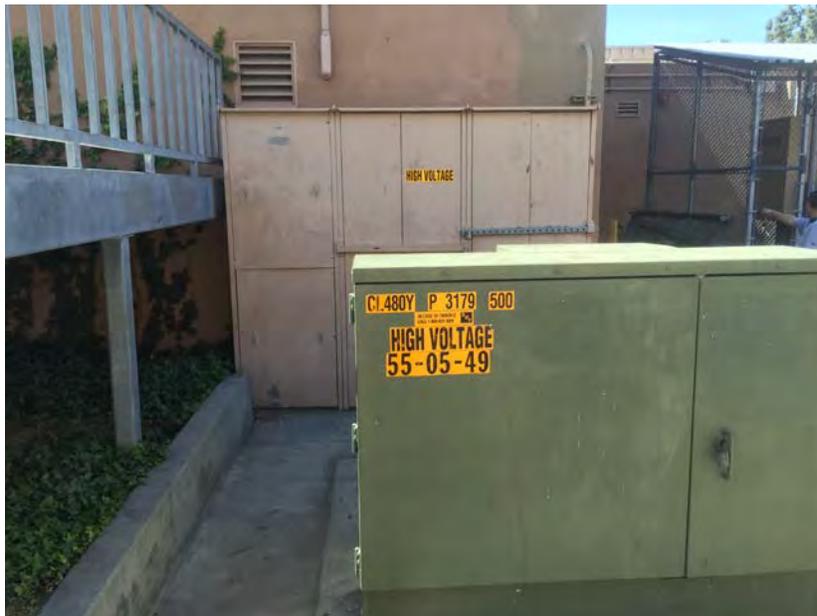
Photo 21: Two transformers located next to the waste and recycling bins, located north of the Building No. 20 (Cafeteria Building).

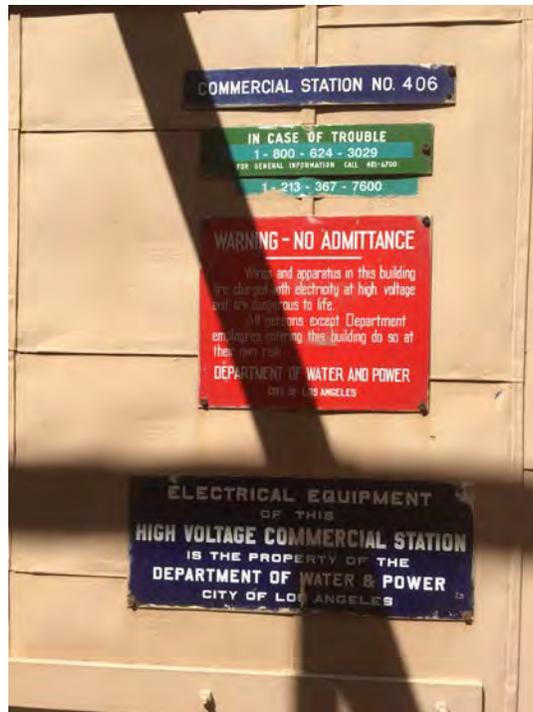
Photo 24: Los Angeles Department of Water and Power electrical equipment room, located in the eastern portion of Building No. 1 (Main/Auditorium Building).

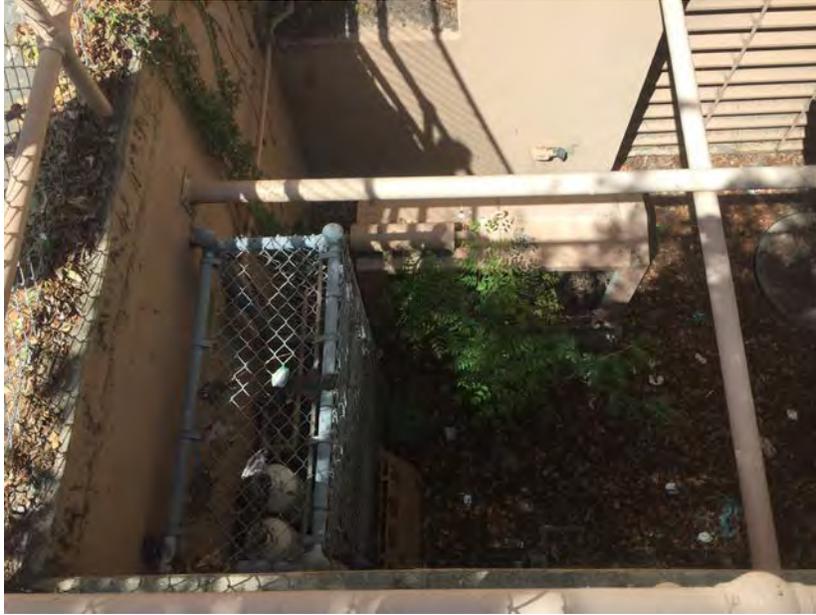
Photo 25: Old generator and compressed gas cylinders located adjacent to the east of Building No. 1 (Main/Auditorium Building).

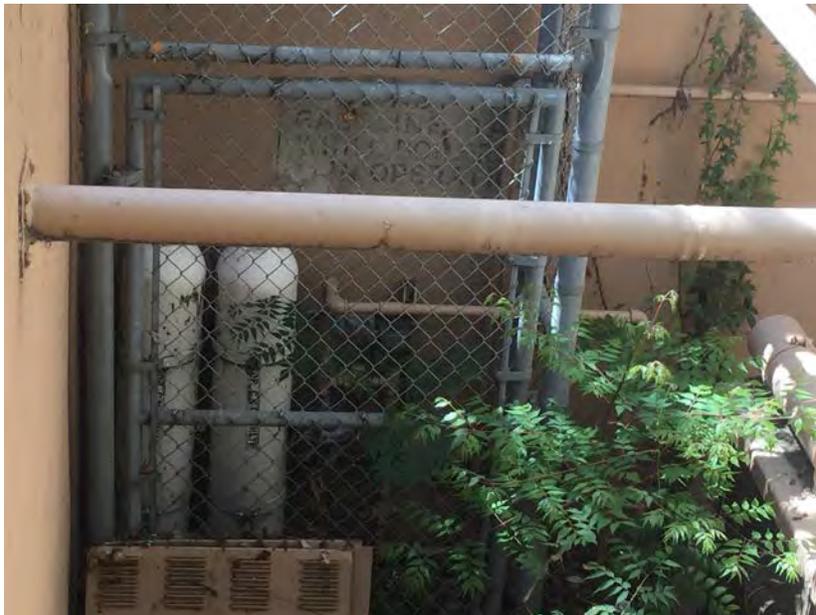
Photo 26: Compressed gas cylinders located adjacent to the east of Building No. 1 (Main/Auditorium Building).
