January 24, 2025

Subject: Site Inspection Report for Canyon Elementary School, 421 Entrada Drive, Santa Monica, California

Field Notes and Photographic Log

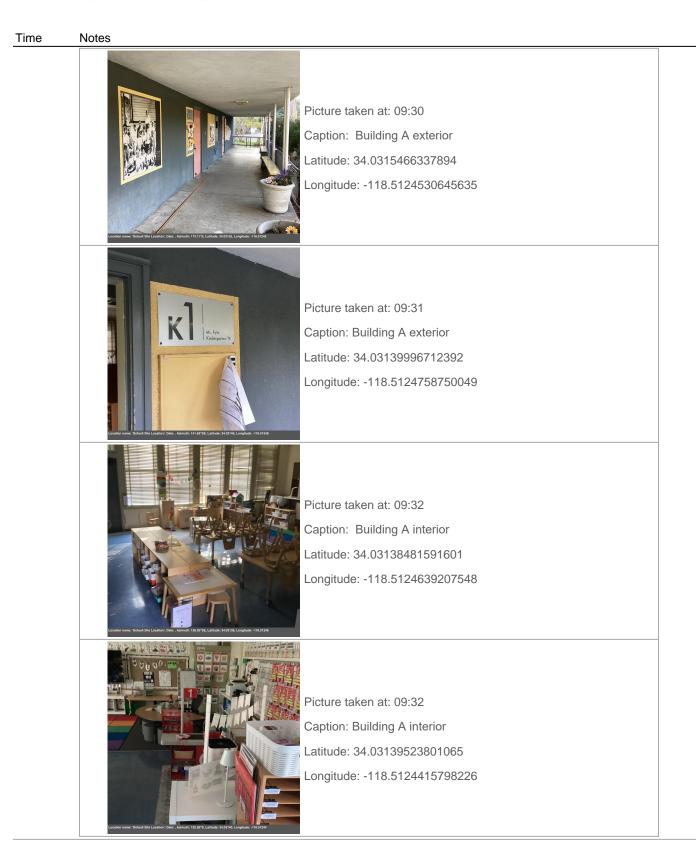
Time	Notes
	Picture taken at: 09:33 Caption: Building A restroom Latitude: 34.03143014970868 Longitude: -118.512416889997
	Picture taken at: 09:33 Caption: Building A restroom Latitude: 34.03143554005902 Longitude: -118.5124149446796
	Finite The Locate For Land Barry Locate Here Here
	Picture taken at: 09:33 Caption: Building A interior Latitude: 34.03143779343374 Longitude: -118.5124059224046

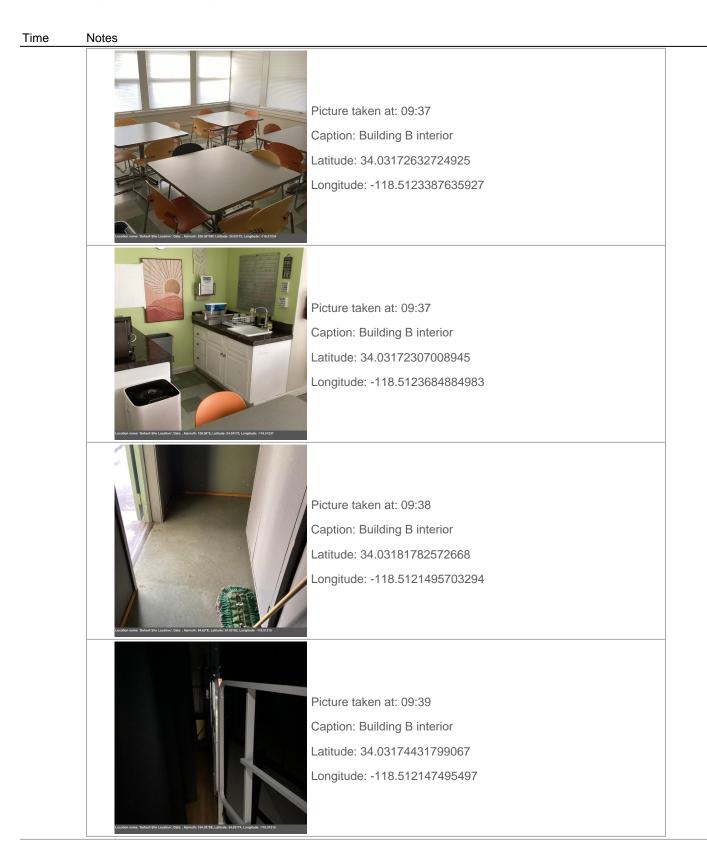
Externance Description of the	Picture taken at: 09:36 Caption: Building B interior Latitude: 34.03174049849208 Longitude: -118.5122986968754
Lader mer: Verde Bie Locator daw. Aannee Baer Landee Juditri Laquest: H1122	Picture taken at: 09:36 Caption: Building B interior Latitude: 34.03176181366845 Longitude: -118.5122874041454
	Picture taken at: 09:37 Caption: Building B interior Latitude: 34.03172922394384 Longitude: -118.5123287922241

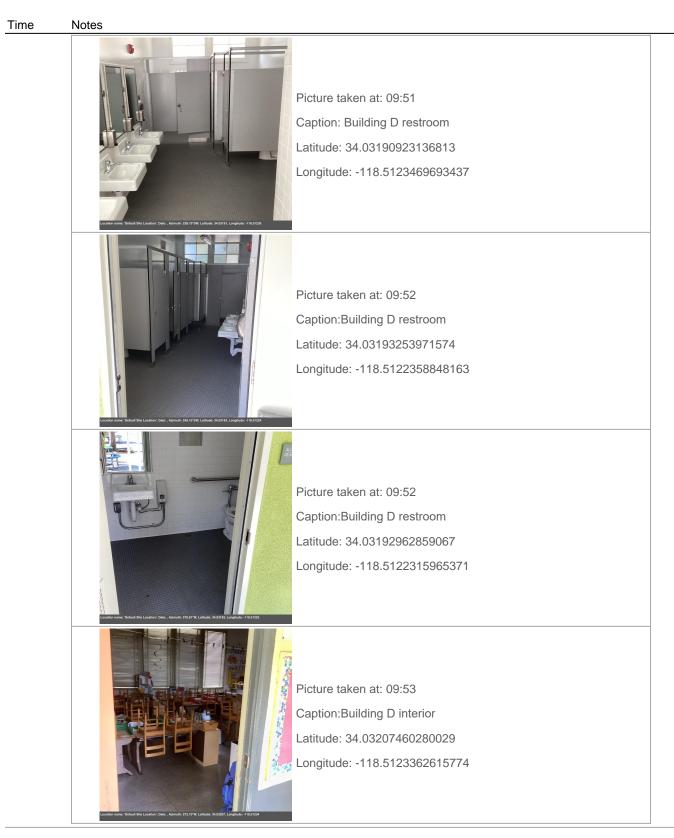
Picture taken at: 09:50 Caption: Building D exterior Latitude: 34.03189348123793 Longitude: -118.5122315096369

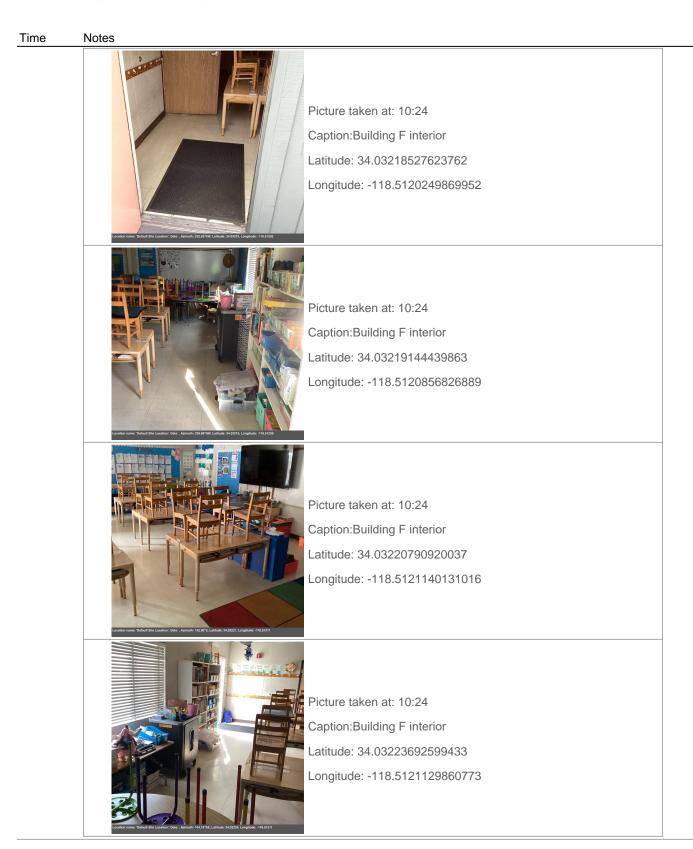
Picture taken at: 10:23 Caption:Building F interior Latitude: 34.03208285978619 Longitude: -118.5120027572246

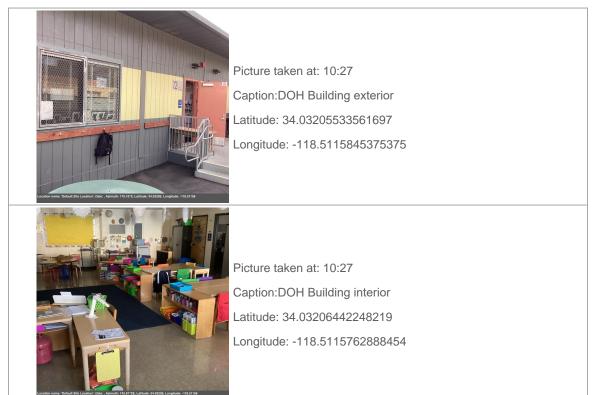
10:27 No ash or odor observed in the DOH building.
