Limited Wildfire Smoke Impact Assessment
Lanai Road Elementary School
4241 Lanai Road
Encino, California 91436

Los Angeles Unified School District
333 S. Beaudry Avenue, 21st Floor | Los Angeles California 90017

January 23, 2025 | Project No. 211936035

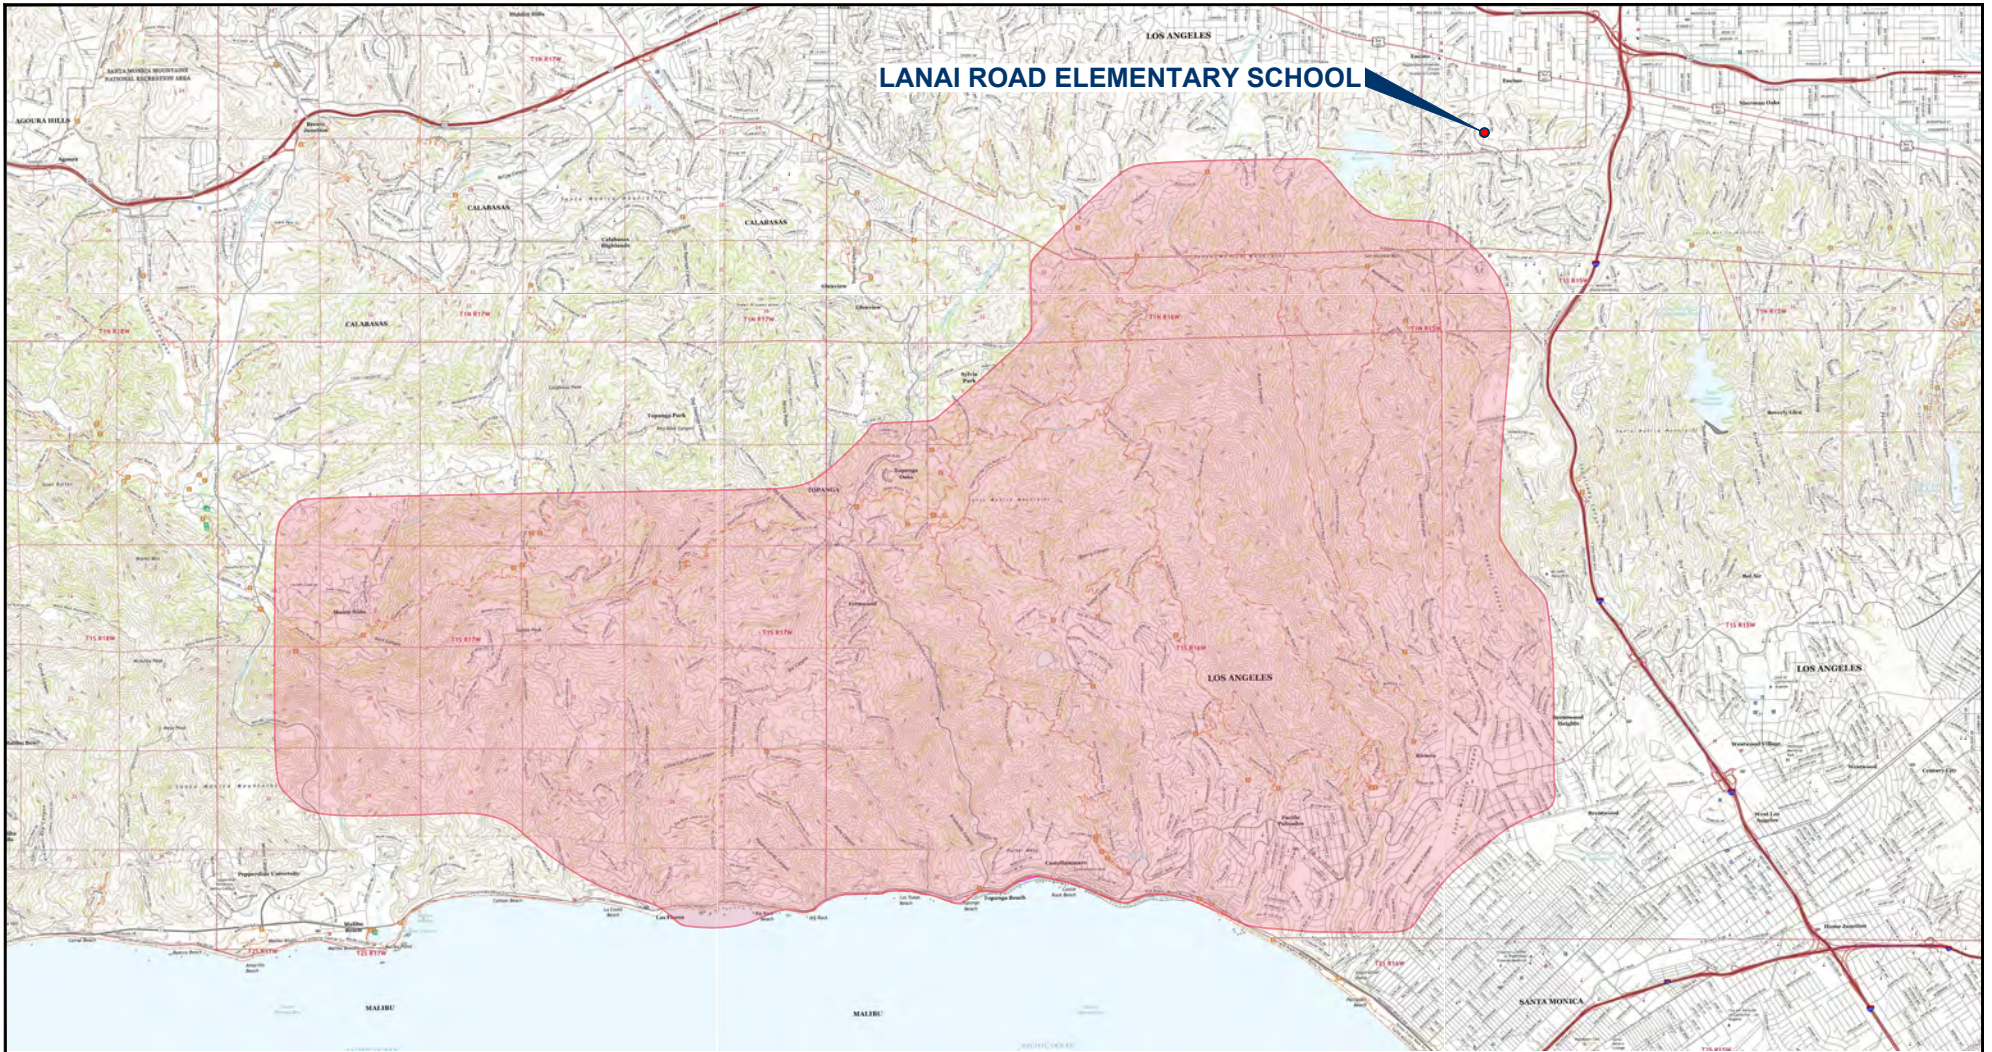
Figure 2 – Lanai Road Elementary School Showing the Areas Inspected

Odors related to the wildfire were not noted in indoor areas. Because a multitude of structures were destroyed during this fire, a calibrated Mini RAE® photo-ionization detector (PID) was utilized on site as a field screening tool to help identify whether measurable levels of gases or organic vapors were present in occupied areas. Organic vapors were not detected when using a PID. Figure 2 depicts the Lanai ES showing the areas inspected. Photographs of the site are provided in Appendix B. Specific classrooms and other interior areas are identified in Appendix C with notes provided for each inspected area.
